# M1 Junction 9 Initial Road Safety Assessment

Hertfordshire County Council

17 June 2025

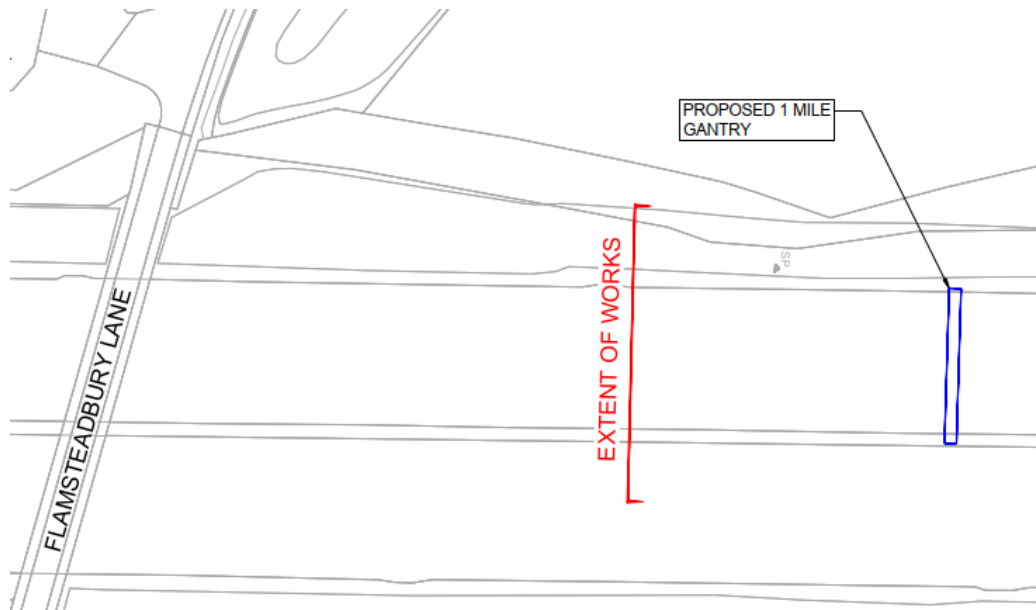
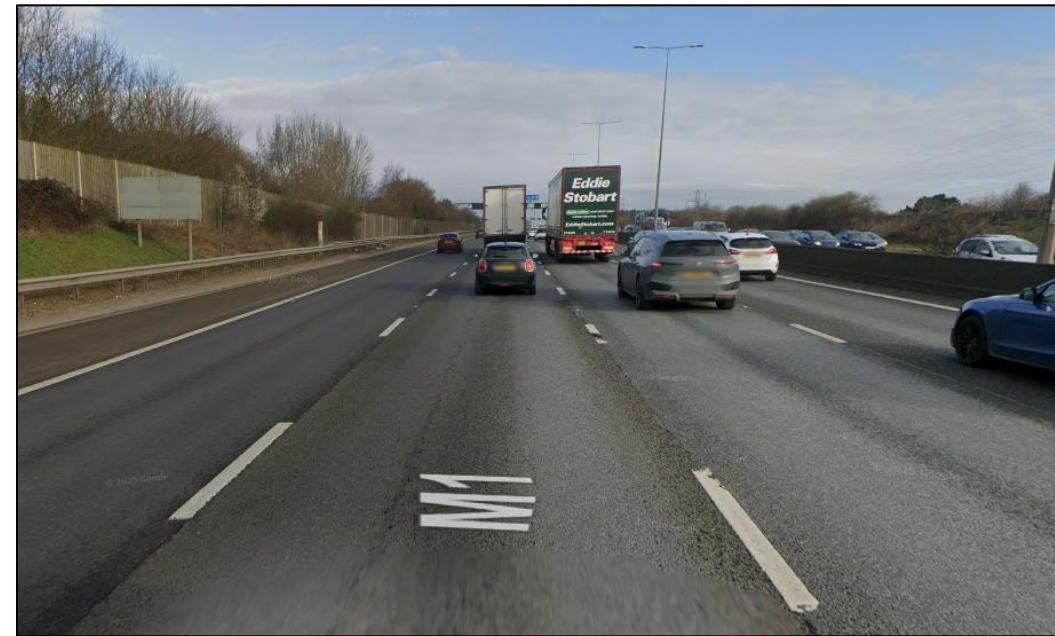
### A. Proposed 1 mile gantry may obstruct visibility to existing (blank) sign

As no site visit has been undertaken, it is difficult in some instances to pinpoint the exact location for existing and proposed infrastructure.

There is an existing sign (which is currently blank) close to the location the proposed 1 mile gantry. Assuming that information is provided on the sign in the future, the relocated nearside gantry leg may obstruct drivers visibility to the sign.

**It is recommended that the gantry is not located in front of this sign. It is also recommended that this sign is removed if no longer required.**

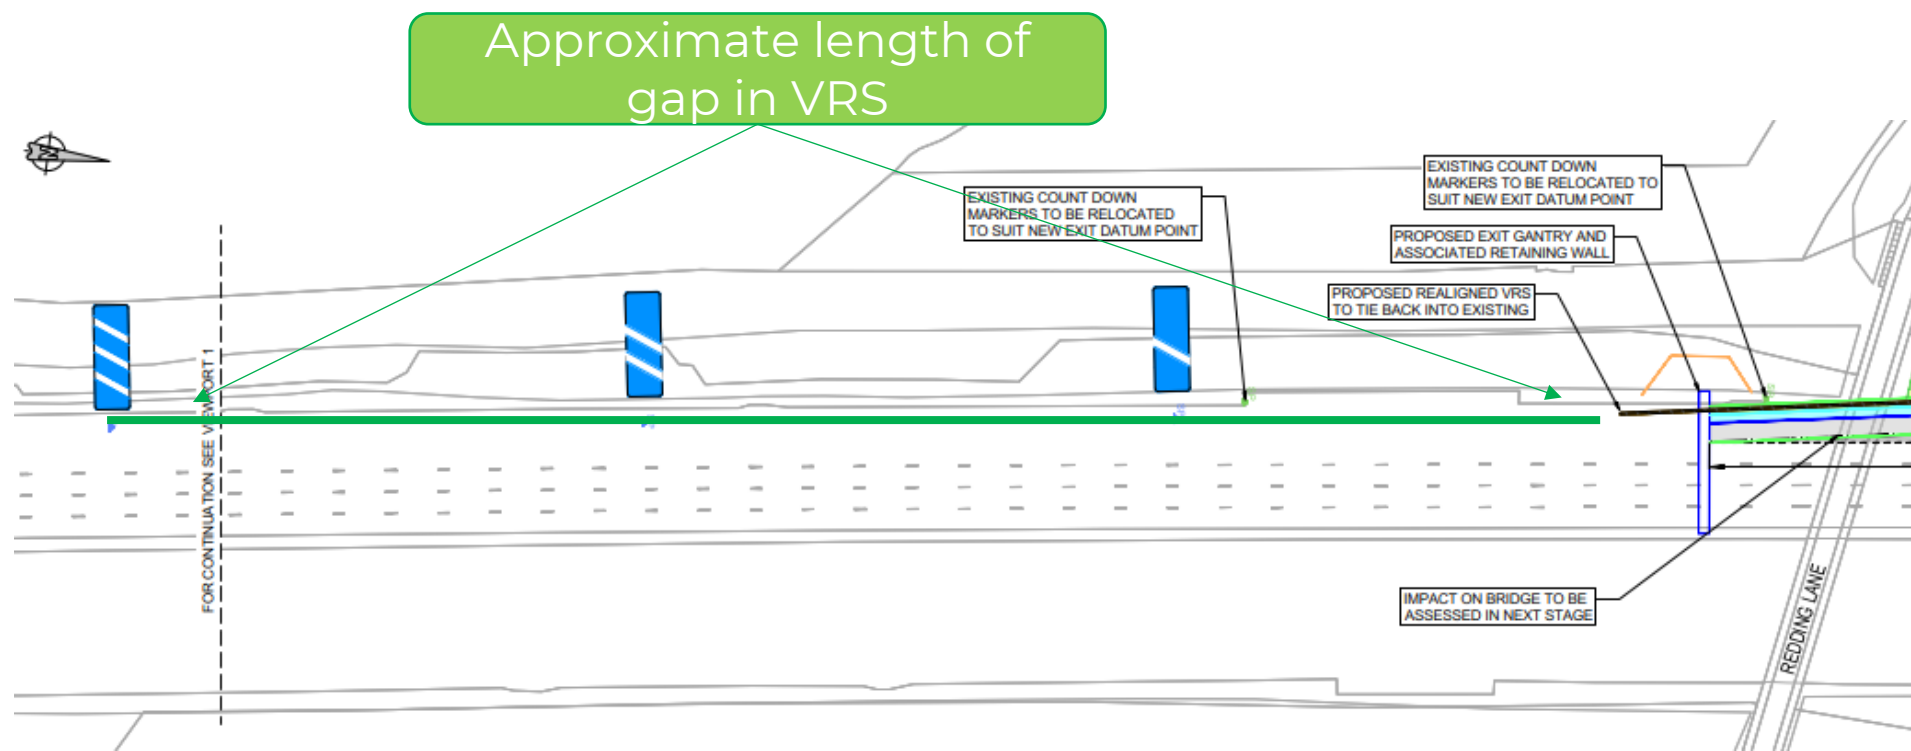
### B. Relocated count down markers may no longer be protected by the Vehicle Restraint System (VRS)

The majority of this section of the M1 is provided with a Vehicle Restraint System (VRS) on the nearside. However, there is a gap in the VRS which begins after the existing 1/3 mile gantry, and starts again after the existing 300 yard countdown marker sign. VRS is not shown on the plans except for at the tie in at the diverge, so it is difficult to see its exact location. Currently, only the first of the countdown marker signs is situated within the gap in VRS.

The scheme relocates all three count down marker signs, so that all three might unprotected by the VRS.

Errant vehicles may hit these signs and this may increase the severity of a collision.

**It is recommended that additional VRS is provided to remove the gap entirely**

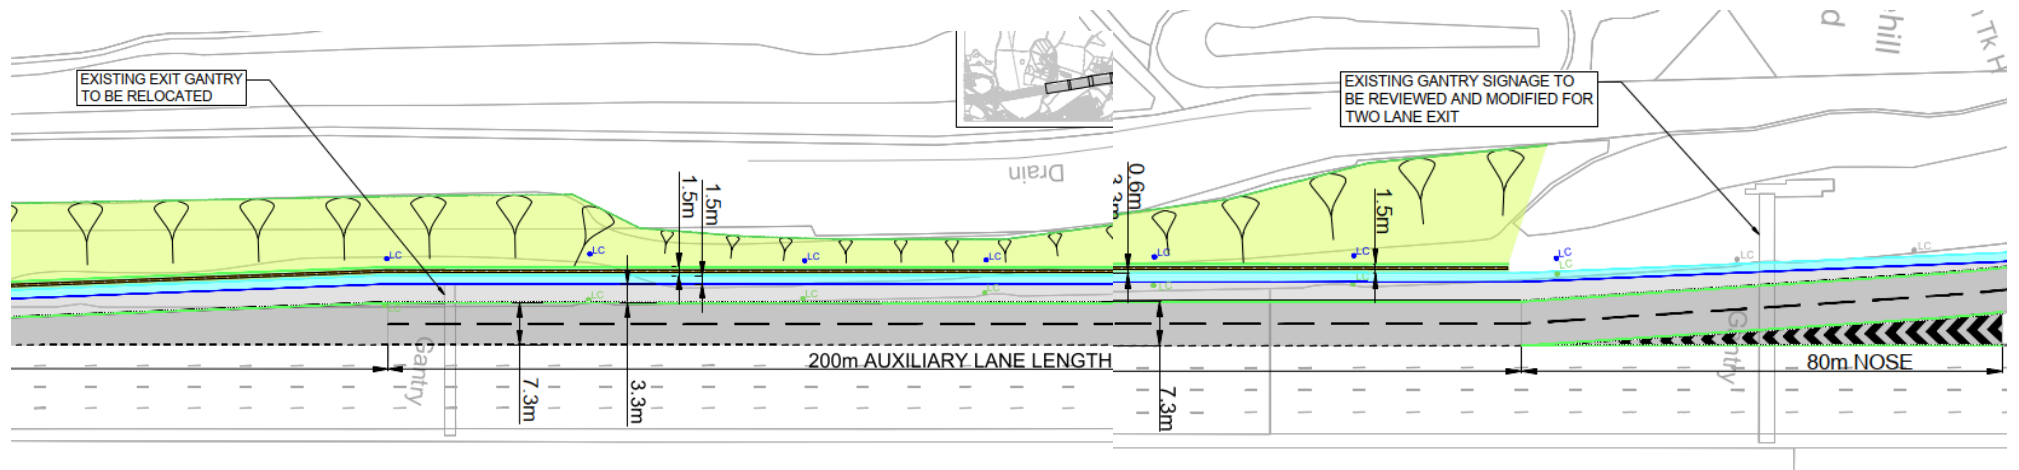
#### C. Existing exit gantry sign may be too late to inform drivers that there are 2 lanes

The plans show that the existing gantry sign located as the off-slip deviates away from the mainline will be reviewed and modified to support two lane operation, however it is not proposed to be relocated.

The scheme extends the length of the off-slip and provides two lanes for its duration. The location of the existing exit sign may be too late to provide useful information to drivers to use two lanes.

This may result in late lane manoeuvres and side-swipe collisions.

**It is recommended that the gantry sign is be relocated to where drivers begin to use two lanes of traffic, and it should provide information that matches the signs and road markings on the roundabout entry.**

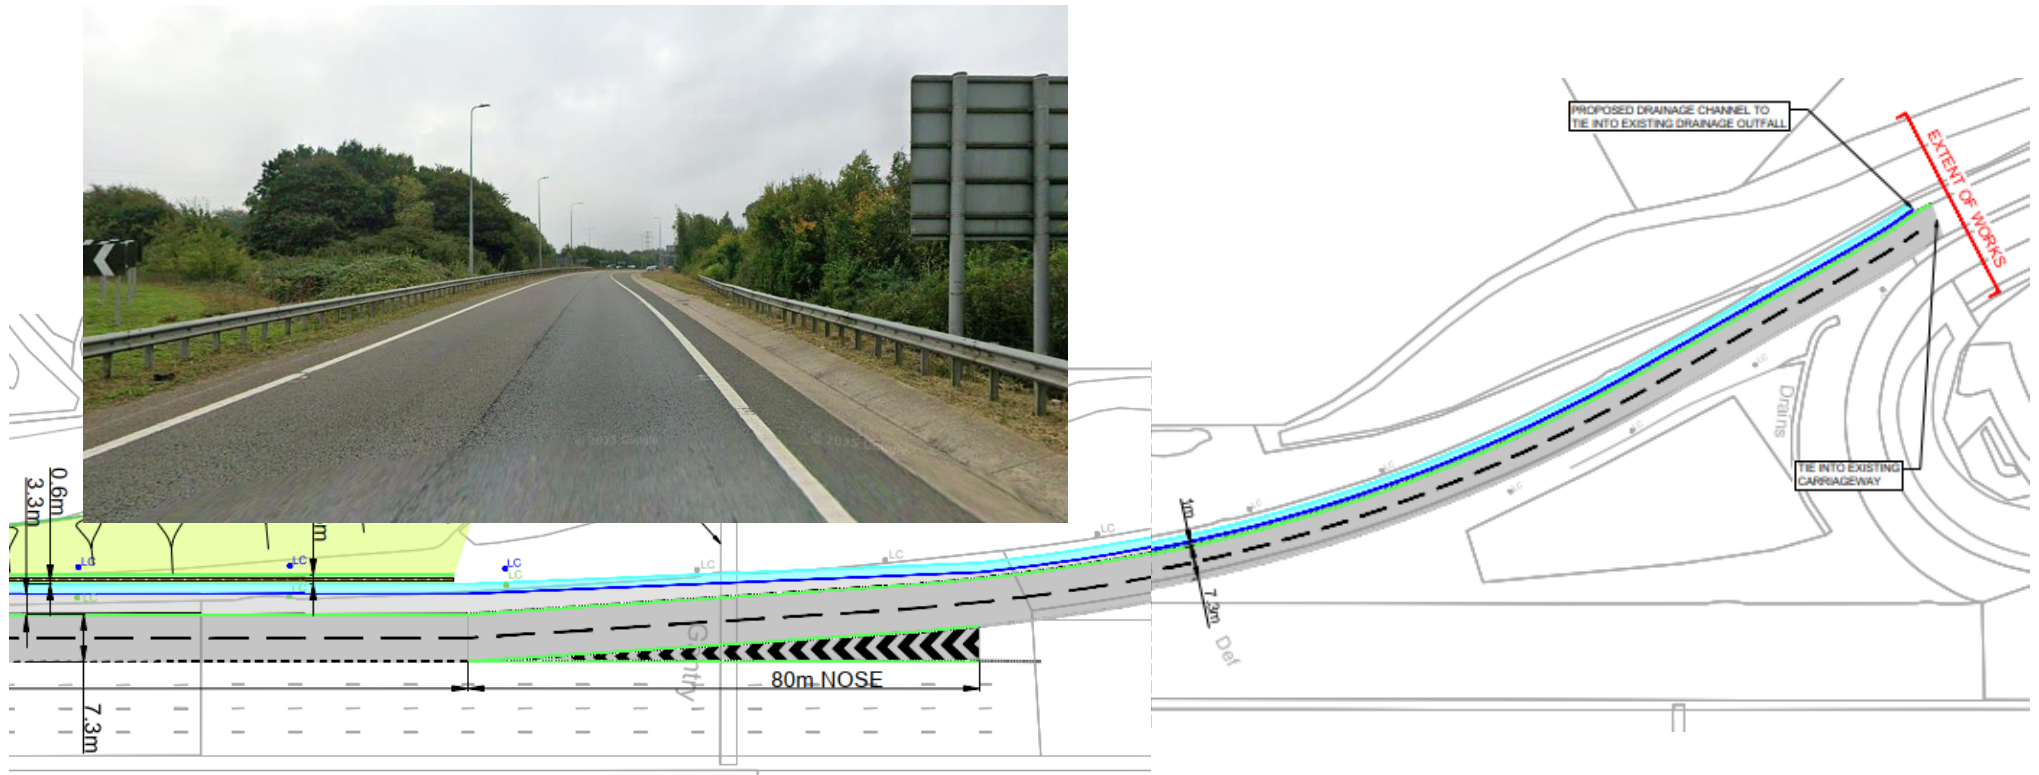
#### D. Visibility around the bend may be reduced due to the widening and change to two lanes

There is an existing left-hand bend within the off-slip that drivers navigate on the approach to the roundabout at junction 9. There is currently an area of land kept clear of vegetation, presumably to maintain adequate forward visibility.

The scheme widens the off-slip and provides two lanes leaving the M1. The drawings do not show any additional areas of vegetation clearance. The changes may result in reduced visibility and drivers may fail to see broken down vehicles, objects in the carriageway or queuing traffic from the approaching junction.

**It is recommended that appropriate visibility is maintained throughout the off-slip.**

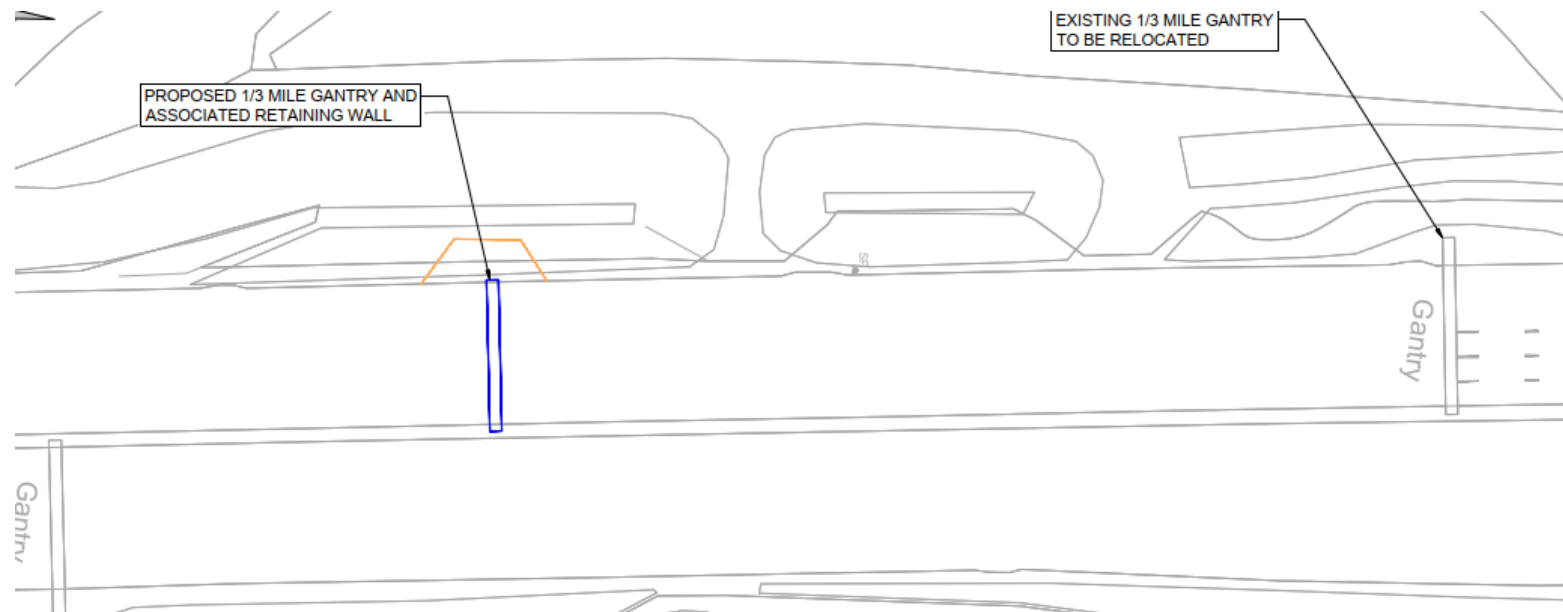
### E. Gantry sign leg may be located too close to Vehicle Restraint System (VRS) for it to operate safely

The scheme proposes to relocate gantry signs as part of the off slip extension. The drawings provided do not show the location of all the Vehicle Restraint System (VRS) and the early stage of design means that the information on sign size and location may be more indicative.

However, as shown, some of the gantry sign legs may be located close to the existing VRS. This may result in the VRS failing and increasing the severity of any injuries resulting from errant vehicles hitting the VRS.

**It is recommended that all the gantry sign legs are installed an adequate distance behind the VRS**

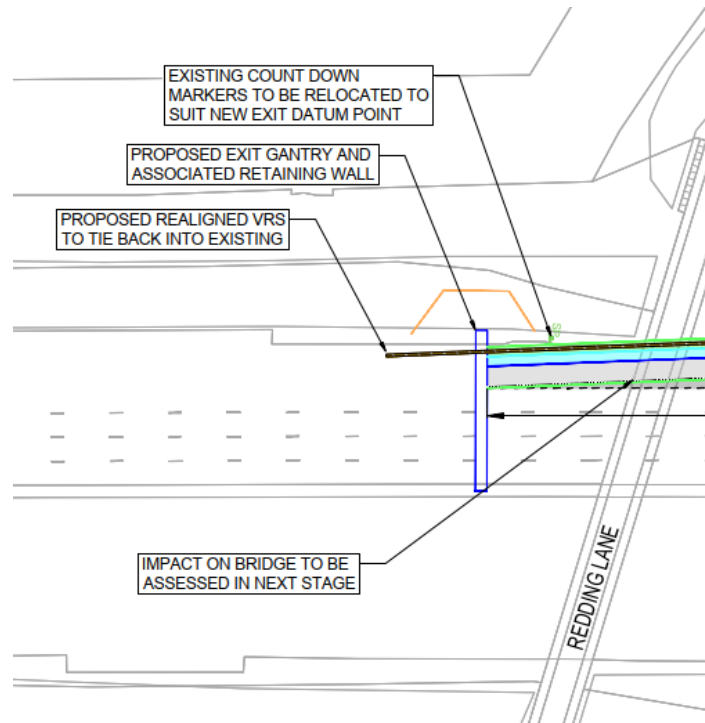
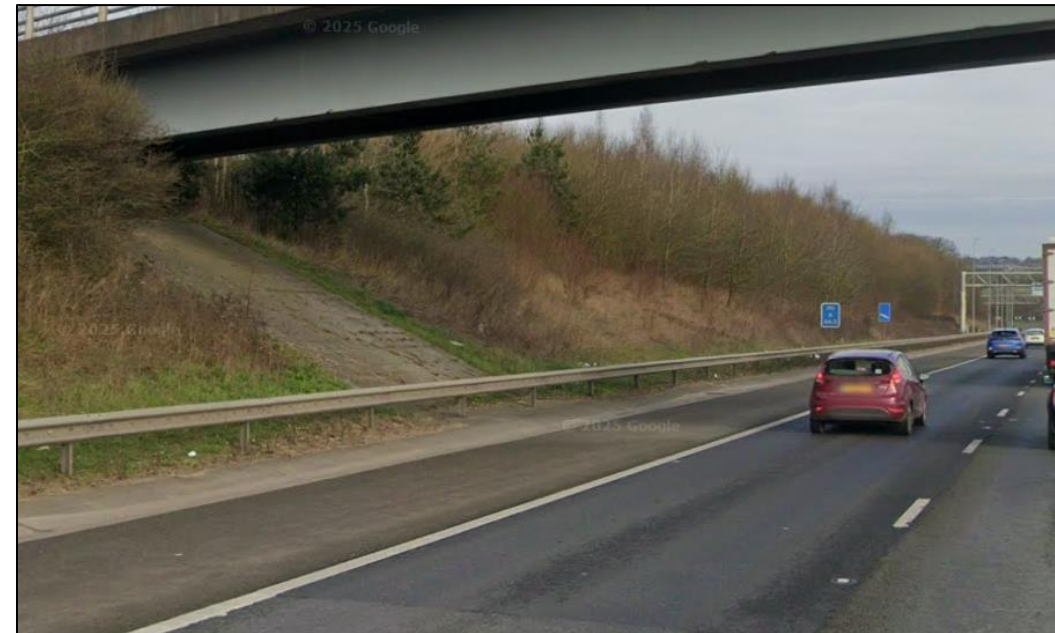
### i. Widening the carriageway under bridge may not be feasible given the proximity of the bridge's retaining structure

The proposal includes the widening of the road underneath the Redding Lane bridge. The widening is relatively modest, however, there appears to be little space between the edge of the road and the bridge retaining structure.

If the plan is to upgrade the retaining structure (and increasing the gradient) to provide additional road-space, then the widening can be accommodated.

However, if there are no plans to adjust the retaining structure, then there may not be enough space to facilitate the road widening. This may result in narrower lanes or a shorter length of exit taper at this location – which may increase the likelihood of collisions.

**It is recommended that this area is reviewed prior to the next phase of design to ensure that current assumptions are workable.**
