5 T2784 OAK TREE - CELL BARNES LANE

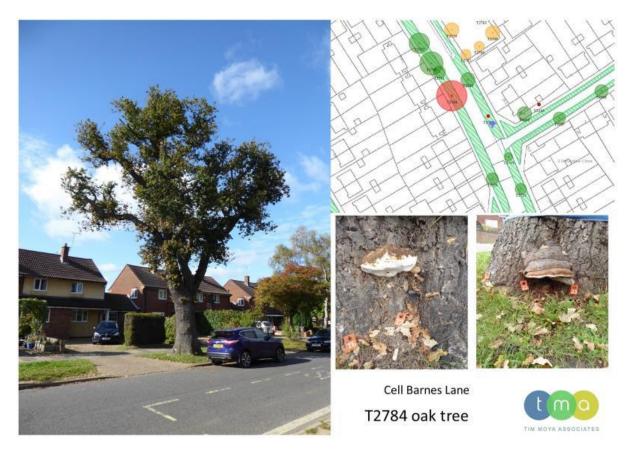
T2784 oak tree Cell Barnes Lane: with map showing location (tree highlighted in red) and Ganoderma sp. fungal fruit bodies around the base.

- 5.1 A large, late-mature tree in poor physiological condition with moderate vitality and well-developed buttressing growing in a grass verge by a busy road within falling distance of residential properties and car parking.
- 5.2 Ganoderma sp⁵ fungal fruit bodies are present around the base and tap testing indicates significant internal decay/hollowing. The crown of the tree has recently been significantly reduced.

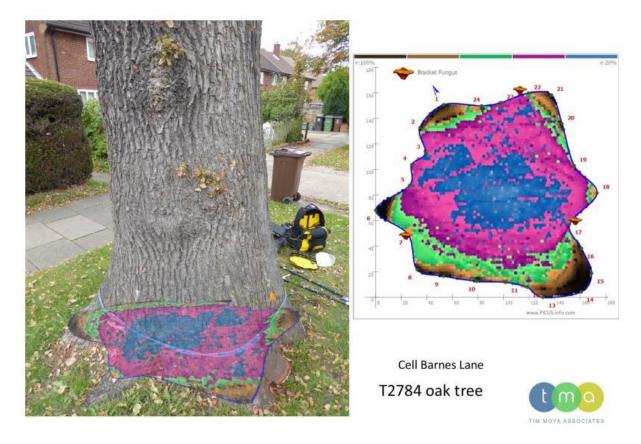
T2784 oak tree Cell Barnes Lane PiCUS: sonic tomogram (right) superimposed in approximate position over the stem (left).

- 5.3 The tomogram reveals low velocities indicating decay/hollowing (blue, pink) which is developing (green) within a small proportion of sound wood (dark brown) remaining around the circumference.
- 5.4 The process of sonic tomography can exaggerate internal decay around the circumference where internal decay (or cracks) are present, so additional testing using the RESI PD was undertaken.

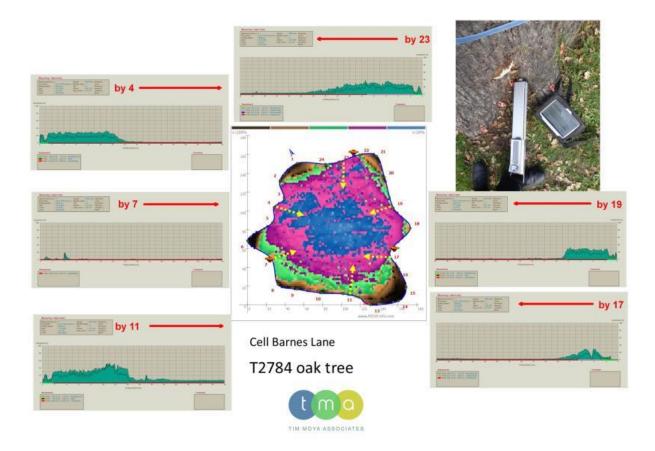
T2784 oak tree Cell Barnes Lane RESI PD: graphs with direction and location indicated, shown around the tomogram for reference with an image of a test being undertaken.

- 5.5 The graphs reveal very little sound wood remaining around the circumference and confirm significant internal decay/hollowing is present at the base of the tree.
- 5.6 The extent of decay identified in this investigation is considered to present an unacceptable risk of harm or damage through tree failure, so tree removal (and replacement) is recommended.
- 5.7 Please see below and updated tree record on the MyTrees server for details.
