Lea Valley Line – Harpenden Section

Greenspace Action Plan

2019 - 2024

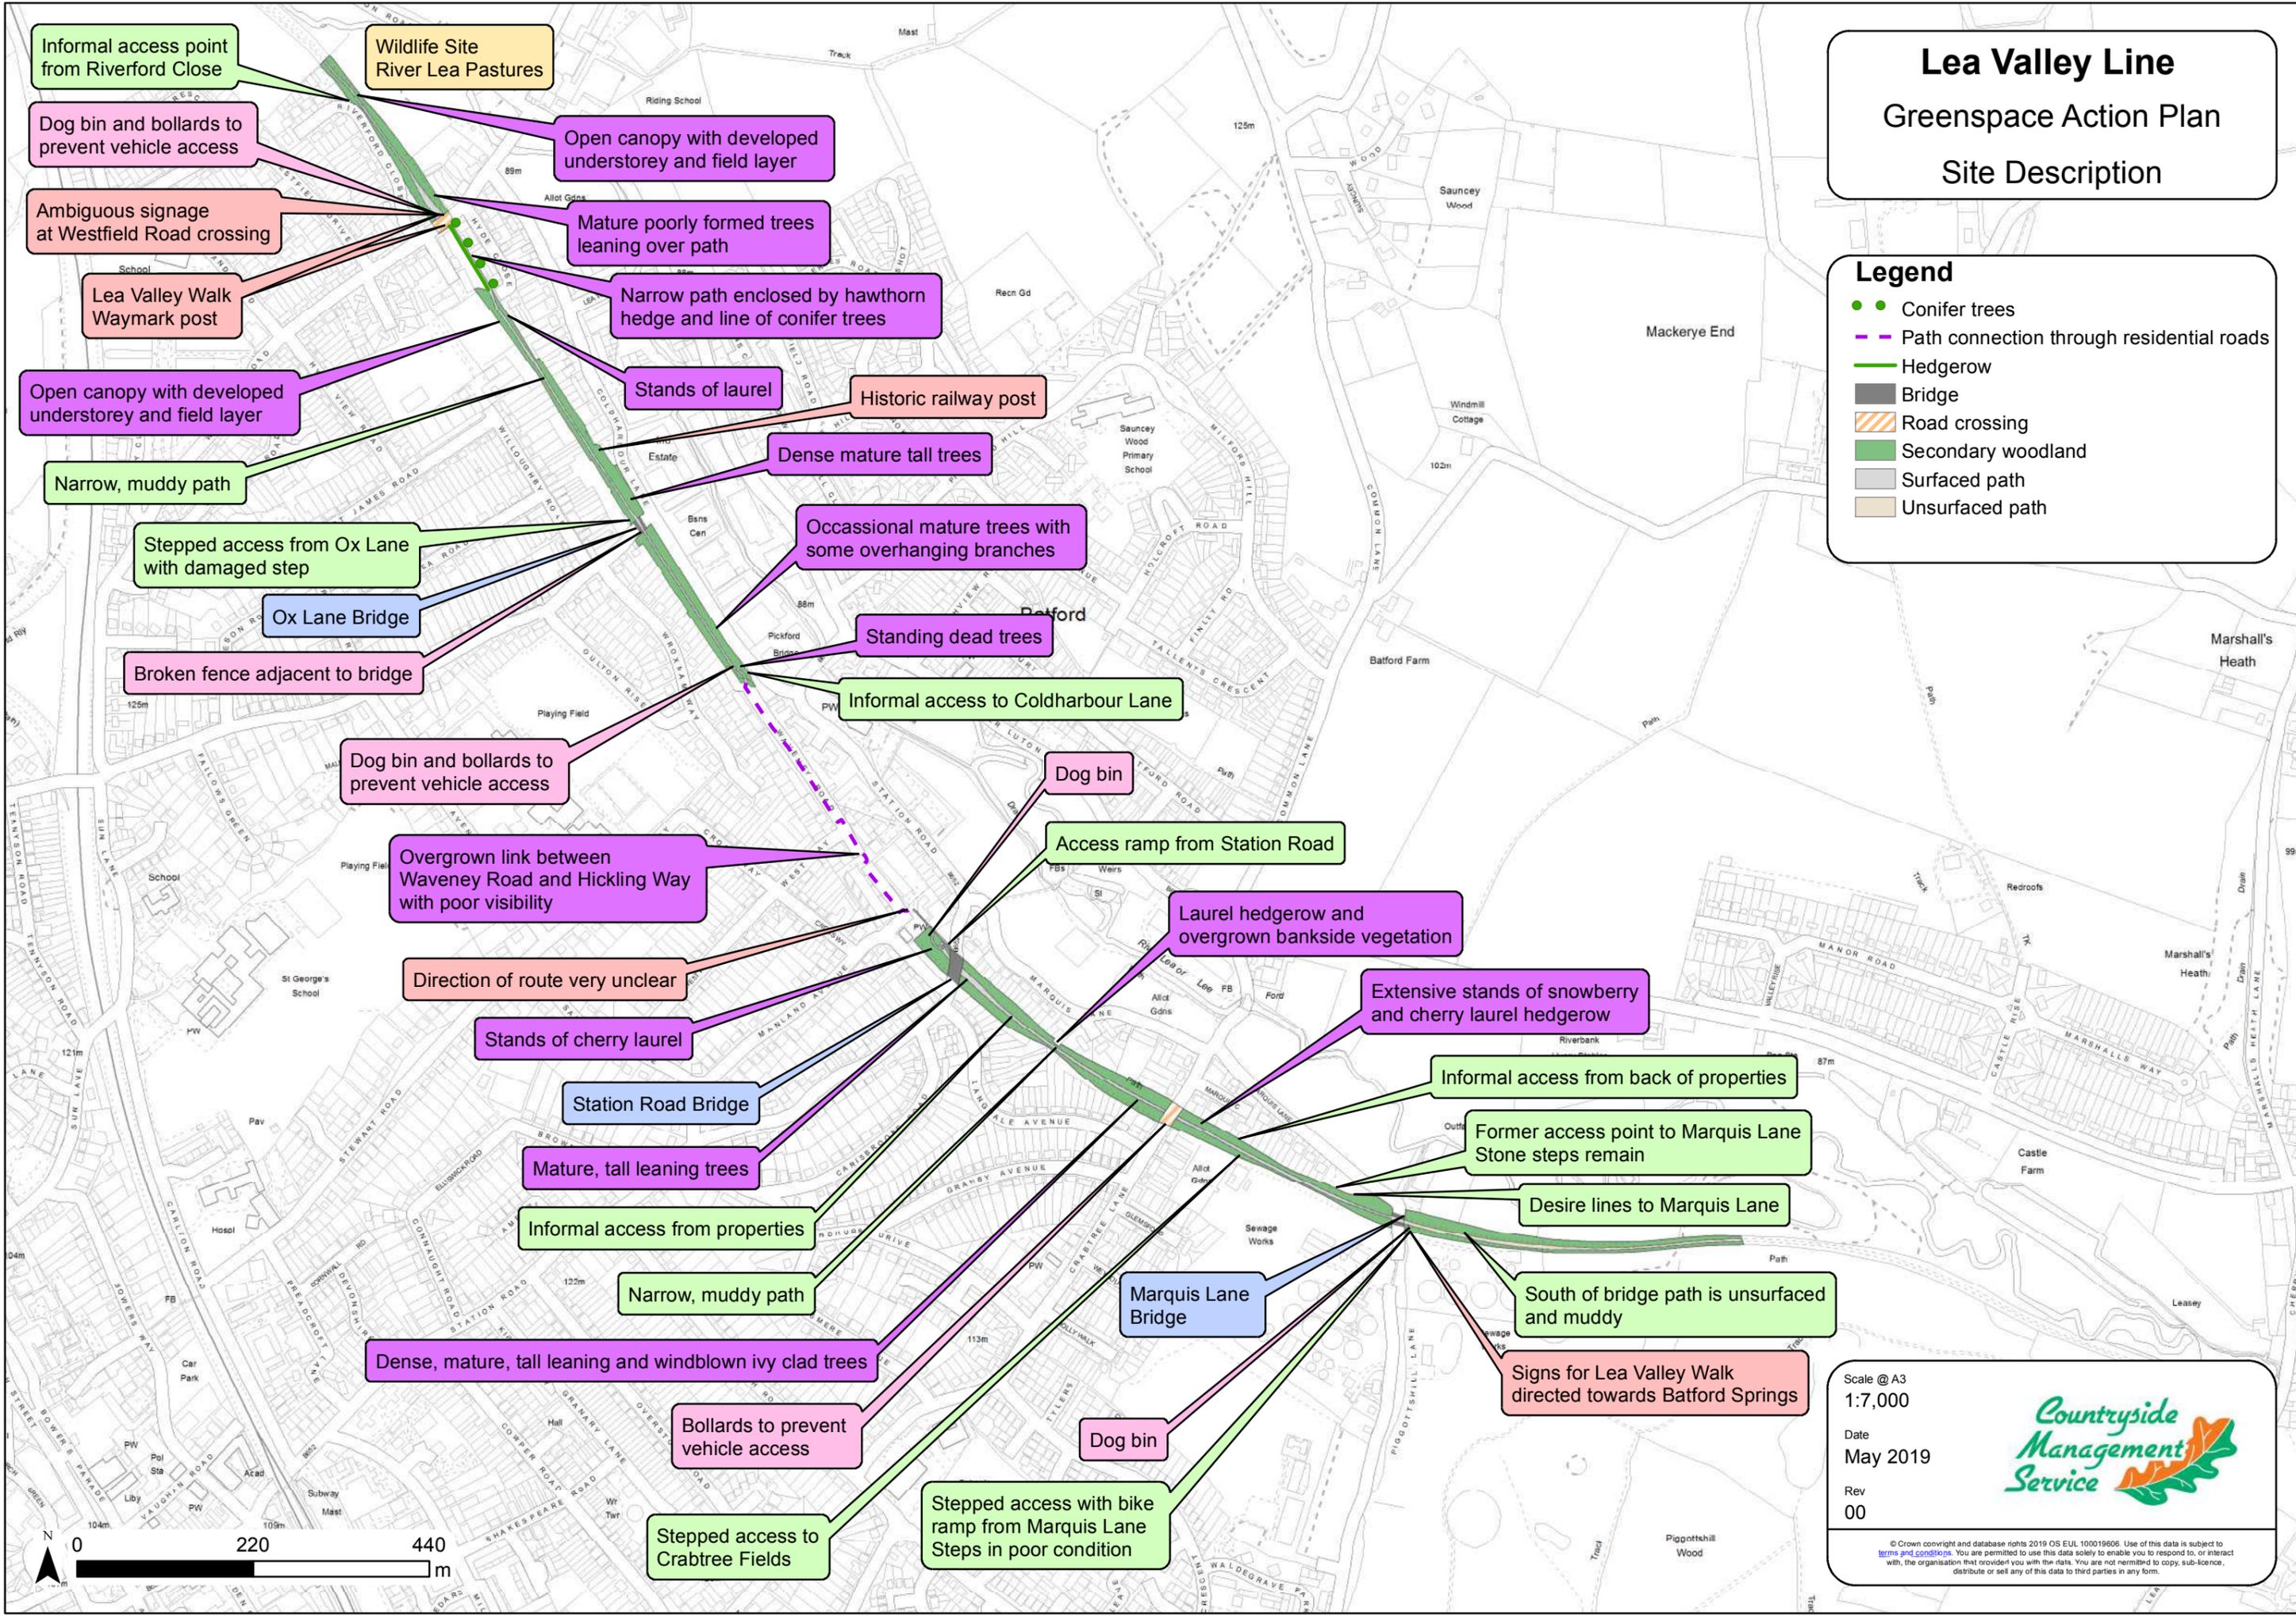
Ambiguous signage at Westfield Road crossing

Mature poorly formed trees leaning over path

Stepped access from Ox Lane with damaged step

Broken fence adjacent to bridge

Overgrown link between Waveney Road and Hickling Way with poor visibility

Stepped access with bike ramp from Marquis Lane Steps in poor condition

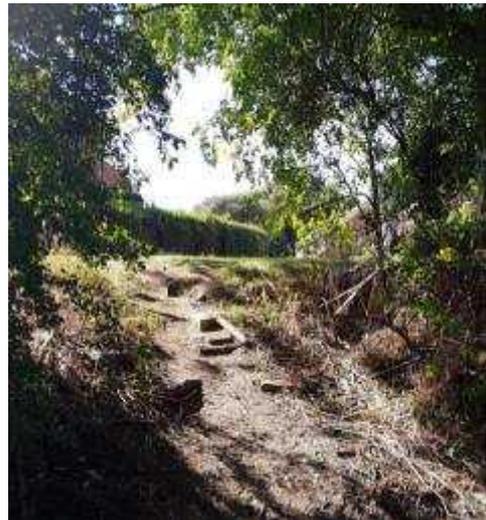
Informal access from Riverford Close

There is evidence of informal access from Riverford Close, which is causing bank erosion and is unsafe for users. This access point needs to be formalised with the installation of steps and appropriate signage. A number of the stepped access points require improvement. The steps adjacent to the bridges from Ox Lane and Marquis Lane require fixing. The steps leading from the Wasteland have an inadequate flat landing which needs to be replaced. Where space allows, channels for bicycle wheels should be installed alongside steps to make access easier for cyclists. This may not be possible at the Ox Lane entrance where space is limited. There are stone steps leading down to Marquis Lane through an area of overgrown scrubby woodland. These steps form a historic route and are in a state of disrepair. This route will not be opened up, and the growth of scrubby vegetation will be encouraged at the entrance to discourage usage.

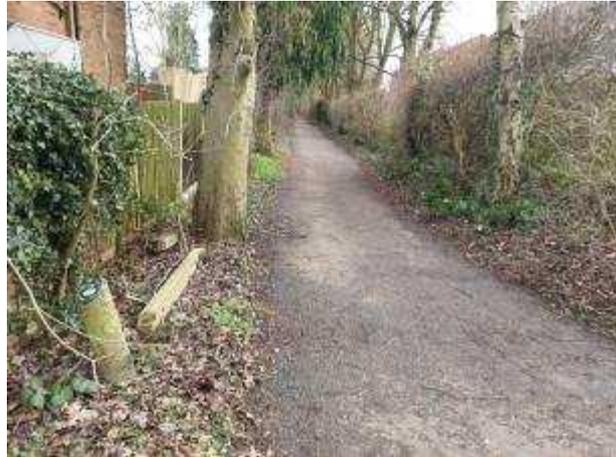
Westfield Road – Open access to pedestrians and cyclists with bollards to prevent vehicular access. Old signs for the Lea Valley Walk are provided here, but these are in poor condition and hidden from view.

Current signage in poor condition and hidden from view

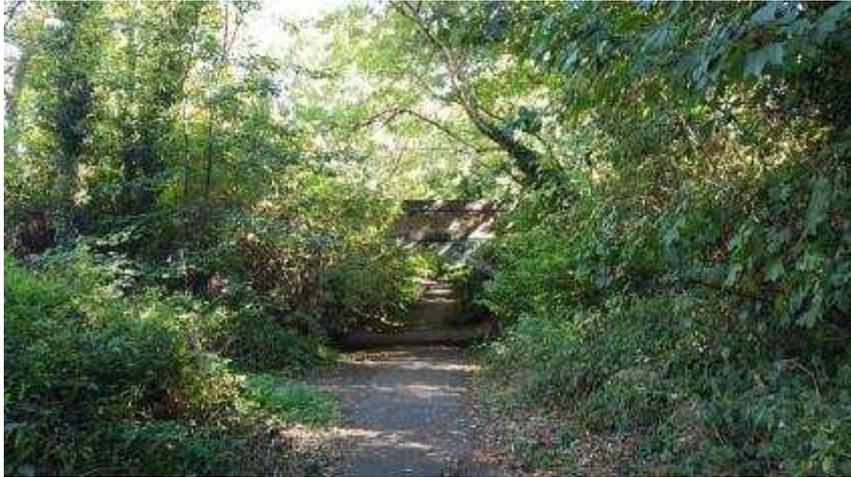
The Station Road Bridge is currently screened from view by overgrown and overhanging vegetation.

Station Road Bridge screened from view

The path passes underneath a bridge which carries Station Road. Overgrown and overhanging vegetation currently obscures the bridge from view. The vegetation surrounding the bridge should be cleared to open it up as a feature.

- a. Clear all trees and scrub within 5 m of Station Road bridge, on both south-east and north-west sides.
- b. Clear all vegetation from the sides and top of the bridge, including all ivy, taking care not to damage the brickwork.
- c. All cut material to be removed from the site.
- d. Tree works to be undertaken between November and February to avoid bird nesting season

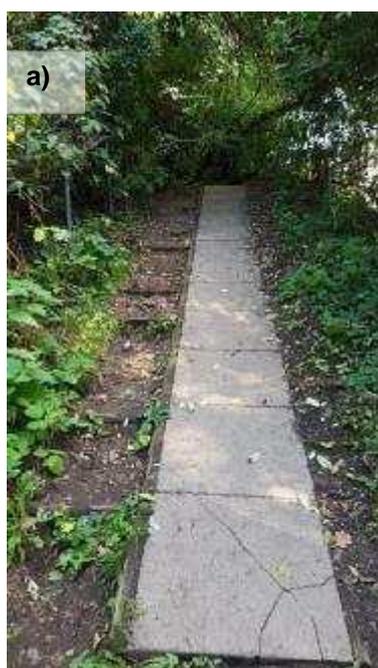
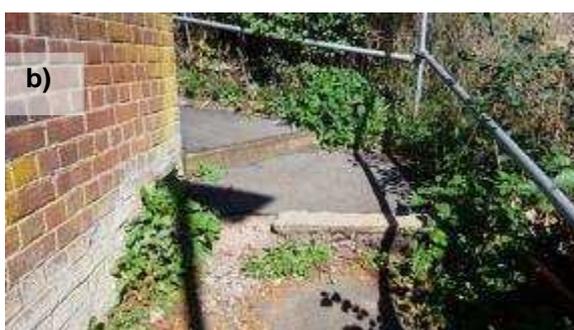
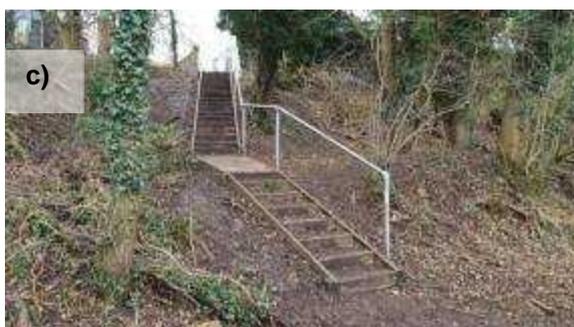
Ox Lane – The route passes over Ox Lane via a bridge, with steps providing access to, and from, the route. Several of these steps have begun to erode and are in need of repair. The fencing adjacent to the bridge is also in need of repair.

Marquis Lane – The route passes over Marquis Lane via a bridge, with steps and adjacent cycle ramp providing access to and from the route. These steps are in poor condition and have eroded. There is also old stone steps present providing access to Marquis Lane through a small overgrown area of woodland.

- a) *Eroded stepped access from Marquis Lane*
- b) *Eroded step from Ox Lane*
- c) *Steps leading towards Crabtree Fields with inadequate flat landing*

1.2	Replace damaged step at Ox Lane Bridge	B2	May	SADC	Contractor	SADC	£500		
1.3	Replace bollards at all road crossings	B2	June	SADC	Contractor	SADC	£5000	S7

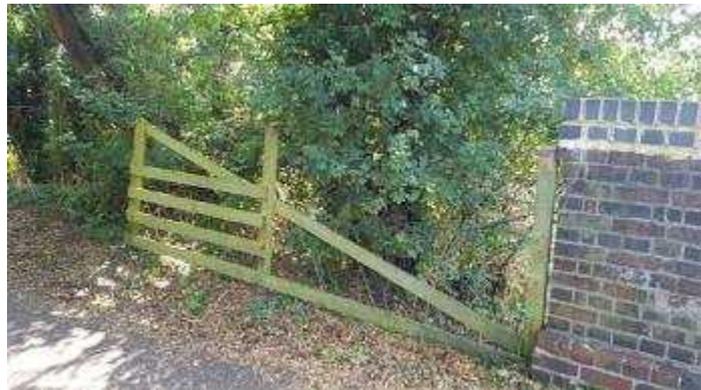
Broken fencing adjacent to the Ox Lane Bridge

The fencing adjacent to the bridge which carries the Lea Valley Line over Ox Lane is in a state of disrepair and requires replacement.

Ref no.	Action	Obj. Ref	When	Lead	Delivery	Funding	Est. Cost	Spec. Ref.	Status
1.1	Remove and replace broken wooden fencing adjacent to Ox Lane Bridge	B2	May	SADC	Contractor	SADC	£300

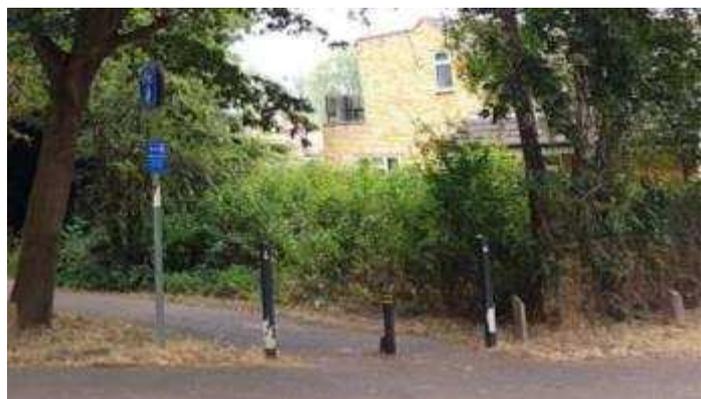
Bollards of varying styles at entrance points

At the road crossings along the Lea Valley Line there are a number of bollards of varying styles. A uniform style will be adopted for all new and replacement bollards which reflect a railways materials palette, such as timber or iron. These will be installed as and when old bollards require replacement.

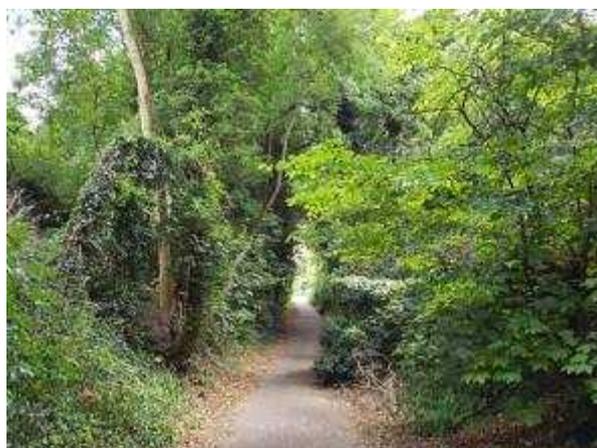
Woodland management is also required to prevent encroachment of trees and scrub onto the route in order to maintain the functional width of the path. This is a particular priority at the following locations; entrance from Westfield Way; adjacent to, and south-east of the Station Road Bridge; and south-east of Crabtree Lane entrance. Woodland management will also be combined with a regular programme of path clearance (see section 4.4.1).

Encroaching vegetation along the route

- a. Maintain a minimum of 4 m height and 1 m margins on either side of the surfaced path free from encroaching vegetation. This includes all access points to the route (see Diagram 1).
