**Land off High Street, Colney
Heath**

**British Standards 5837:2012 Tree
Survey: Arboricultural Impact
Assessment, Method Statement and
Tree Protection Plan**

RSE_5500_01_V1

January 2022

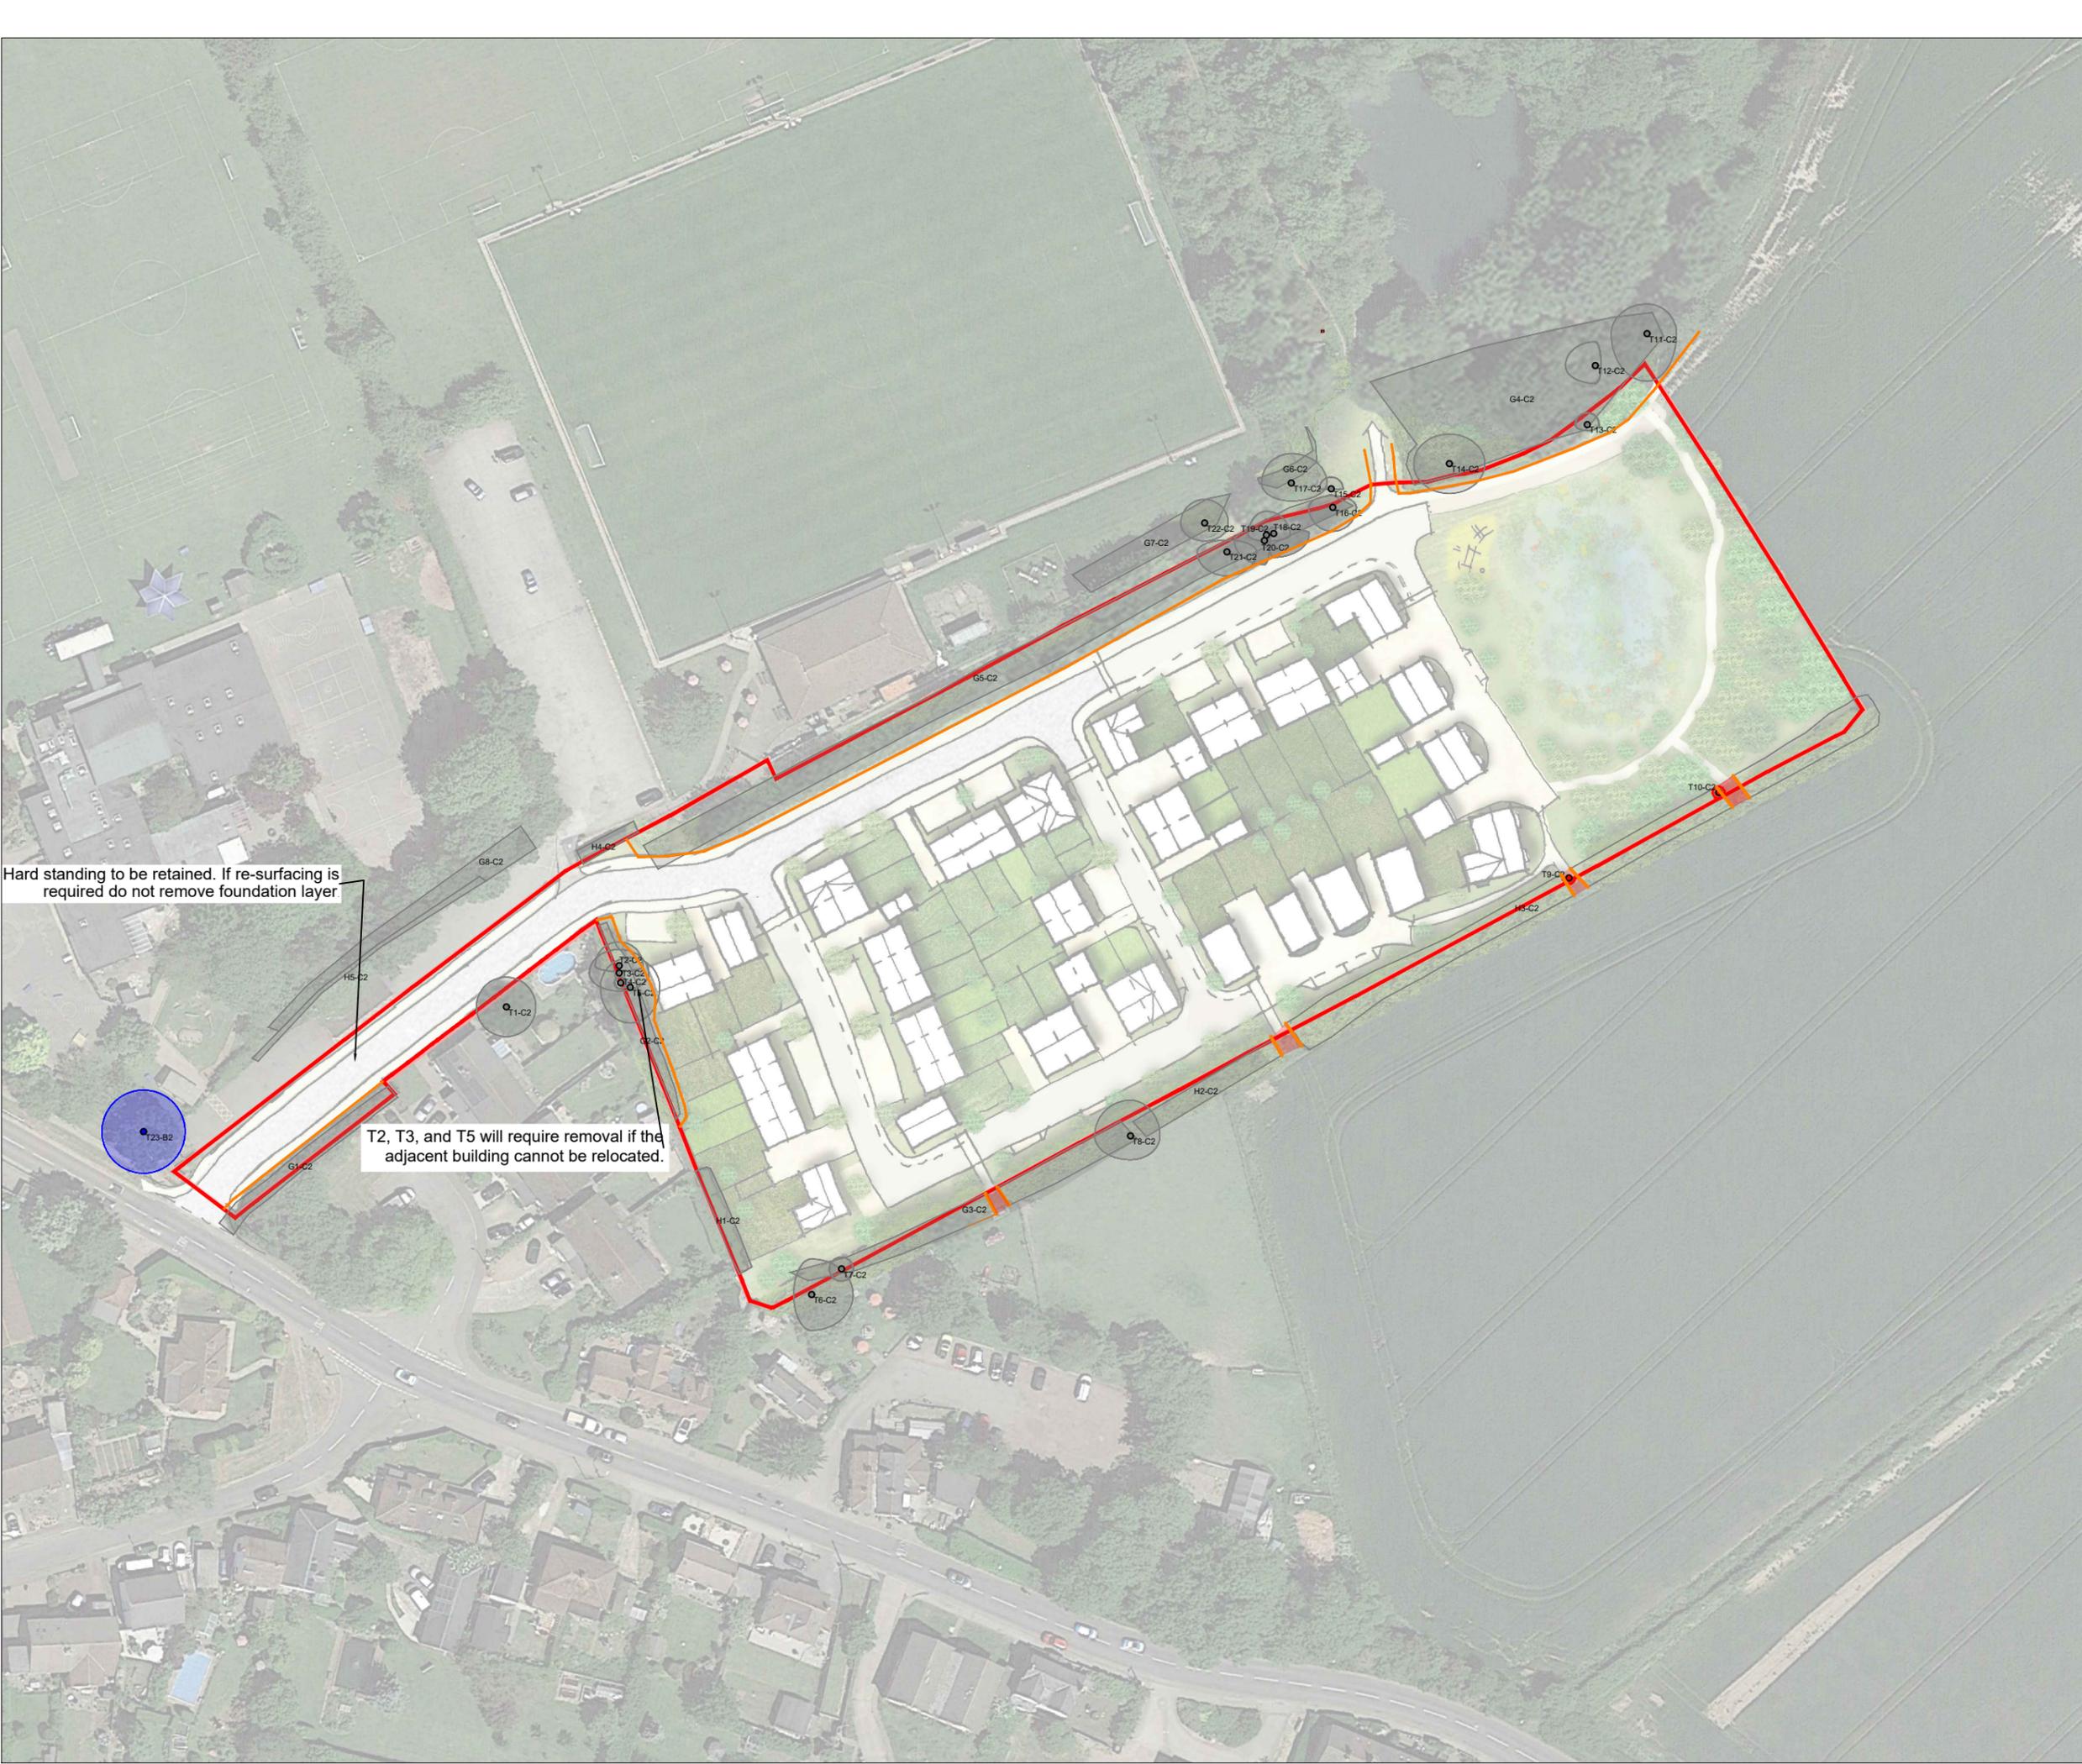
Hard standing to be retained. If re-surfacing is required do not remove foundation layer

T2, T3, and T5 will require removal if the adjacent building cannot be relocated.
