## **River Ver and Verulamium Park Lakes Improvement Project**

### **Reach 1**

#### **Upper section of Verulamium Park including lakes**

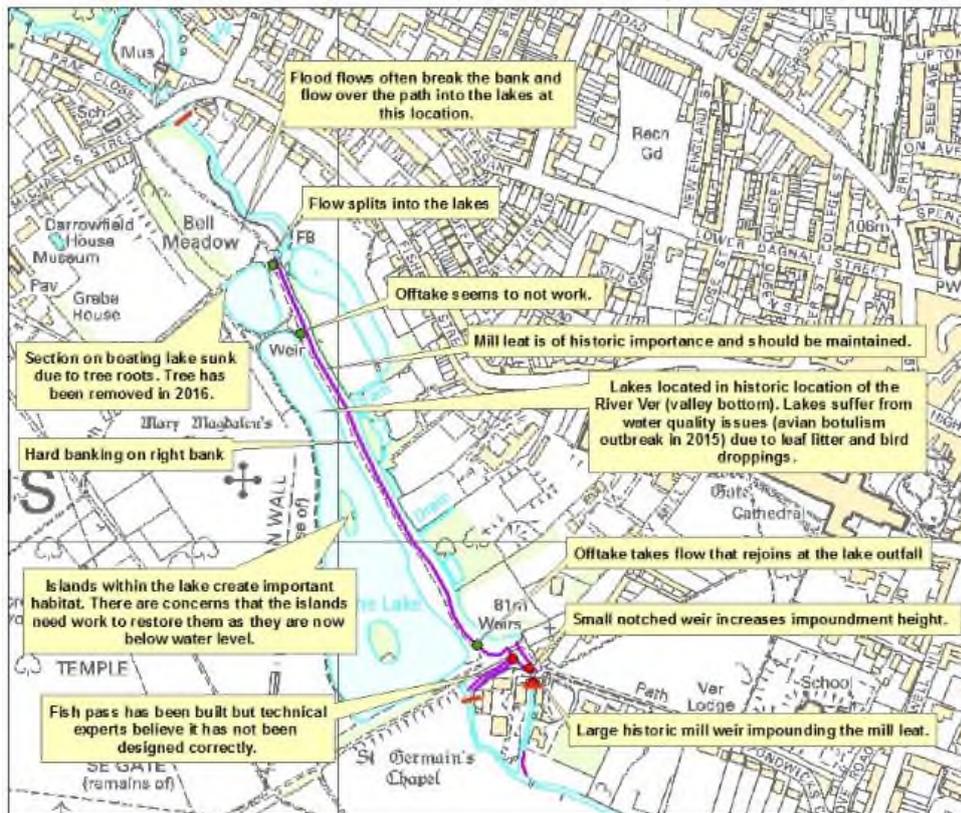
**Figure 3**, Reach 1 issues annotated map

- The river flow is split between the mill leat and the lakes at the upstream end of the reach. At the downstream end of the reach the water flows through another offtake and rejoins the River Ver at the lake outfall. The channel bifurcates into the fish pass channel and the old mill channel.
- The lake suffers from water quality issues which are believed to be due to the shallow nature of the lake, leaf litter accumulating in the lake, wild fowl populations and inappropriate feeding habits of park visitors. This has resulted in suspected avian botulism outbreak and algal blooms.
- The mill leat is impounded and higher than the natural valley bottom. It is over wide with hard banking on the right bank. As such, the habitat within the mill leat is very poor with silt dominated bed and homogenous flows.
- Technical experts believe the fish pass does not work effectively.

Figure 3 highlights these issues on an annotated map.

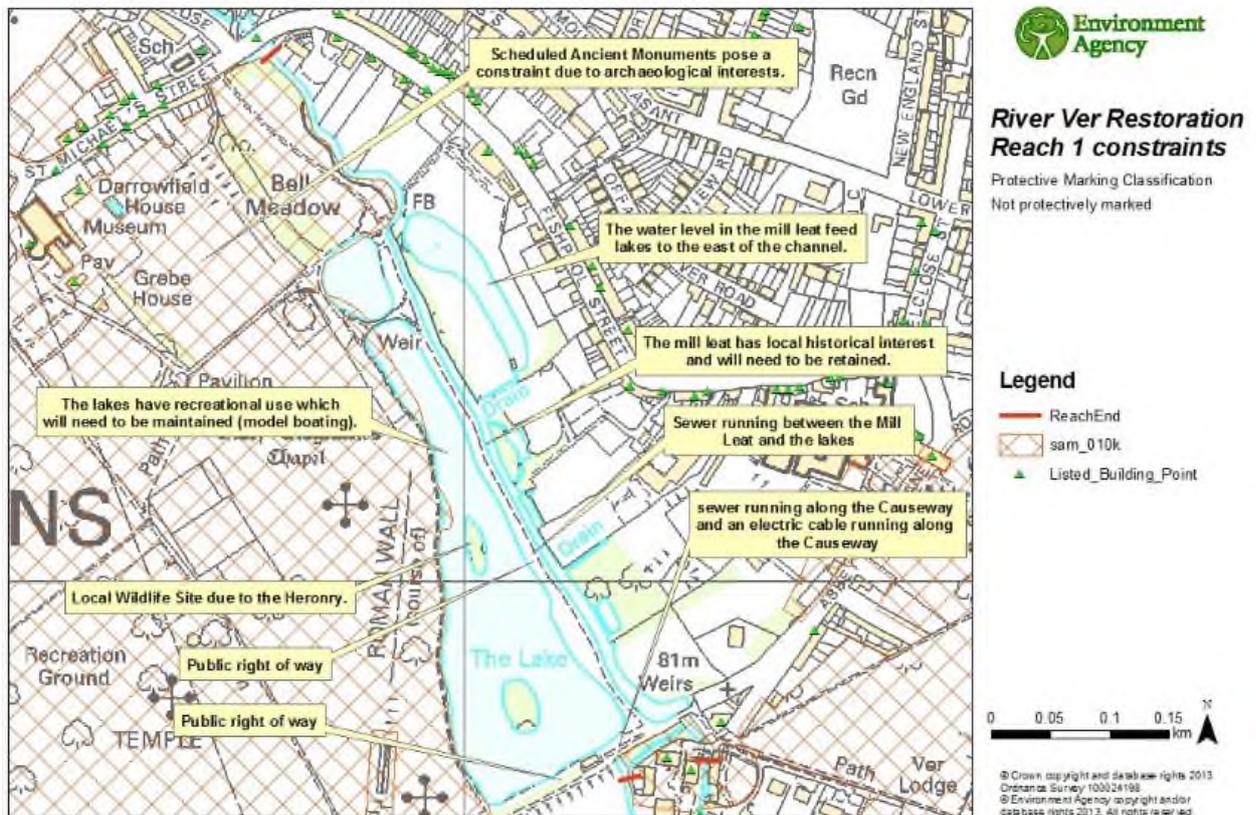
Figure 4, Reach 1 constraints annotated map

- The Scheduled Ancient Monuments.
- The mill leat has local historical interest and may need to be retained in some form.
- The water level in the mill leat feeds online lakes to the north east of the channel.

- Planning restrictions as the site falls within a conservation area.
- The structural condition of the concrete in the lakes is not known.
- Recreational uses of upper lake may need to be maintained for instance model boating.

- The islands on the lakes are a Local Wildlife Site due to the Heronry.
- Services may pose a constraint to the option development (e.g. sewer running between the Mill Leat and the lakes, sewer running along the Causeway and an electric cable running along the causeway).

- Flood risk – there is both potential for increased risk and opportunities for the scheme to deliver a reduction in flood risk.
- Both the causeway and the eastern bank hold Public Rights Of Way, St Albans City 030 & 034.

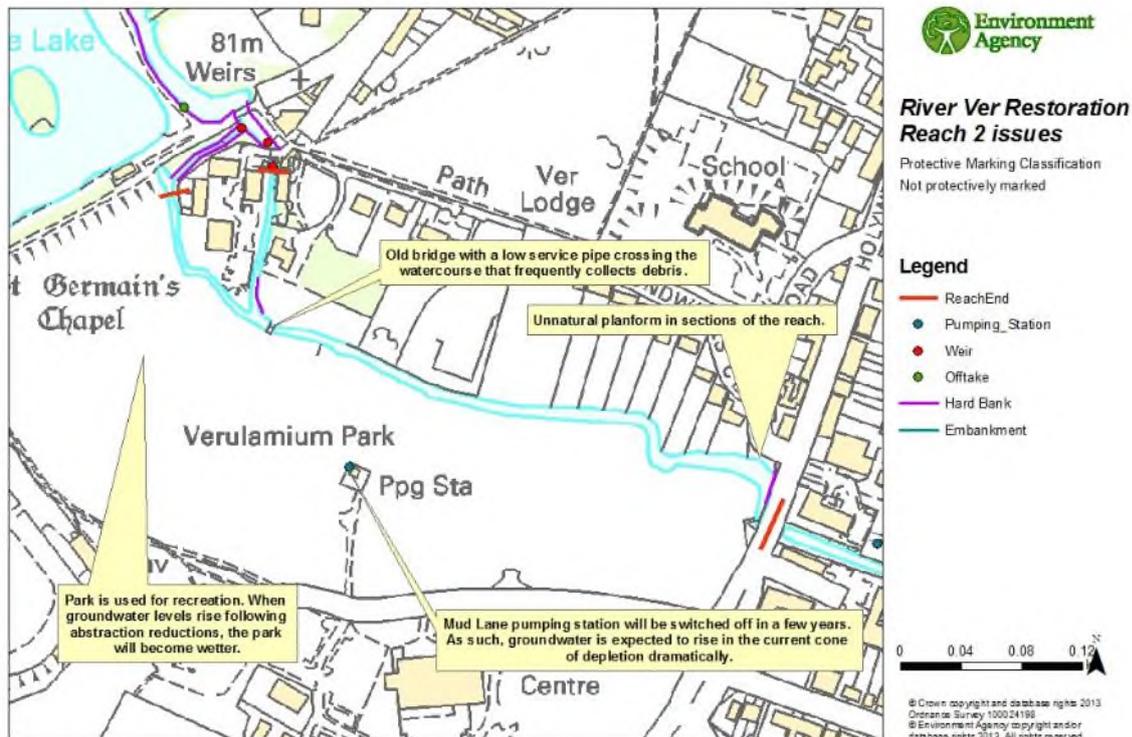
Figure 5, Reach 2 issues annotated map

- The channel is not in the natural valley bottom.
- Some of the channel is too heavily shaded
- An old bridge with a low service pipe crosses the watercourse and collects debris.
- Mud Lane pumping station is located in this reach and Holywell pumping station is located just downstream. Abstraction at these pumping stations is planned to be reduced in the near future.

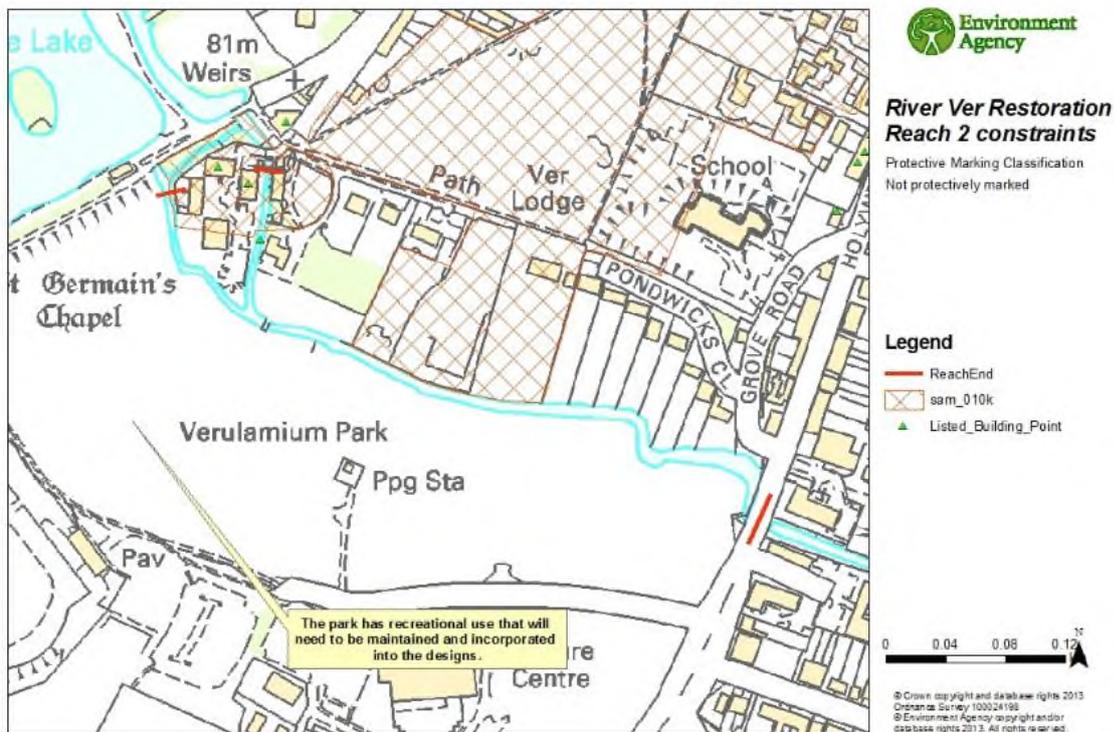
**Figure 6, Reach 2 constraints annotated map**

- Scheduled Ancient Monuments.
- Planning restrictions as the site falls within a conservation area.

- The park's current and future recreational use must not be impacted negatively, this is currently the main events space within the park.
- Services may pose a constraint to the option development.
- Flood risk – there is both potential for increased risk and opportunities for the scheme to deliver a reduction in flood risk.
- Trees and scrub along the river provide a screen for properties to the north.
- The river runs adjacent to a number of properties

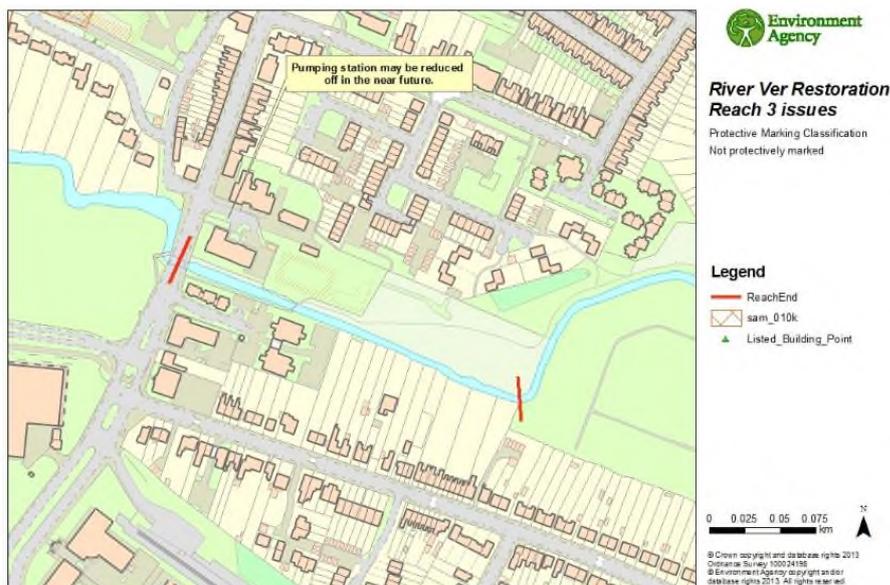
Figure 7, Reach 3 issues annotated map

- The river is in a very straight channel and is lacking in habitat diversity. It is also heavily shaded for most of this reach.
- Holywell pumping station is located in this reach and Mud Lane pumping station is just upstream. Abstraction at these pumping stations is planned to be reduced in the near future.

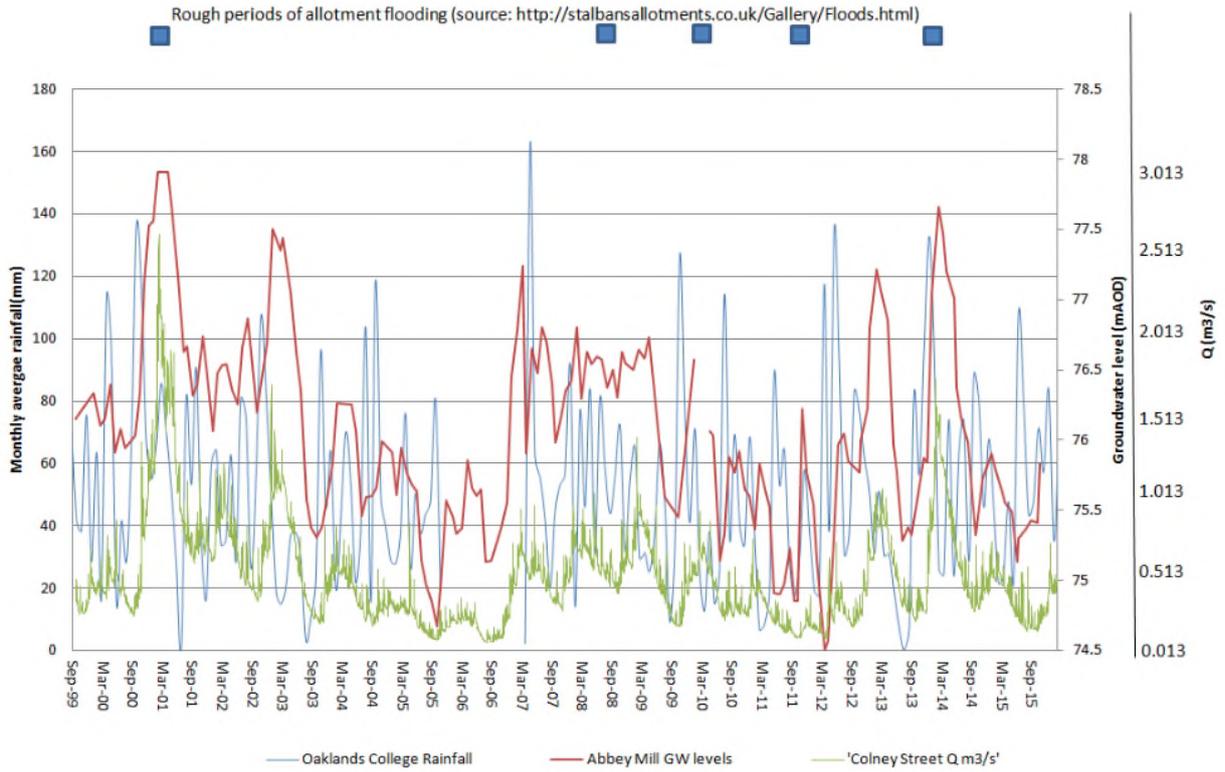
**Figure 8**, Rainfall, groundwater and discharge data comparison to Allotment flooding periods

- There is a small weir at the downstream end of the reach near the road bridge.
- The allotment site floods frequently and for extended periods of time. It is believed that the flooding is a combination of fluvial, groundwater and possibly surface water drainage / historic drainage. The allotments are at a lower level than the river and the timing of flooding does not always coincide with high groundwater or rainfall events. For further information please see figure 8.

- This reach is just downstream of Holywell and Mud Lane pumping stations. Reduction in abstraction is planned in the near future and groundwater levels are expected to rise within the current cone of depression. Given that the allotments have flooded in the past when pumping has been reduced, flooding here is likely to increase.

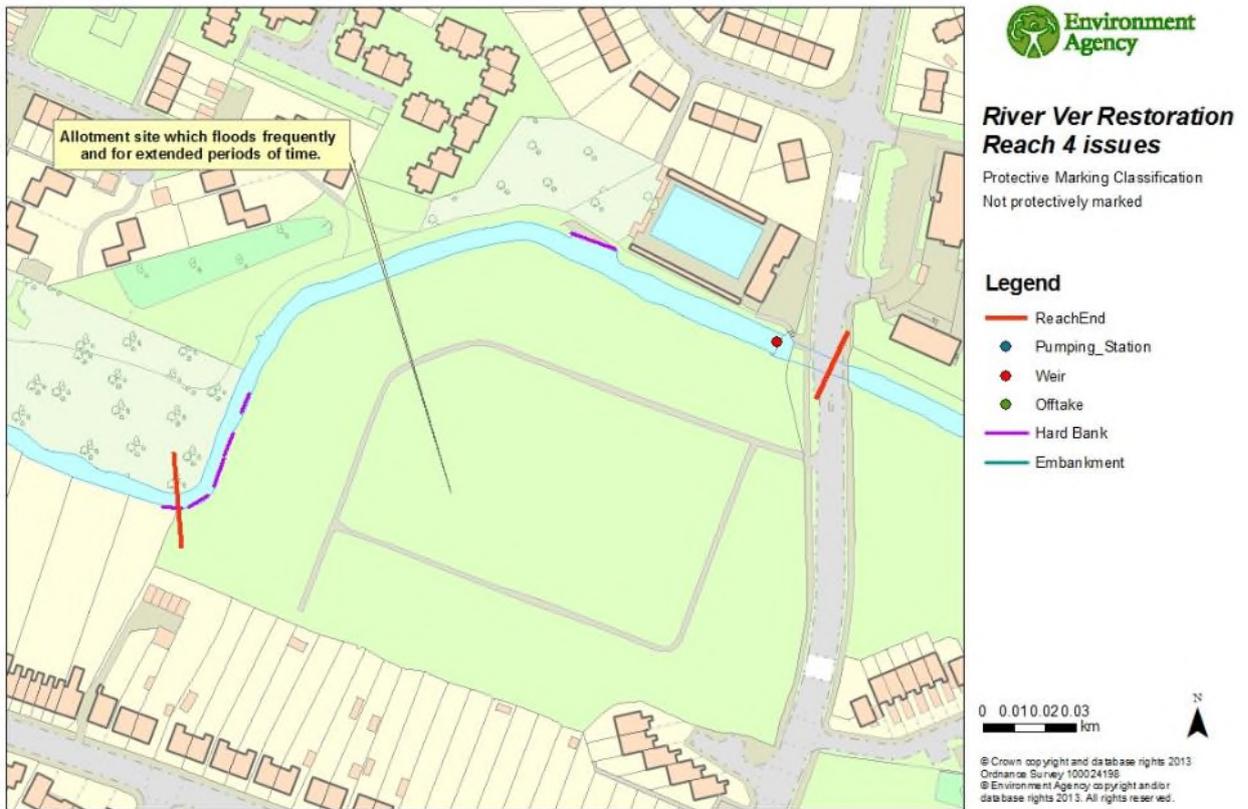
Figure 9, Reach 4 issues annotated map

- The river channel is not in the natural valley bottom.
- Channel habitat is poor as a result of over shading and lack of bed gradient.
- Hard bank engineering is present along some of the channel.

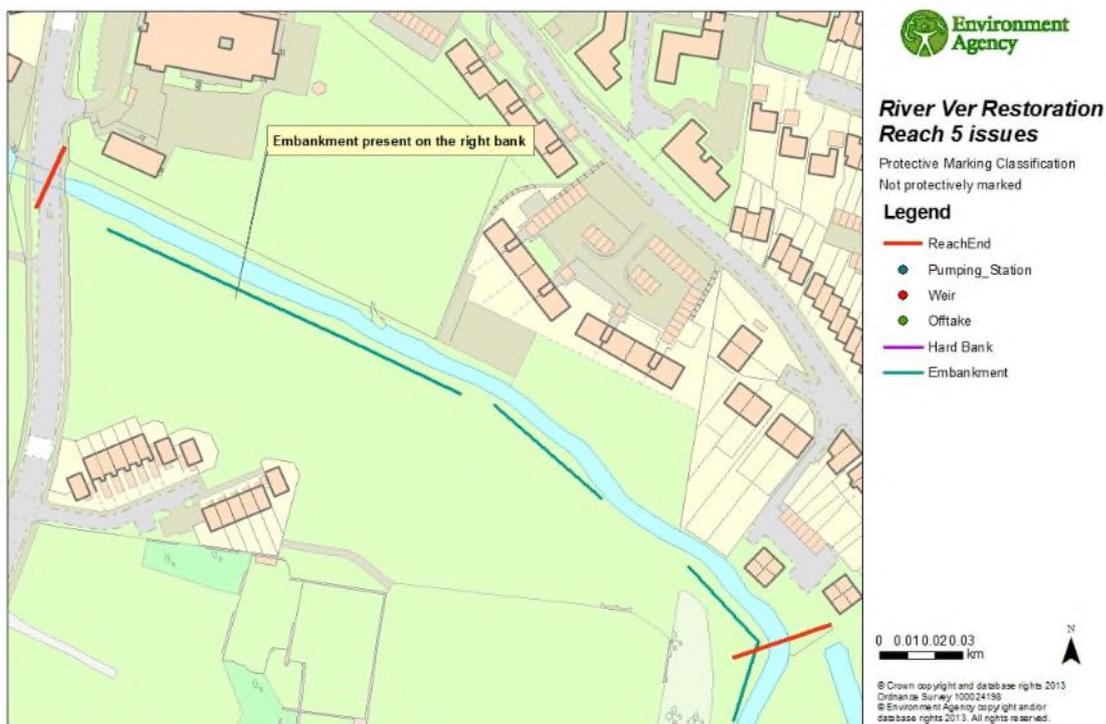
Figure 10, Reach 5 issues annotated map

- There is an embankment on the right bank that could be removed or set back to allow better floodplain connectivity, however care will need to be taken not to disturb the nesting kingfishers.
- The river is not in the bottom of the valley and therefore probably not connected to the groundwater. An area to the south of the channel becomes wet during some winters. Holywell and Mud Lane pumping stations are upstream of this reach and abstraction at these is due to be reduced in the near future. This area and others through this reach may see groundwater emergence as a result of this.

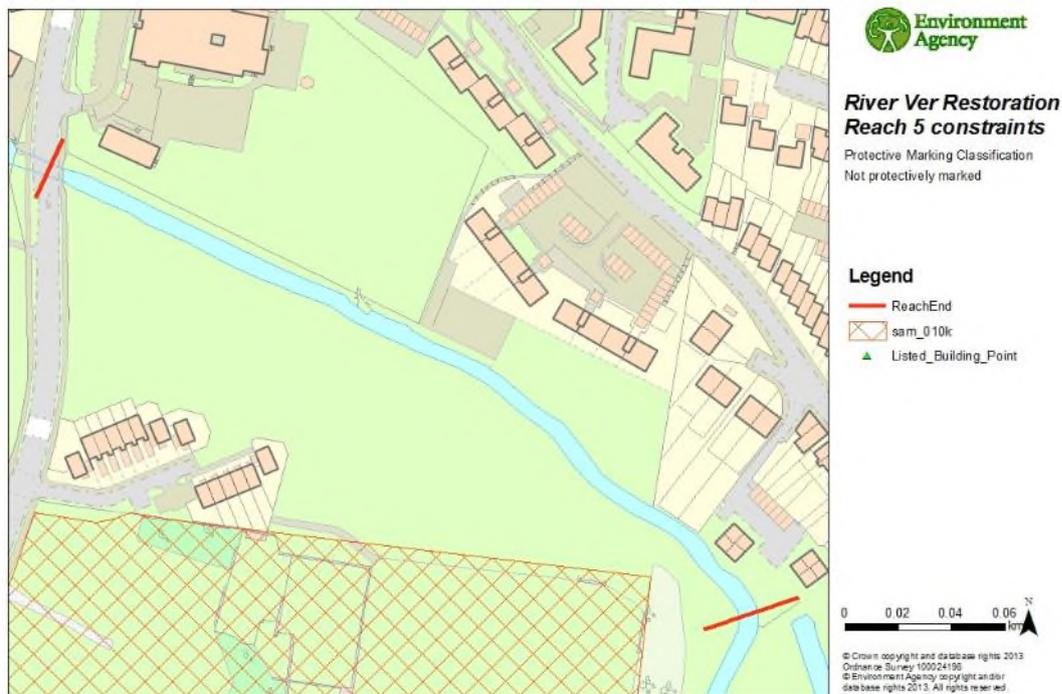
Figure 11, Reach 5 constraints annotated map

- Scheduled Ancient Monuments.
- Services may pose a constraint to the option development.
- Flood risk – there is both potential for increased risk and opportunities for the scheme to deliver a reduction in flood risk.
- Potential for groundwater emergence from reductions in abstraction at Mud Lane and Holywell Hill pumping stations.
- Kingfishers nest in the river bank here.

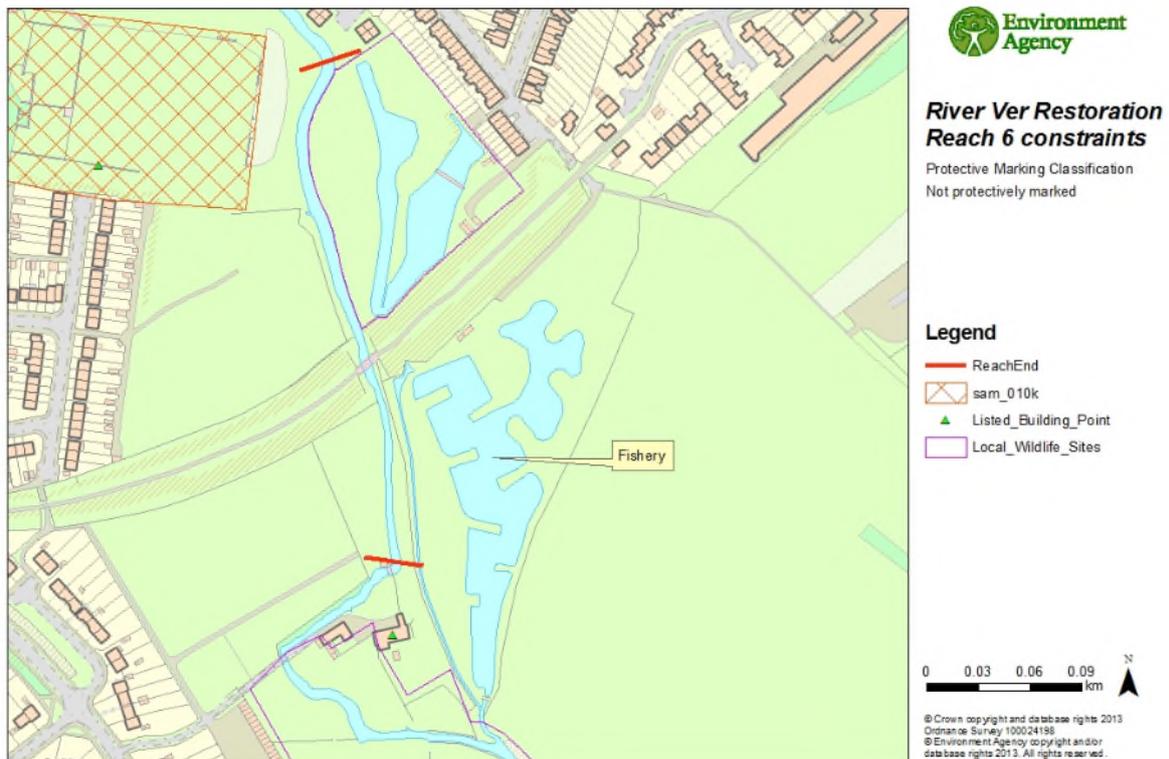
Figure 12, Reach 6 issues annotated map

- The flow is split between the river and the Watercress Wildlife Site and fishing lake. There is little understanding of the nature of the flow split.
- There are raised embankments present on top of the right bank of the river.
- The path is on the edge of the steep right bank of the river and is eroding in several places due to its close proximity and exacerbated by dogs accessing the river.
- Downstream of Alban Way the channel has been dredged in the past.
- Recent works to allow more light into the river have made some improvements to the channel habitat downstream of the Alban Way.
