# **LEA VALLEY LINE**

## **GREENSPACE ACTION PLAN**

2024 – 2029

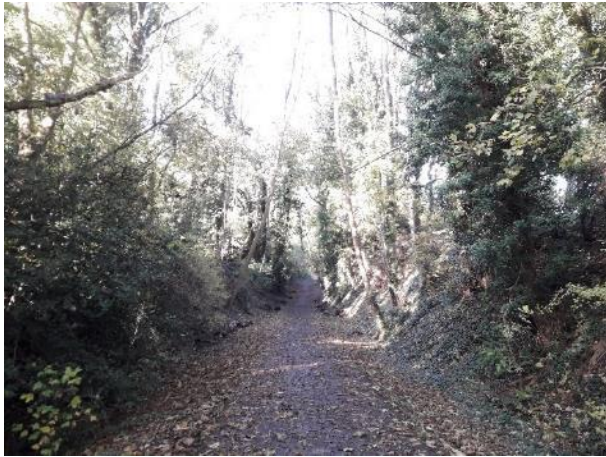
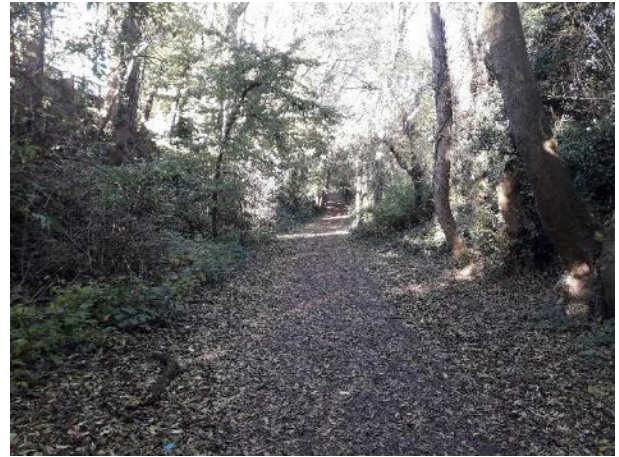
While the railway was operational, the embankments and surrounding areas would have been composed of more open habitats. Closure of the railway and subsequent end of regular habitat management along the route has allowed the colonisation of secondary woodland and scrub. This linear strip of secondary woodland is dominated by mature ash and oak, which has formed a tall and densely shaded canopy. In particular, ash is common throughout the route and has been affected by Chalara dieback. The mature trees have all developed since the closure of the railways and as such are similar in age. Other tree species along the embankments and cuttings include sycamore, hornbeam, willow spp., hawthorn, hazel and field maple. In many places, the dense semi-mature woodland on the embankments and cuttings prevents light from reaching the floor, and results in a poor, shade tolerant ground flora dominated by ivy and rank grass. In many areas along the route there are also a large number of trees covered in an extensive amount of ivy. Ivy does not pose a risk to healthy trees and is important for wildlife through the key provision of shelter and nectar. However, the substantial growth of ivy, particularly associated with low, overhanging branches, has enclosed the route in some areas and contributes towards the low light levels.

*Tall, dark vegetation in cuttings*

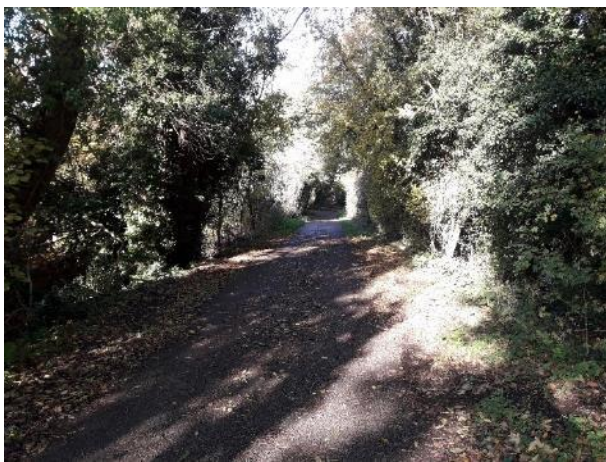
*Vegetation overshadowing top of embankment*

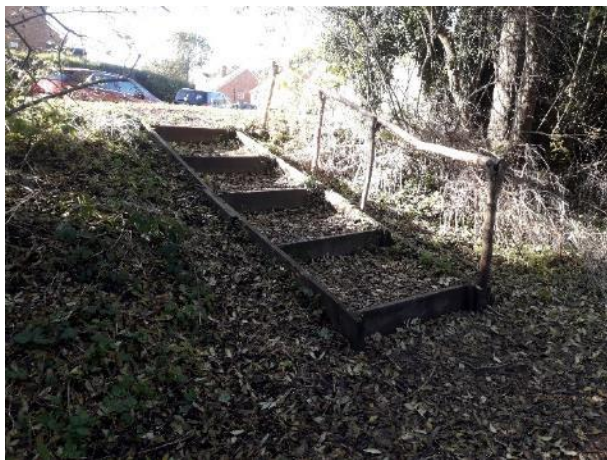
Riverford Close – Stepped access from Riverford Close was formalised during the last five years, however the handrail is in poor condition.

*Stepped access from Riverford Close*

Riverford Close – Replace handrail.

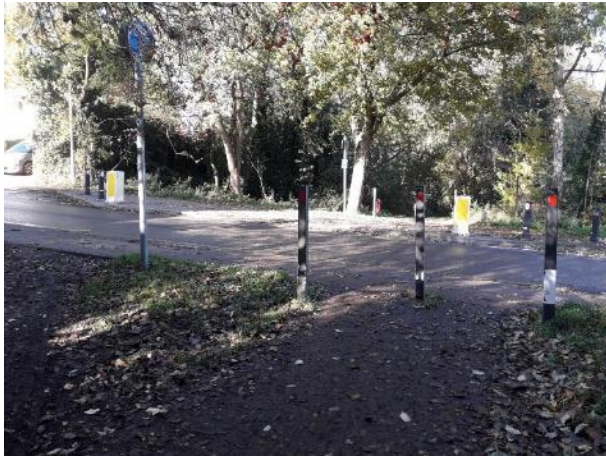
Westfield Road – Open access to pedestrians and cyclists with bollards to prevent vehicular access.

*Westfield Road road crossing*

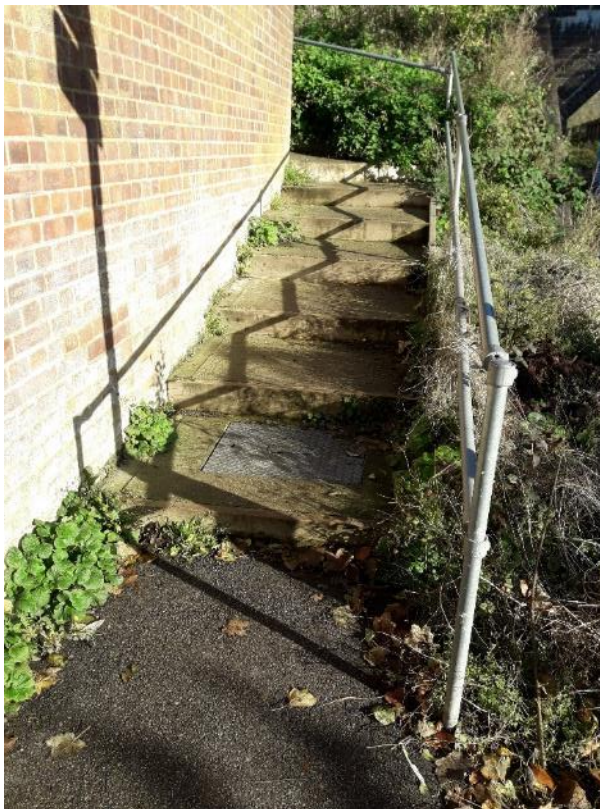
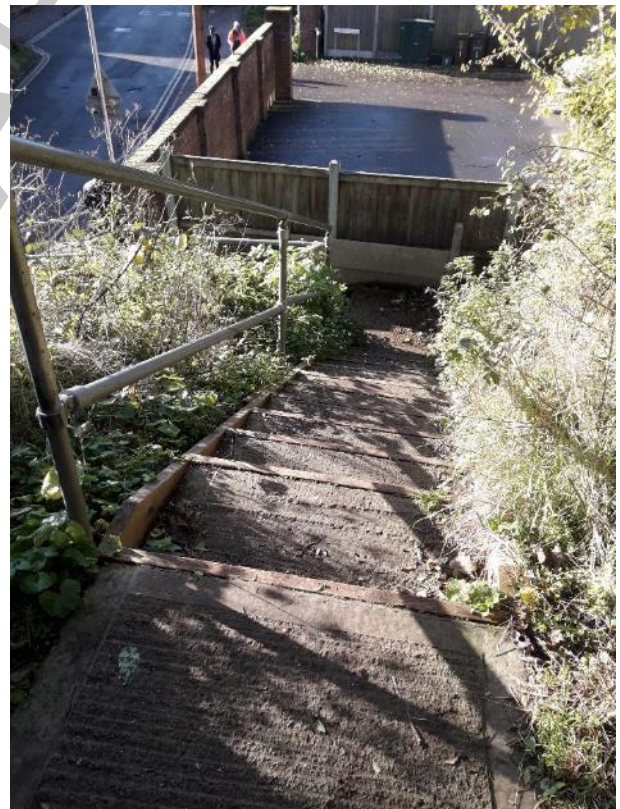
Ox Lane – The route passes over Ox Lane via a bridge, with steps providing access to, and from, the route. The steps were renovated during the last five years, with new timber risers and step surfaces installed. The fencing adjacent to the bridge was also replaced.

*Stepped access from Ox Lane*

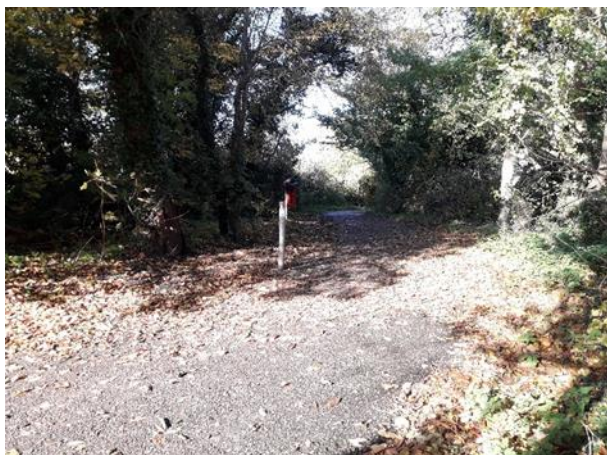
Waveney Road – The off-road path meets with the end of Waveney Road, with bollards to prevent vehicle access.

*Access from end of Waveney Road*

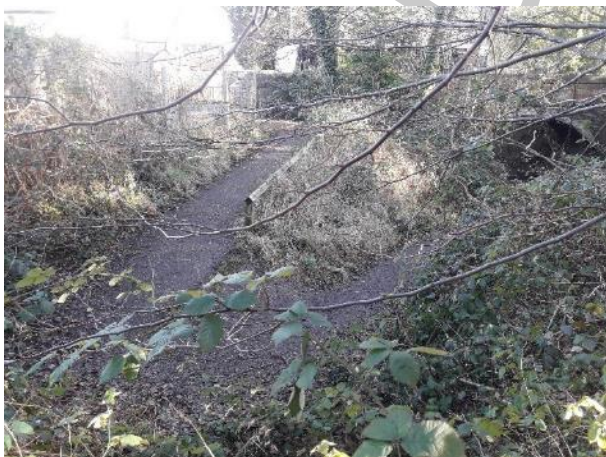
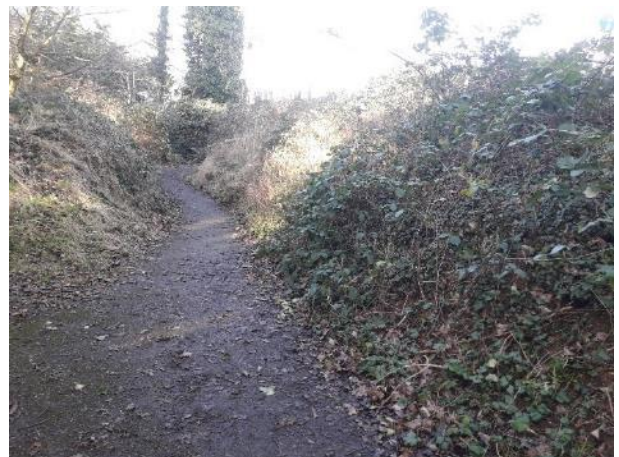
Station Road – There is ramped access from Station Road onto the Lea Valley Line which then passes underneath the road.

*Ramped access from Station Road*

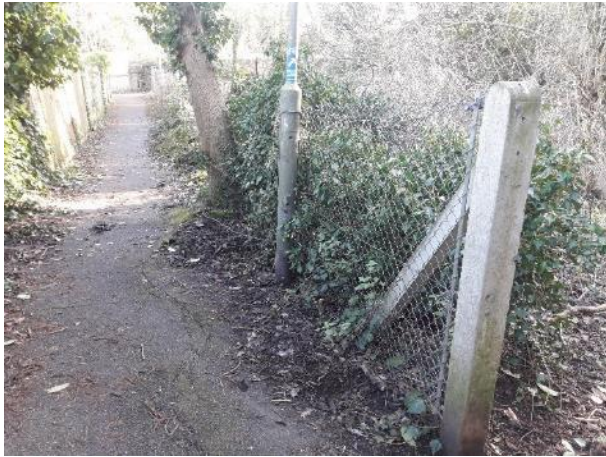
A chain-link fence runs across the path at the top of the ramp.

*Chain-link fence at Station Road entrance*

Station Road – Replace chain-link fence running across the path at the top of the ramp with post and rail fencing.

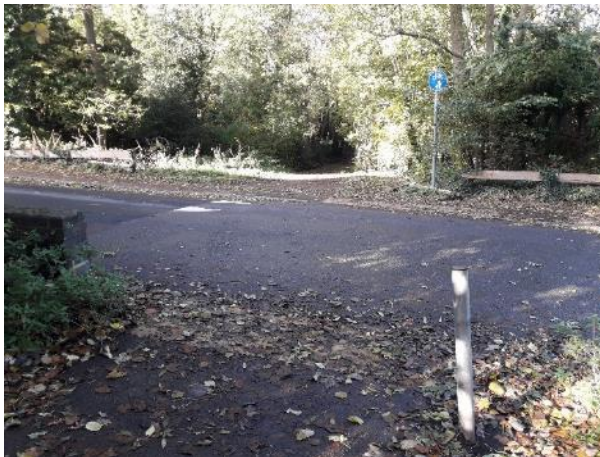
Crabtree Lane – Open access to pedestrians and cyclists with bollards to prevent vehicular access. Kickrail fencing is in poor condition.

*Crabtree Lane road crossing*

Crabtree Lane – Replace damaged kickrail fencing.

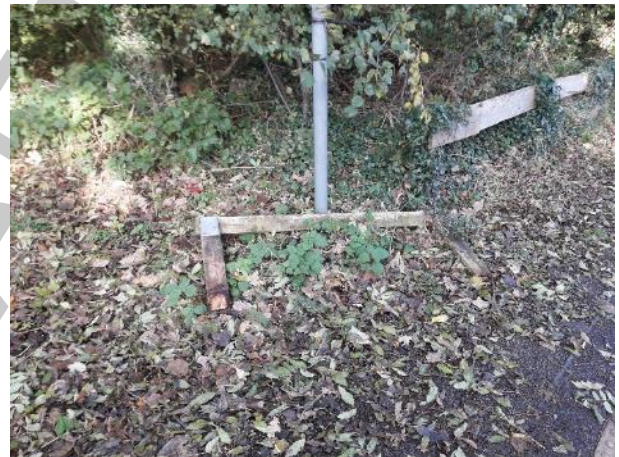
*Damaged kickrail fencing*

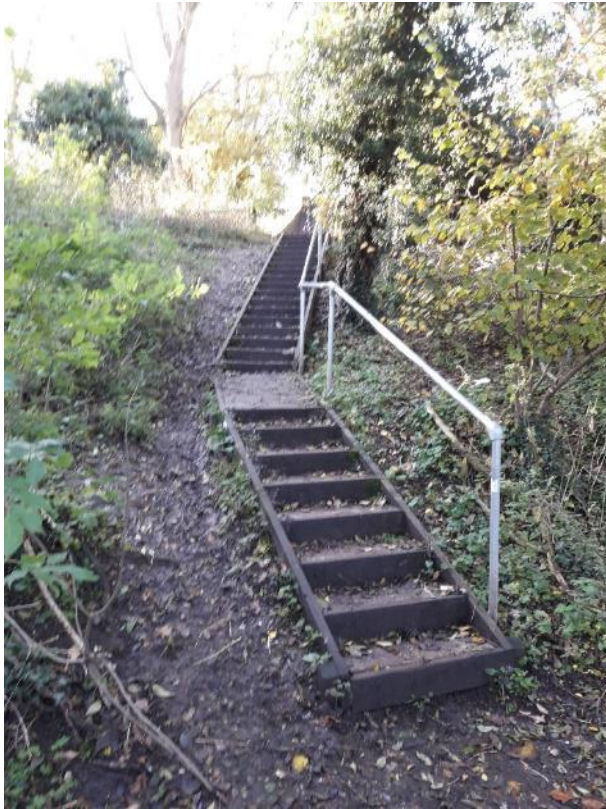
Crabtree Fields – There are steps which lead down from the area of waste ground and woodland adjacent to Harpenden Sewage Works. There are a number of informal paths through the woodland leading to Crabtree Fields, a local greenspace, and surrounding residential streets.

*Stepped access towards Crabtree Fields*

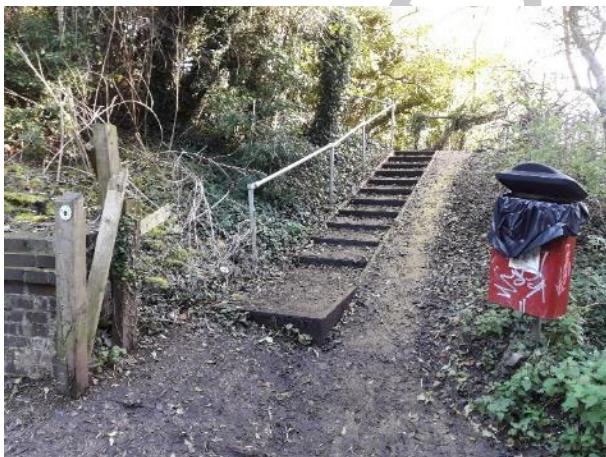
Marquis Lane – The route passes over Marquis Lane via a bridge, with steps and adjacent cycle ramp providing access to and from the route. These steps were renovated during the last five years with new timber risers and stepped surface, however erosion at the bottom of the steps has created an uneven final step.

*Stepped access from Marquis Lane*

Marquis Lane Bridge – Existing fencing adjacent to the top of the bridge should be replaced to match the post and rail fencing recently installed at the Ox Lane bridge. The ground at the bottom of the steps should be reprofiled to fix the uneven final step.

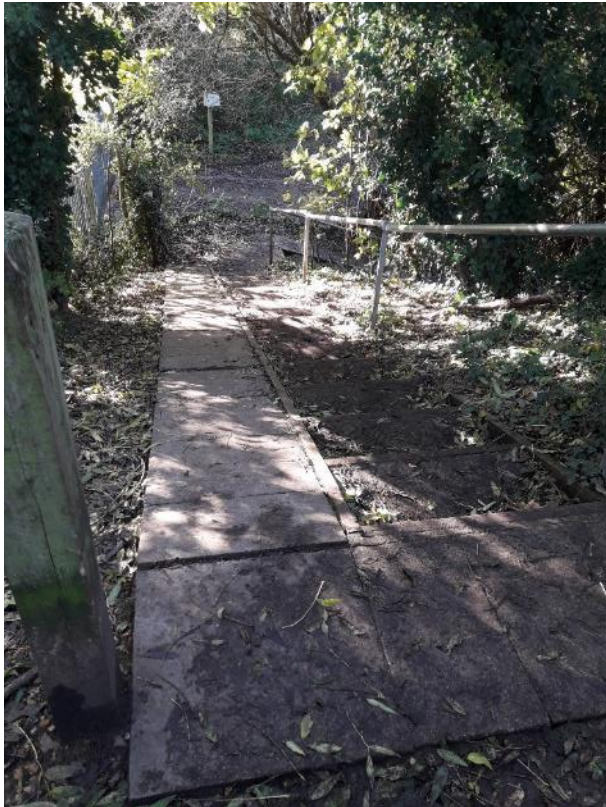
*Stepped access from Marquis Lane with adjacent ramp*

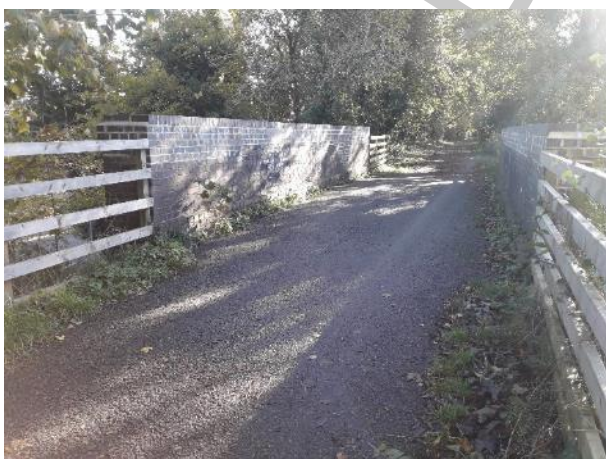
Ox Lane Bridge –owned by HCC, carries the Lea Valley Line over Ox Lane.

*Route over Ox Lane bridge*

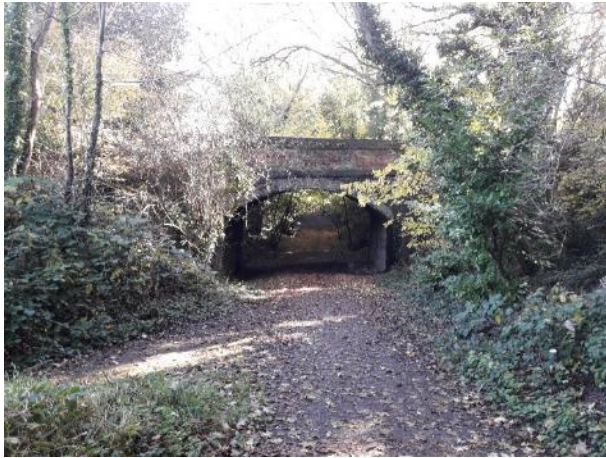
Station Road Bridge – owned by HCC, carrying Station Road over the Lea Valley Line. The bridge is currently screened from view by overgrown and overhanging vegetation.

*Route under Station Road bridge*

- a. Clear all trees and scrub within 5 m of Station Road bridge, on both south-east and north-west sides.
- b. Clear all vegetation from the sides and top of the bridge, including all ivy, taking care not to damage the brickwork.
- c. All cut material to be removed from the site.
- d. Tree works to be undertaken between November and February to avoid bird nesting season.

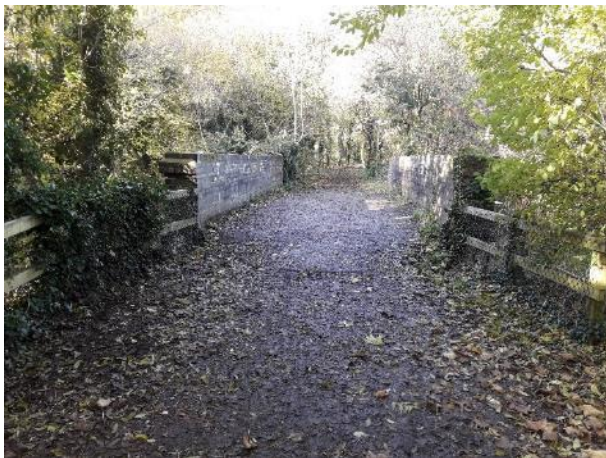
Marquis Lane Bridge – owned by HCC, carrying the Lea Valley Line over Marquis Lane.

*Route over Marquis Lane bridge*

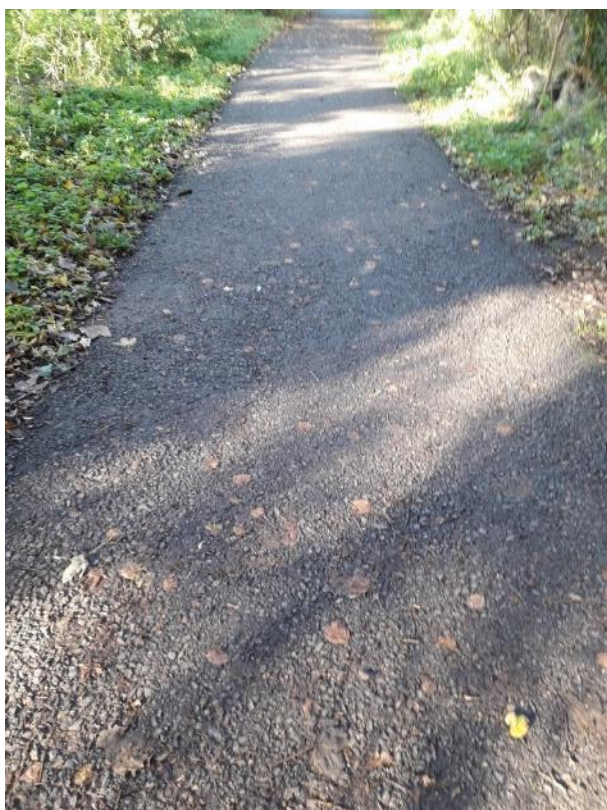
The majority of the Harpenden section of the Lea Valley Line covered within this GAP has been surfaced with tarmac, providing a smooth surface suitable for use in all weathers. This path is for the most part in good condition.

#### *Tarmac surface*

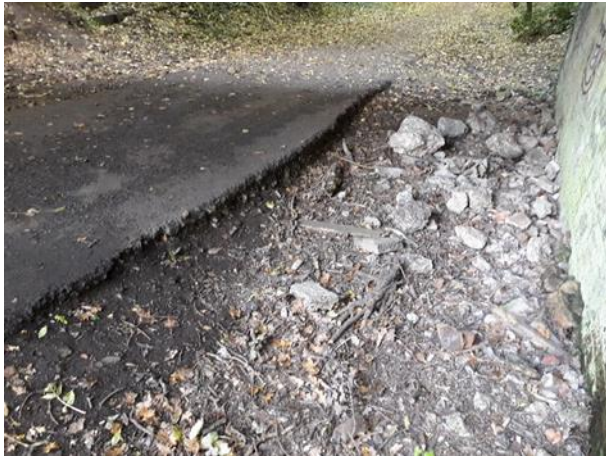
As the path travels under Station Road bridge, there is significant erosion at the side of the path. Route sweeping is carried out monthly on sections owned by SADC.

*Eroded edge under Station Road bridge*

erosion at the side of the path, the area should be topped up with material to protect the tarmac surface from damage, using railway ballast as the fill material would act as a further link to the railway heritage of the route and further enhance the bridge as a feature.

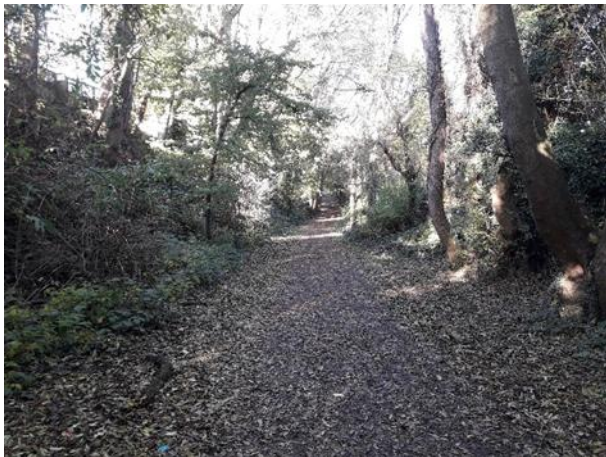
The section heading east from the Marquis Lane Bridge is surfaced with crushed stone and can become muddy at times.

*Crushed stone surfaced section of route*

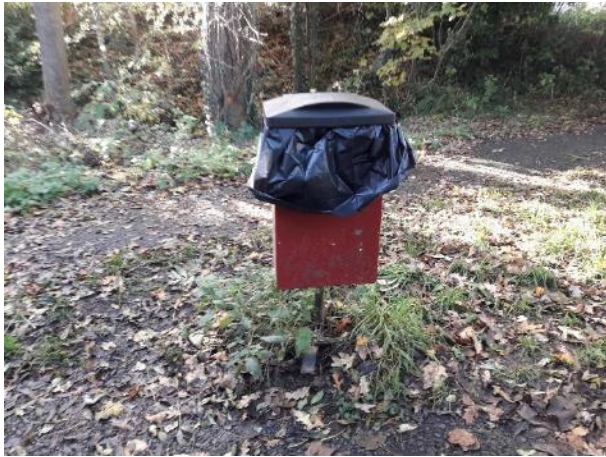
There are five dog waste bins situated at the entrances from Westfield Road, Waveney Road, Hickling Way, Crabtree Lane and Marquis Lane.

*Dog waste bin*

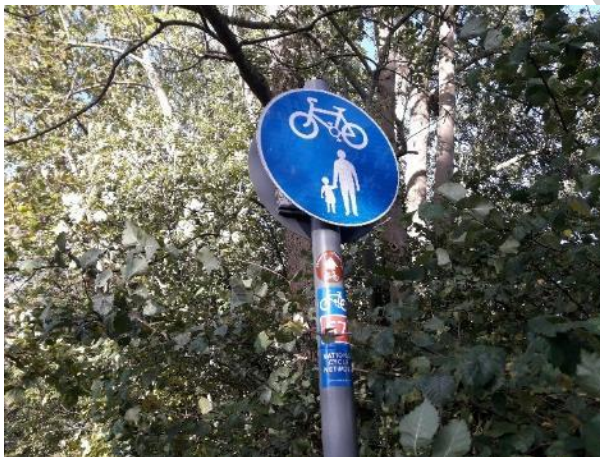
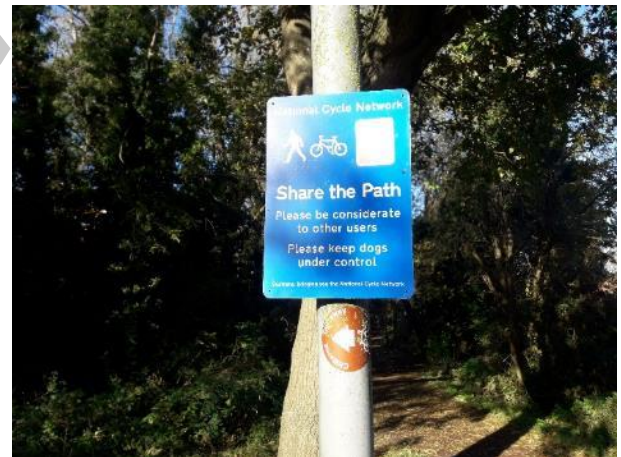
Signage along the route is currently limited, with no information provided on the length of the route, destinations, and little indication of the connections available to other routes. The majority of route-specific signage concerns shared-use of the path, with a number of styles installed.

*Shared-use signage*

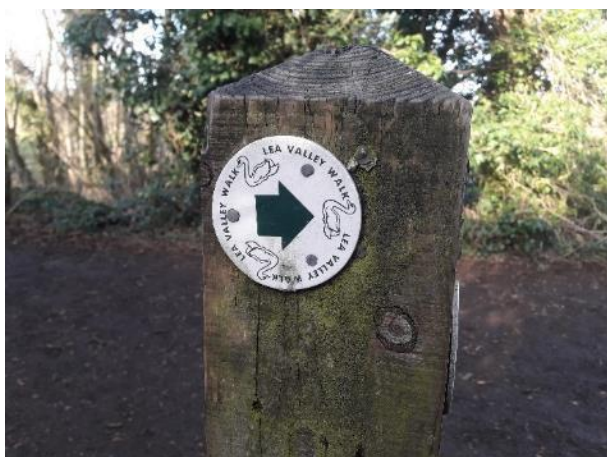
Waymark signs are found for many of the promoted routes for which the Lea Valley Line forms part of the routes. These include the Lea Valley Walk, Sustrans National Cycleway Network routes, and the Chilterns Cycleway.

*Waymark for the Lea Valley Walk*

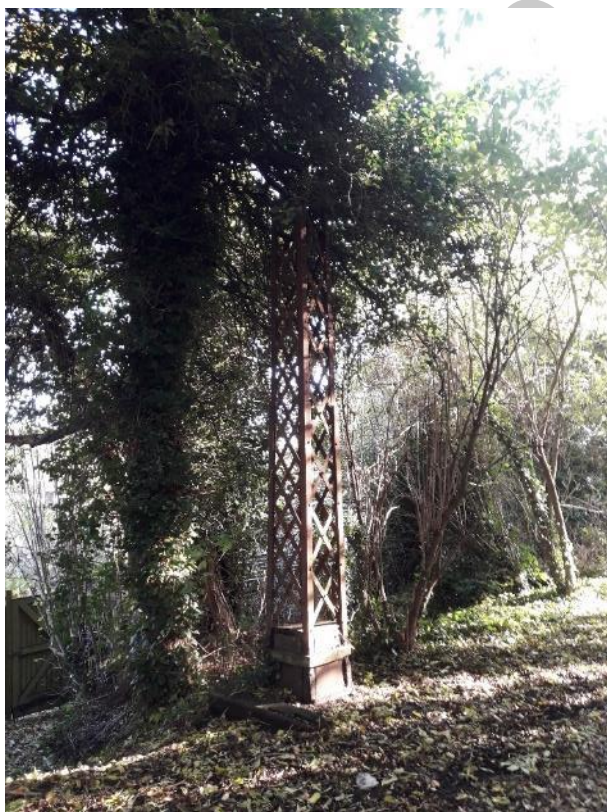
Few features relating to the railway heritage of the route survive, with the main remaining feature a lattice post found along the section between Westfield Road and Ox Lane.

*Historic lattice post*

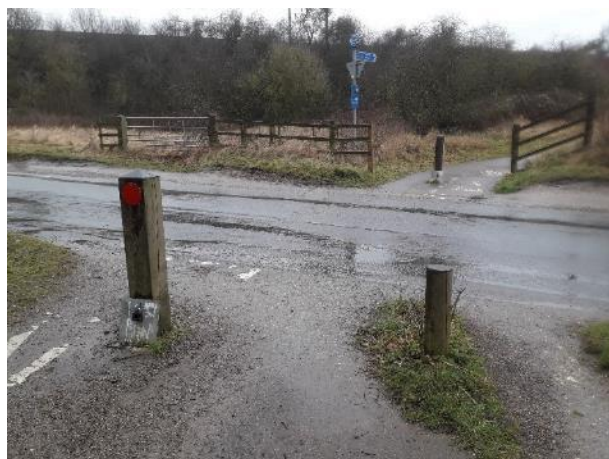
Bollards at road crossings are currently of varying styles. Adopting a standard style for all new and replacement bollards in timber, to match those used elsewhere on the route towards Luton, would help create a stronger identity for the site, reflecting the railway heritage.

*Example of bollards used on route towards Luton*

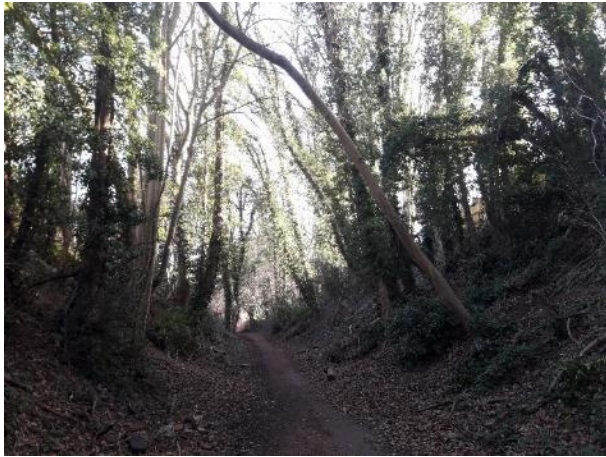
Light thinning should be undertaken along the wooded cuttings, favouring specimen trees and prioritising the felling of either dangerous trees or those of poor form, particularly large multi-stemmed specimens and those leaning heavily over the route. Attention should be paid to ash trees, and those showing signs of ash dieback targeted for felling. Woodland thinning is a high priority where the route is very dark and enclosed, primarily the section immediately north of the Westfield Road crossing and between Station Road bridge and the south-eastern end of the SADC owned section of the route.

*Heavily leaning trees over route*

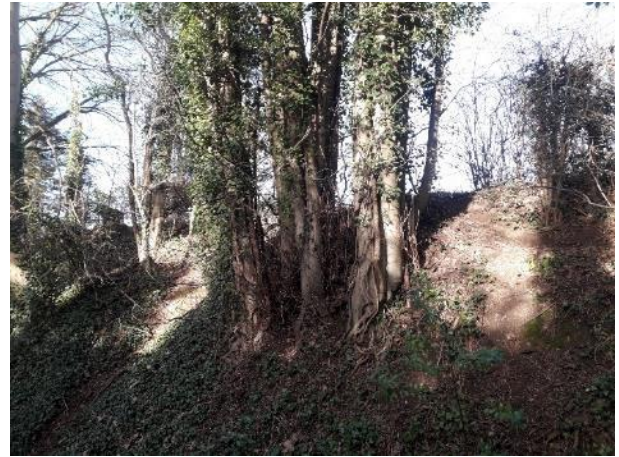
*Large, multi-stemmed trees*

Thinning will protect older trees from becoming over-shaded and will encourage the development of a diverse woodland canopy. This will also allow light to reach the woodland floor, encouraging ground flora and an understorey of small plants, shrubs and trees to thrive, creating a more diverse structure. Thinning will give the remaining trees more space to develop and will break up any uniform pattern that may be emerging.

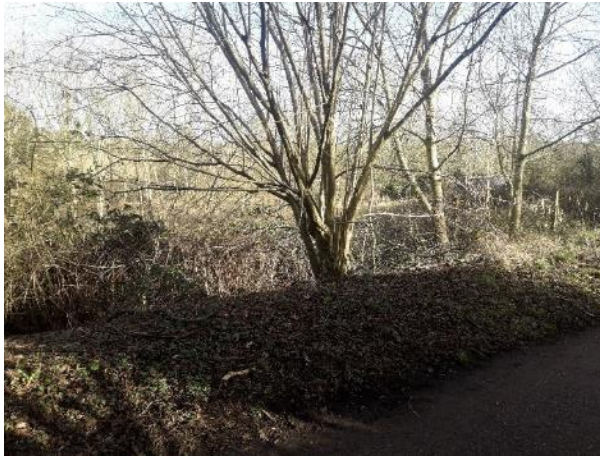
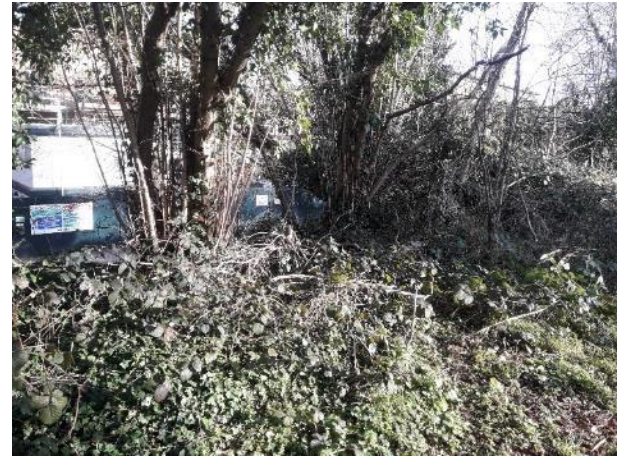
Coppicing is a traditional method of woodland management where understorey trees are cut low to the ground and allowed to re-grow in a multi-stemmed form. Periodic cutting boosts the trees growth and coppiced trees in their various stages of growth provide a variety of habitats for animals, birds and butterflies. Rotational coppicing of previously coppiced hazel will create temporary open pockets which will not only improve the user experience and feeling of safety, but also contribute to the development and maintenance of the secondary woodland and scrub habitats which predominate. In order to maintain screening for residential properties, sections prioritised for coppicing will be those on top of embankments not adjacent to properties, including the northern side of the route opposite Riverford Close and the northern edge of the route between Waveney Road and Ox Lane, adjacent to Coldharbour Lane.

#### *Previously coppiced hazel*

Additional coppicing of shrub species within cuttings where thinning will be taking place will help with the development of a more varied understorey.

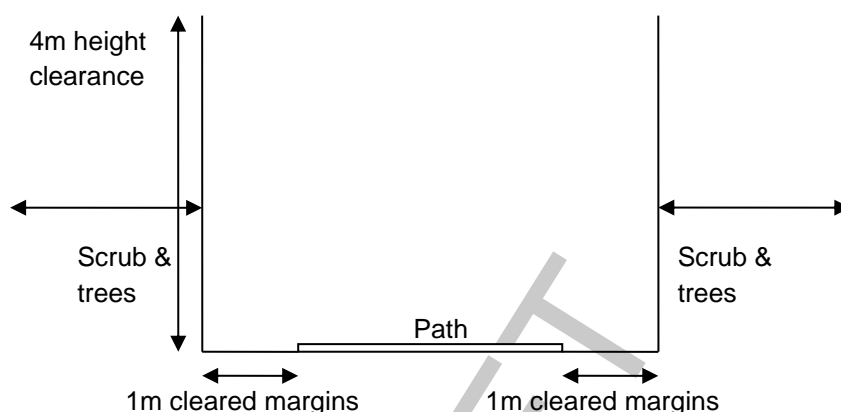
- a. Maintain a minimum of 4 m height and 1 m margins on either side of the surfaced path free from encroaching vegetation. This includes all access points to the route (see Diagram 1).

*Diagram: Minimum standard of maintenance along the route.*

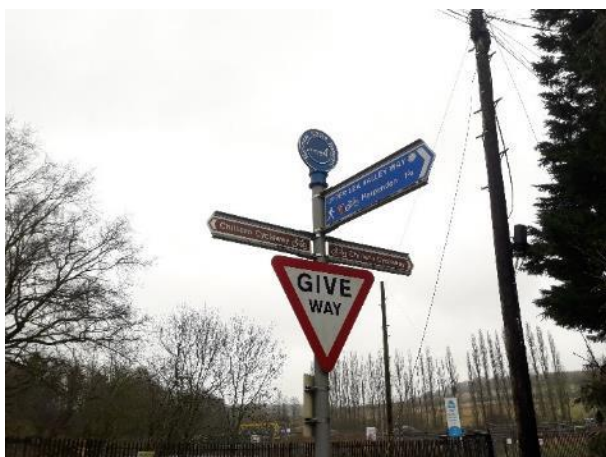
- a. New Rights of Way and Sustrans signage will follow the already established specification for these styles of sign, with finger posts located at main entrances and at the link between Hickling Way and Waveney Road. Where the route is shared with the Lea Valley Walk, signage will include the established Swan Logo.

*Example of existing signage used on route towards Luton*
