RE: ST ALBANS LOCAL PLAN EXAMINATION 2025 – ADDITIONAL DOCUMENTS CONSULTATION SADC/ED77 – FLOOD RISK ADDENDUM
SITE M20 – LAND AT LOWER LUTON ROAD, HARPENDEN

Lower Luton Road, Harpenden AL5 5ES (M20 in Draft Local Plan)

Geo-Site Assessment Lower Luton Road Harpenden AL5 5AF

Issue Date: May 2025 Report Ref: 21372R1 (Issue A)

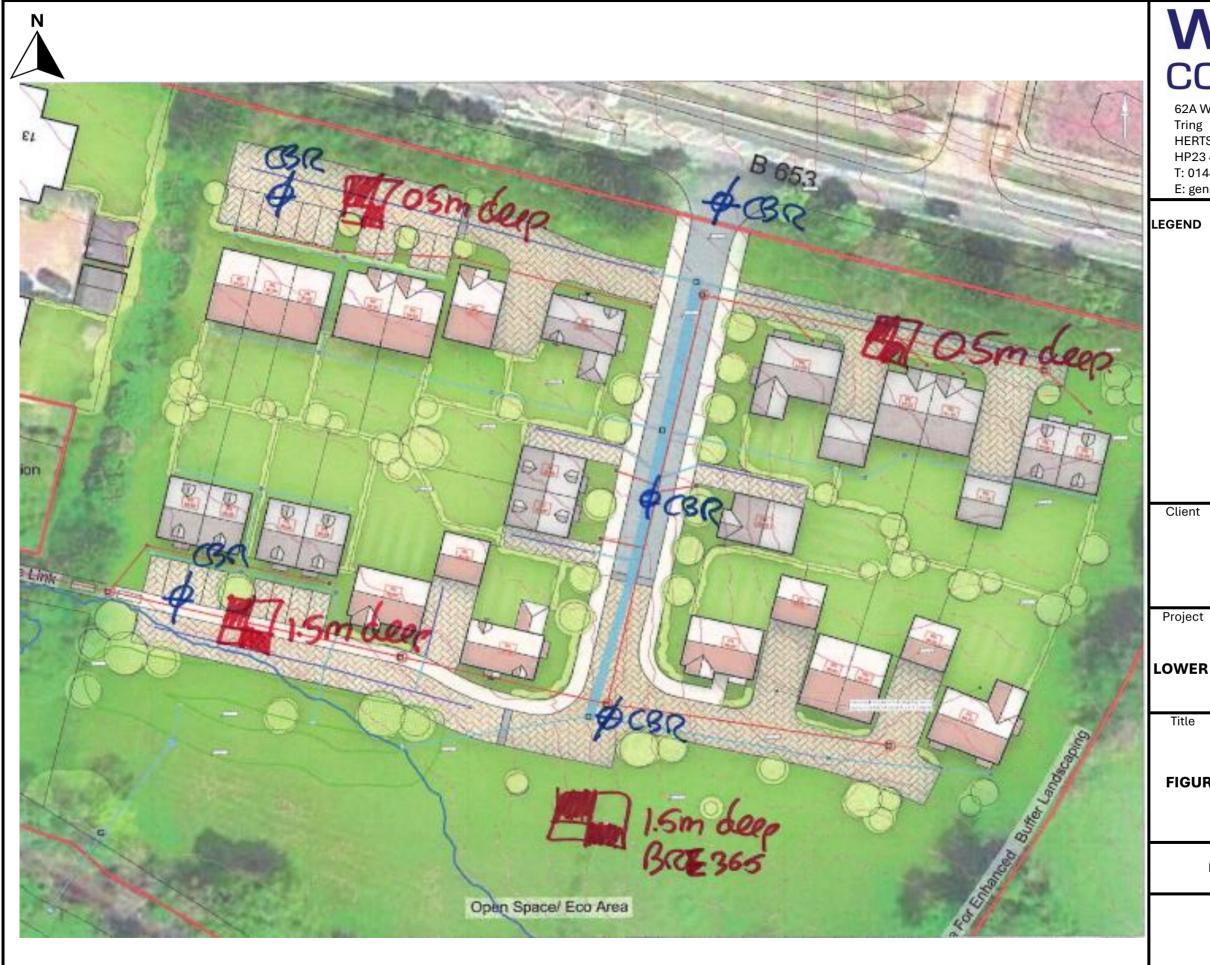
FIGURE 3:PROPOSED SITE PLAN

It is understood that the proposed development comprises the construction of ~22 residential dwellings (Figure 3).

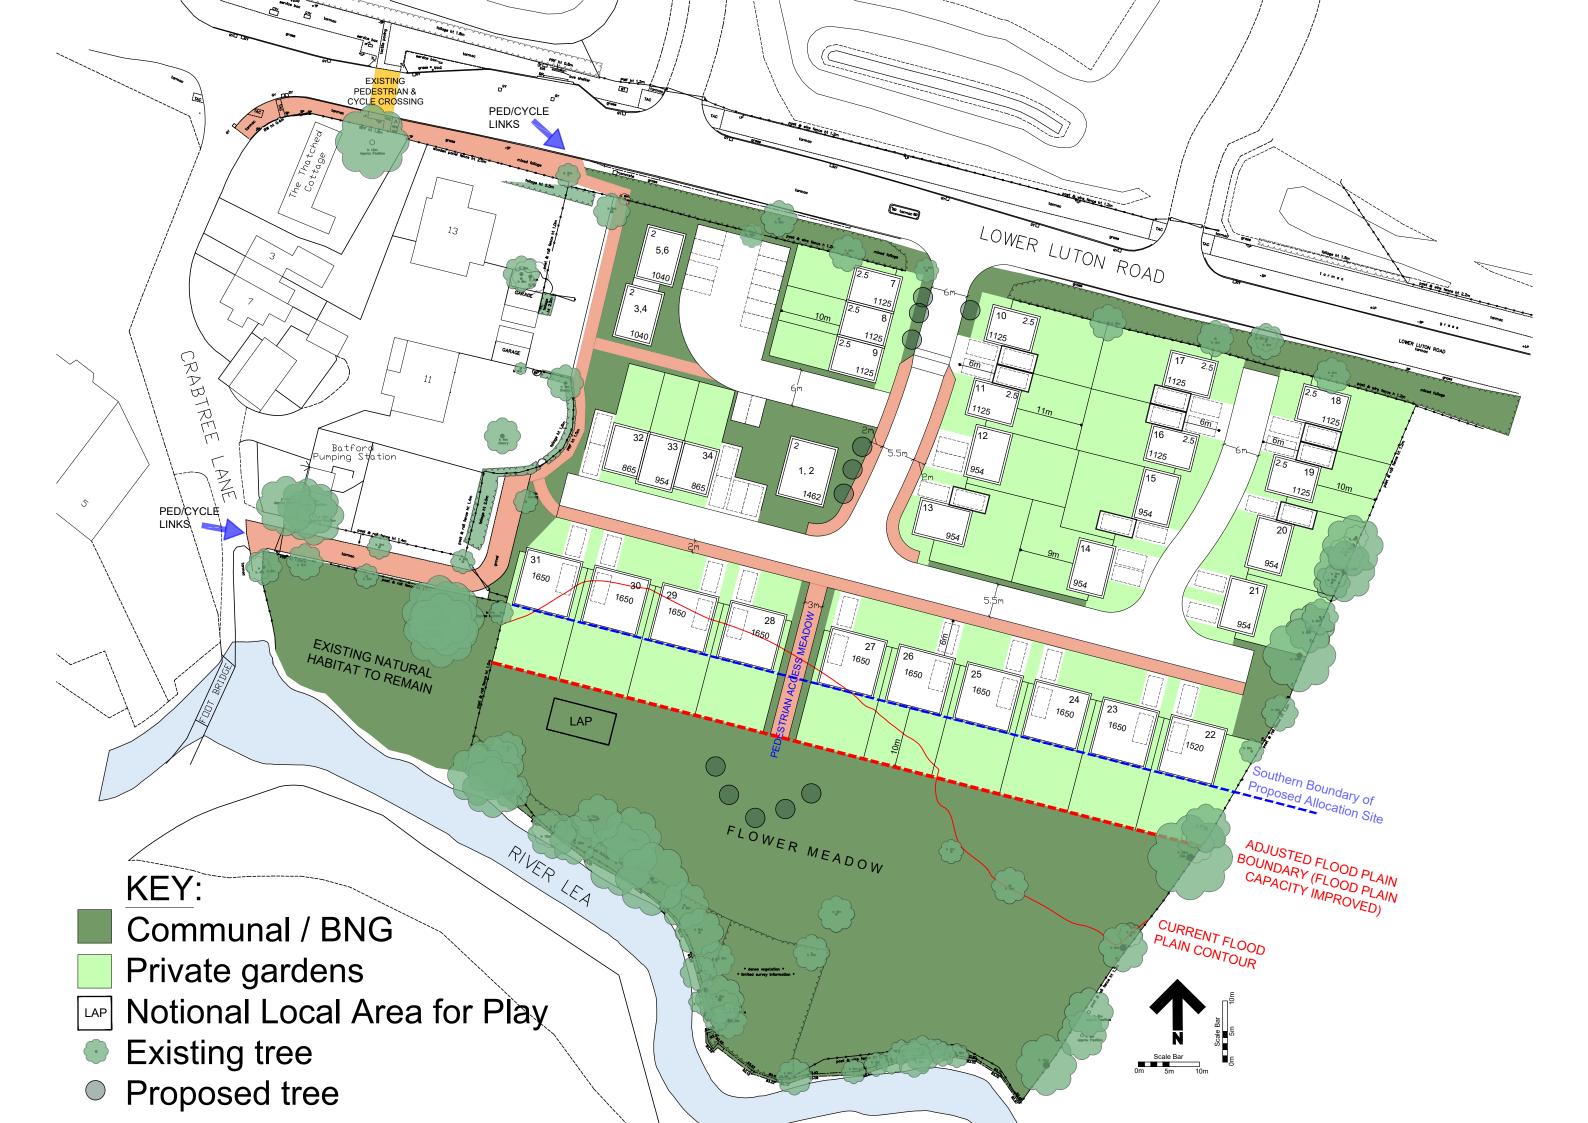
Appendix B

Based on these findings we believe a scheme close to the one submitted as part of a recent pre-application (See attached in Appendix B) could be feasible from a flood risk and drainage perspective. Especially if 4 of 5 houses are removed to provide a large above ground SuDs feature, and all finished floor levels are at 85.00mAOD or higher.
