# Examination of the St Albans City and District Local Plan Matters, Issues and Questions for Stage 2

**Matter 7 – Issue 1 – St Albans Site Allocations**

**Policy M3 – Land at Bedmond Lane, St Albans**

# TARGETED ARCHAEOLOGICAL EVALUATION

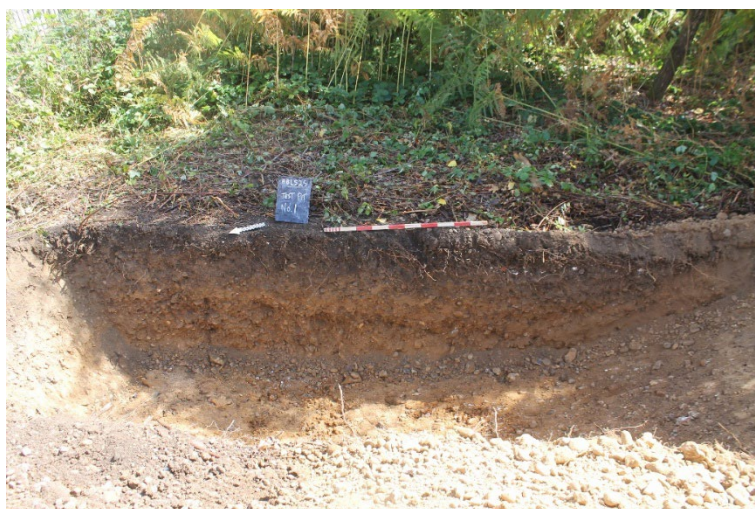
- 7.1.1 Test Pits 1 and 3 (Figures 3 & 4) were combined to form a single entity aligned NE-SW and measuring 5.19m x 1.74m.
- 7.1.2 Within TP1 & TP3 four layers were identified. Natural gravel [4] at the base (0.91m BGL, 116.14m OD) was overlain by a layer of sandy silt and gravel colluvium [3] at 116.74m OD from which CBM was recovered. The made ground was sealed by subsoil [2] and topsoil [1].

*Plate 1 TP1 & TP3, looking southeast, 1m scale*

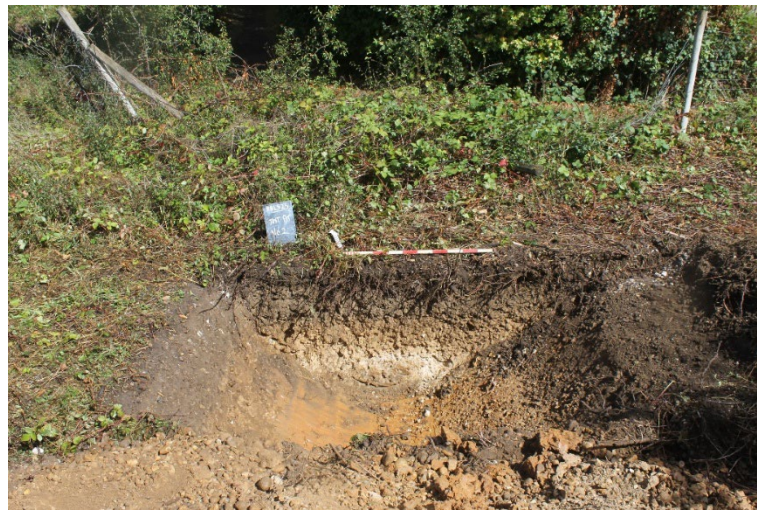
- 7.2.1 Test Pit 2 (Figures 3 & 4) measured 2.69m x 1.70m
- 7.2.2 Within TP2 four layers were identified. Natural gravel [8] at the base (0.77m BGL, 116.25m OD) was overlain by a layer of sandy silt and gravel colluvium [7] at 116.87m OD. The made ground was sealed by subsoil [6] and then topsoil [5].

*Plate 2 TP2, looking northeast, 1m scale*

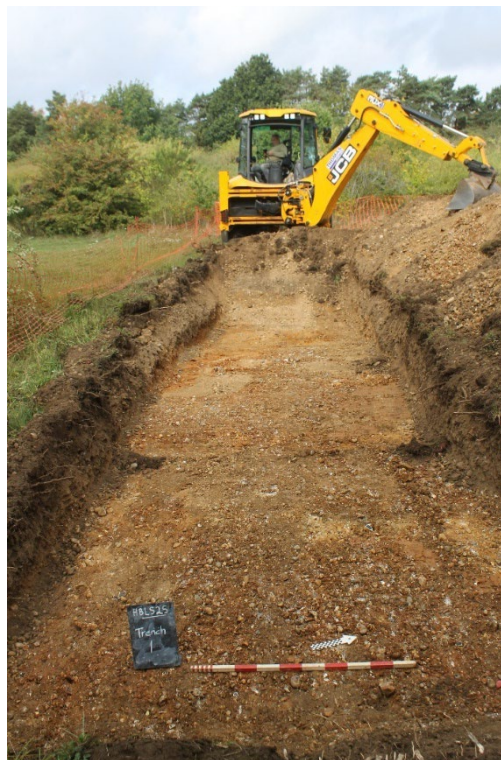
- 7.3.1 Trench 1 (Figures 3 & 4) measured 12.29m x 3m and was aligned NW-SE.
- 7.3.2 Three layers were identified in Trench 1: natural [16] at the base (0.62m BGL, 116.40m OD), overlain by subsoil [15] and then topsoil [14].
- 7.3.3 A rectangular modern feature was noted in Trench 1 cutting through the subsoil [15].

*Plate 3: Tr1 looking northwest, 1m scale*

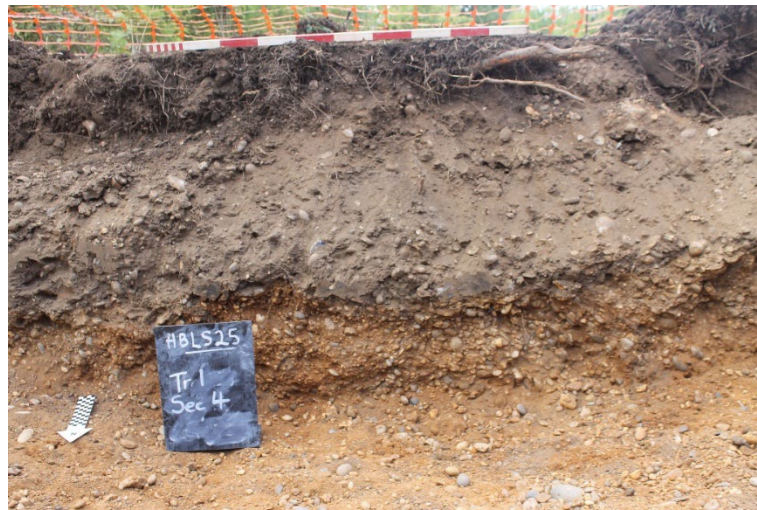
*Plate 4: Looking southwest, s.4, 1m scale.*

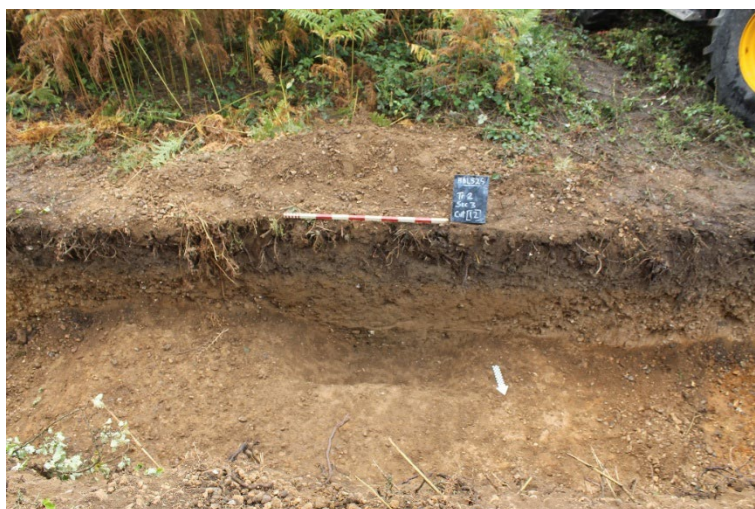
- 7.4.3 The natural deposits were overlain by a layer of sandy silt and gravel colluvium [13] at 116.59m OD.
- 7.4.4 Layer [13] was truncated by a northeast-southwest aligned ditch [12] which was filled by a very well compacted almost concreted grey-yellow silty clay [11]; pottery, metal and a possible struck flint were recovered from the excavated slot. The ditch was recorded at a height of 116.59m OD, and was at least 0.65m deep. The fill of the ditch was extremely compact and excavation was thus very difficult, such that the base of the feature could not be reached (Figure 4).

*Plate 6: Looking south-southwest at section 3 ditch [12], 1m scale*

- 8.4 Cutting through the gravel [13] in Trench 2 was a substantial ditch with steep sides, aligned NE-SW and filled with a very compact silty-clay [11]. The ditch could not be bottomed however was 1.69m wide and at least 0.65m deep, cut from a height of 116.59m OD.
- 8.5 Fill [11] from the ditch yielded three small sherds of pottery, 2 undiagnostic iron nails and a lithic fragment. The pottery, weighing 7g, was derived from two vessels; both are Verulamium Region White wares (VRW), dated to AD40-160/200<sup>2</sup>.
