*River Ver
Restoration St
Albans*

With and on behalf of the Environment Agency

Document name	Ref	Prepared by	Date	Reviewed by	Approved By
River Ver Restoration St Albans	Final	Omar Sholi	25-1-2019	Nigel Pilkington	Omar Sholi
River Ver Restoration St Albans	Draft	Omar Sholi, Alex Deacon, Kate de Smeth, Seb Bentley, George Heritage, Tim Jones, Amy Jones	31-10-18	Nigel Pilkington	Omar Sholi

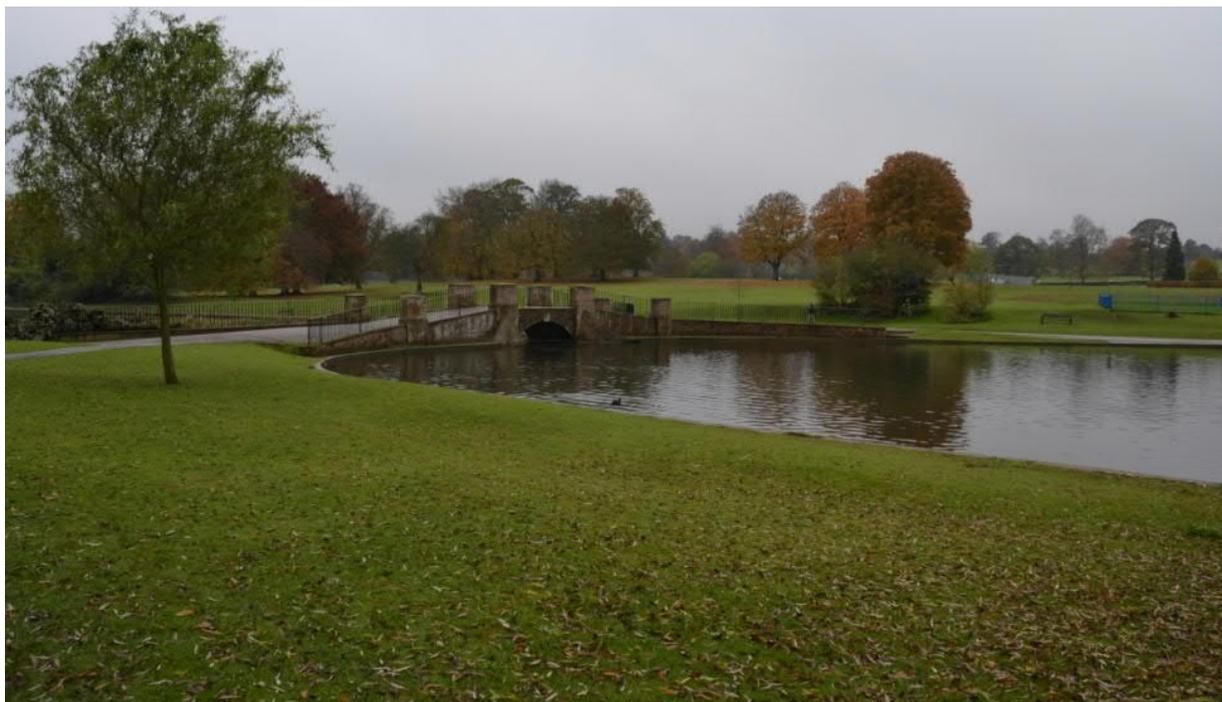
The ornamental lakes in Verulamium Park (Plate 1.2) are fed by the River Ver. They suffer from a range of issues including poor water quality, siltation and excessive numbers of wild fowl. As a result, algal blooms and reduced oxygen levels in the water have occurred, which have a negative impact on wildlife and are likely to have contributed to outbreaks of avian botulism.

Plate 1.2 The artificial lakes in Verulamium Park

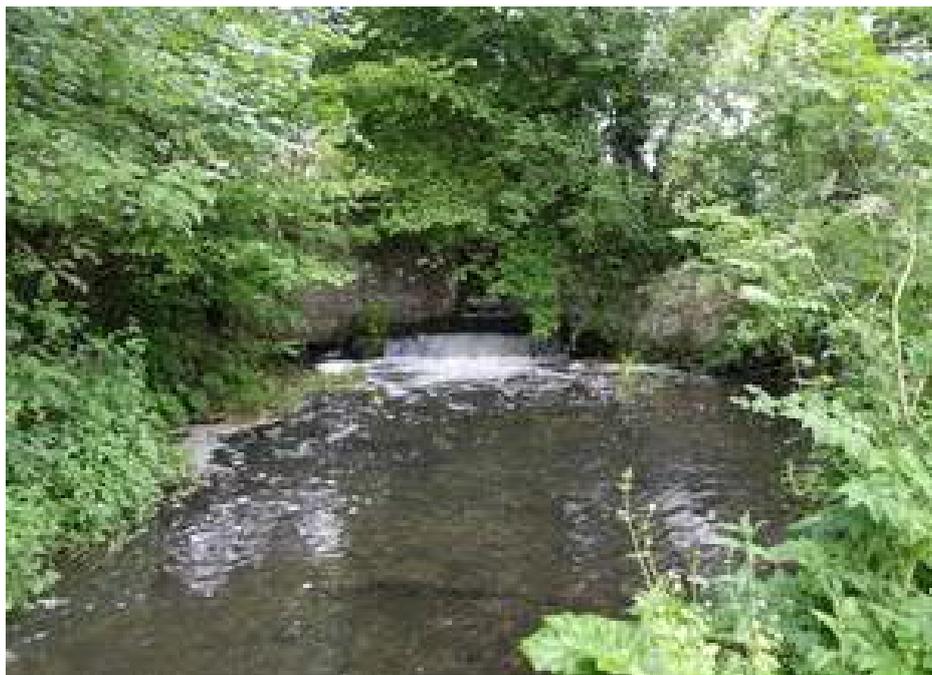
The River Ver has been historically diverted through the mill at Burydell Lane (Plate 1.4). It flows over a substantial weir which impounds flow and obstructs fish passage. To the east of the river are disused watercress beds, which are thought to be in the location of the original course of the river. We are looking at options to allow for fish passage and restore chalk stream characteristics along this section of the river.

Plate 1.4 Ver at Burydell Lane

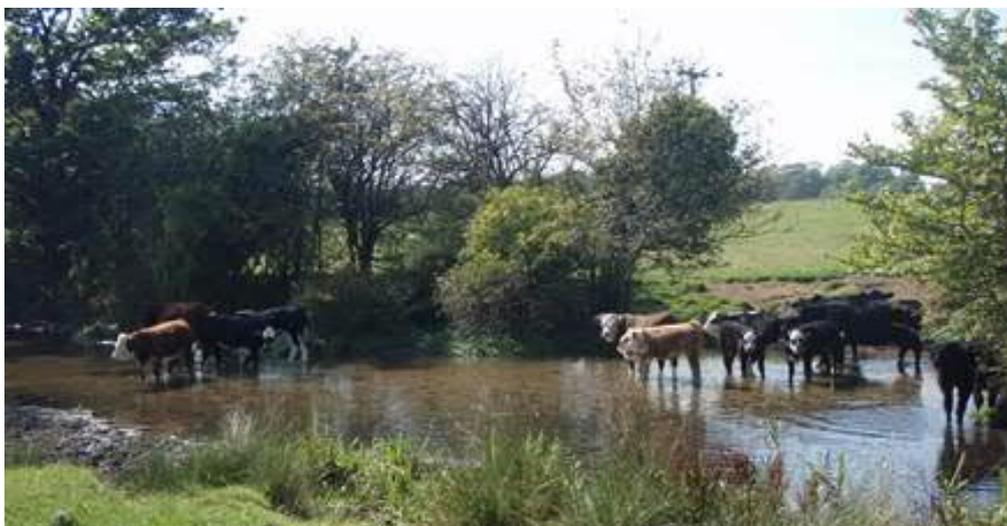
Plate 1.5 Ver at Hedges Farm

In this location (Plate 1.5) the River Ver flows through fields grazed by cattle, and as a result the banks have been widely poached. This has caused sections of bank de-stabilisation and erosion, which has resulted in siltation in the river. An additional impact of cattle poaching is the destruction of bank and marginal vegetation. Our aim of this project is to create controlled access for cattle accessing the river by installing fencing, crossing points, water gates, and cattle drinking stations. We are also looking to carry out tree work to all more light into the river channel to facilitate the growth of marginal plant species.

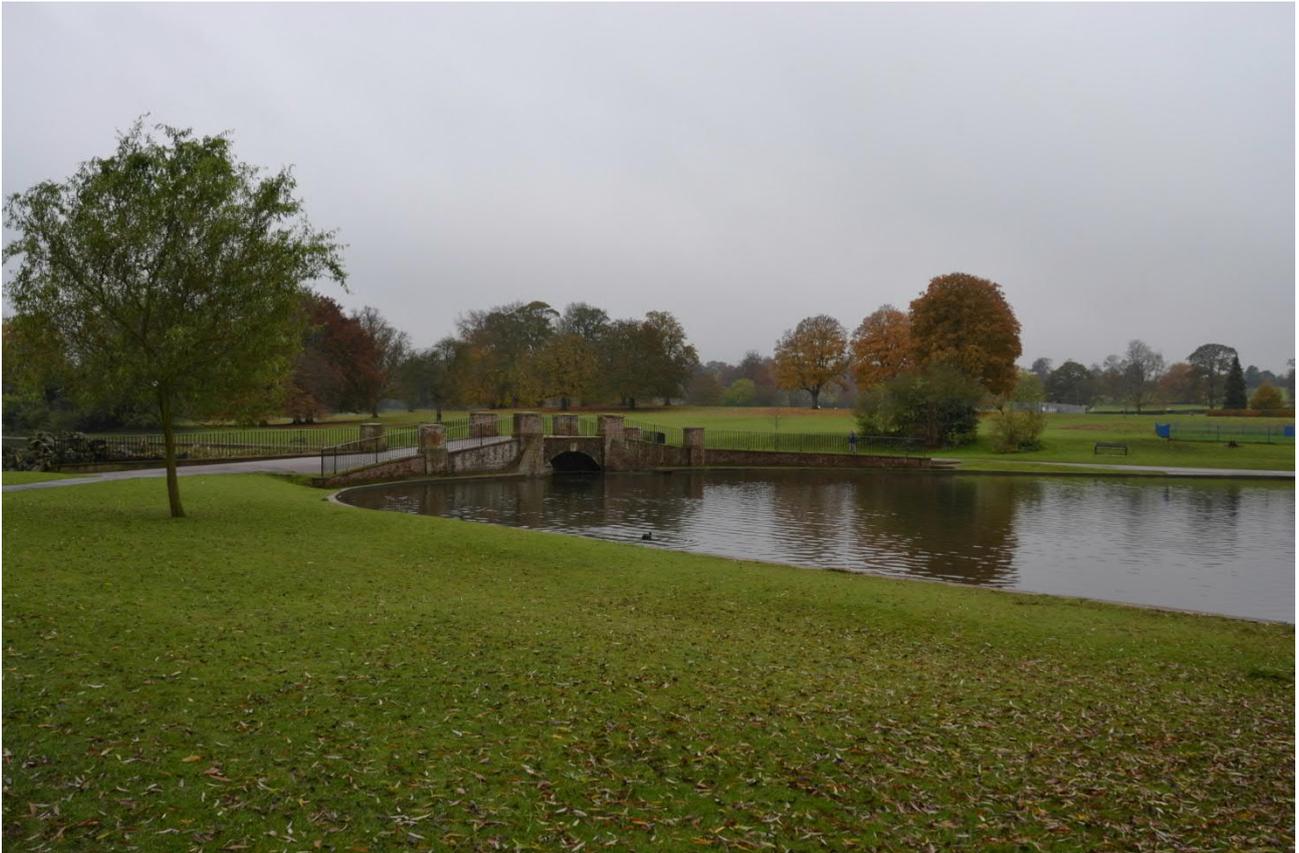
A previous study³ in 2012 found water depths of only 0.16-0.40 m in the upper lake and 0.13-0.59 m in the lower lake.

Plate 3.1 Upper lake, looking downstream, and the bridge that separates the upper and lower (Verulamium) lakes

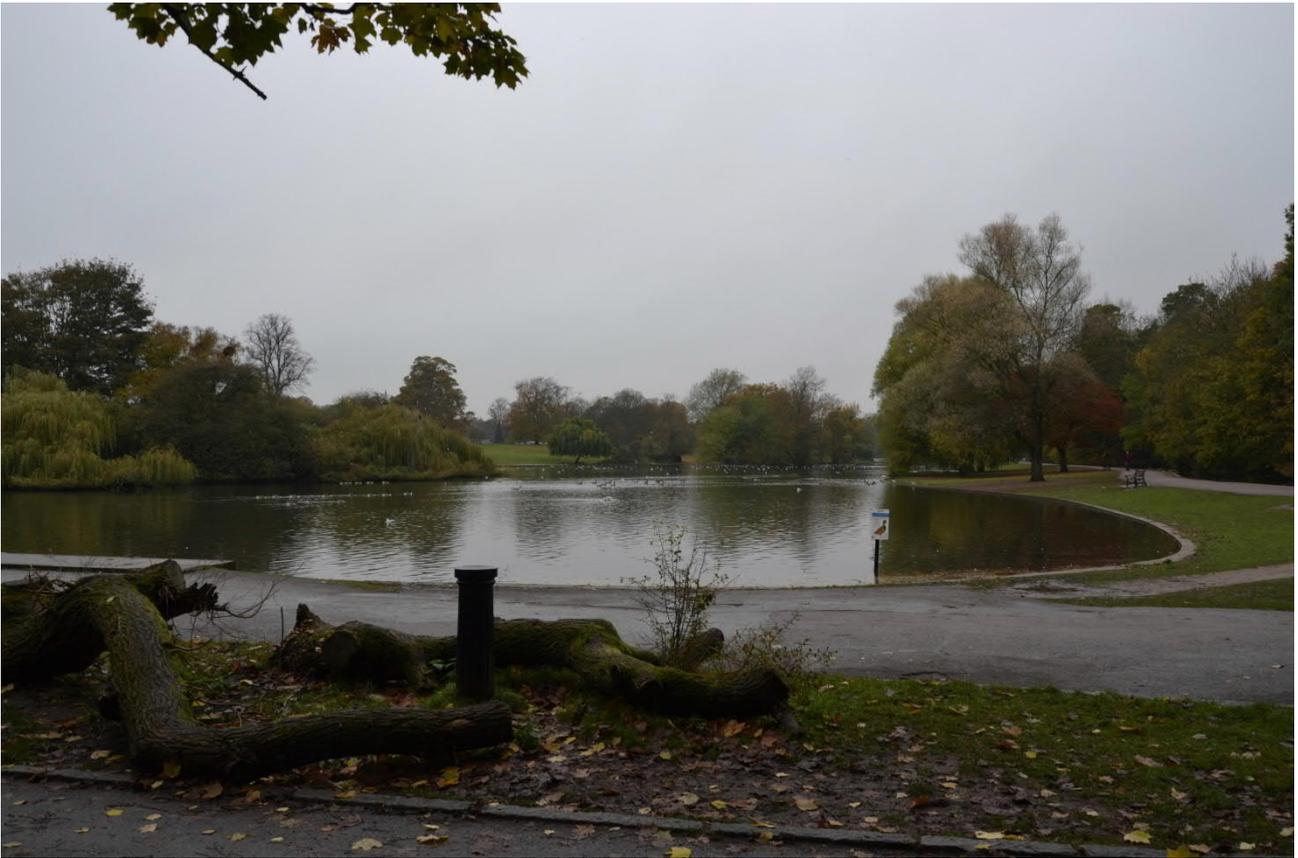
Plate 3.2 Lower lake looking upstream from its downstream end

The areas of the upper and lower lakes are $4,300 \text{ m}^2$ and $33,600 \text{ m}^2$. Approximate average depths of the upper and lower lakes are low and around 0.3 m and 0.45 m , respectively. As such their respective volumes are around $1,290 \text{ m}^3$ and $15,120 \text{ m}^3$ and total Verulamium Lake volume is around $16,410 \text{ m}^3$ (noting this may vary under different climatic conditions).

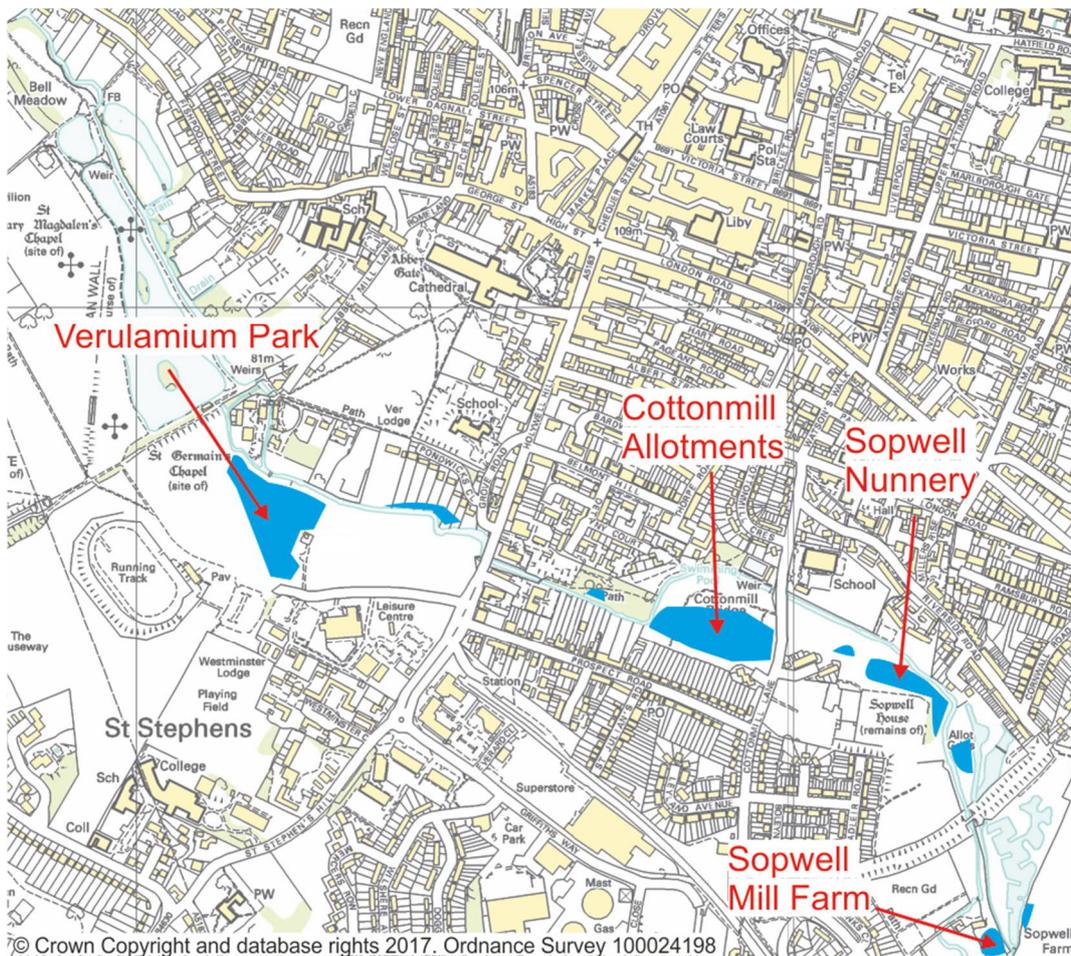
The study found there is a low risk of groundwater emergence in the lake area, and also limited potential for the lake water level to be maintained by groundwater discharge (if it were not sourced from river water).

Figure 3.2 Areas Predicted to be at Increased Risk of Groundwater Emergence (Flooding) When Abstraction is Reduced

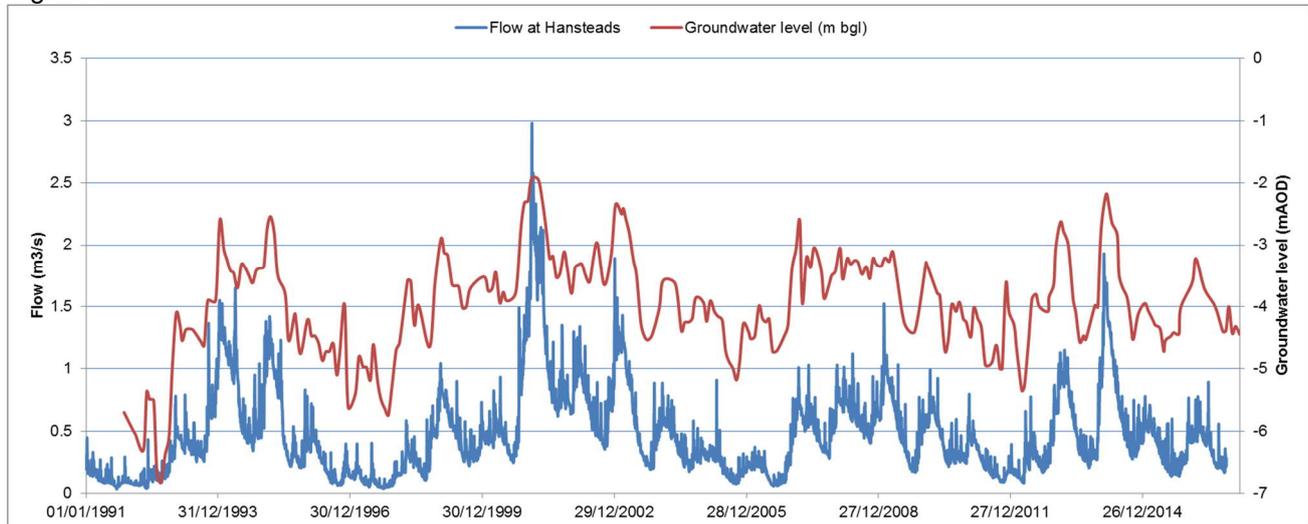
Approximately monthly groundwater levels for Abbey Mill observation borehole (OBH) were obtained for the period November 1991 to March 2017. These have been plotted against flow in the Ver (at Hansteads, downstream of St Albans and just upstream of the confluence with the River Colne) in Figure 3.3 below. Groundwater levels are presented regarding ground levels (m below ground level (bgl)), which were found to be 79.85m AOD at the borehole (based on LiDAR data). The location of Abbey Mill OBH is provided on Figure 3.4.

Figure 3.3 Time series of flow in the Ver and groundwater levels at Abbey Mill OBH (with respect to ground level)

This shows that groundwater levels are typically 4m (~76 m AOD) bgl at the borehole and that they have been observed to fall to almost 7m bgl (~73 m AOD). Regarding high groundwater levels, they have been found to only be less than 3m bgl (~77 m AOD) for 10% of the time and the highest observed level was just under 2m bgl (~78 m AOD).

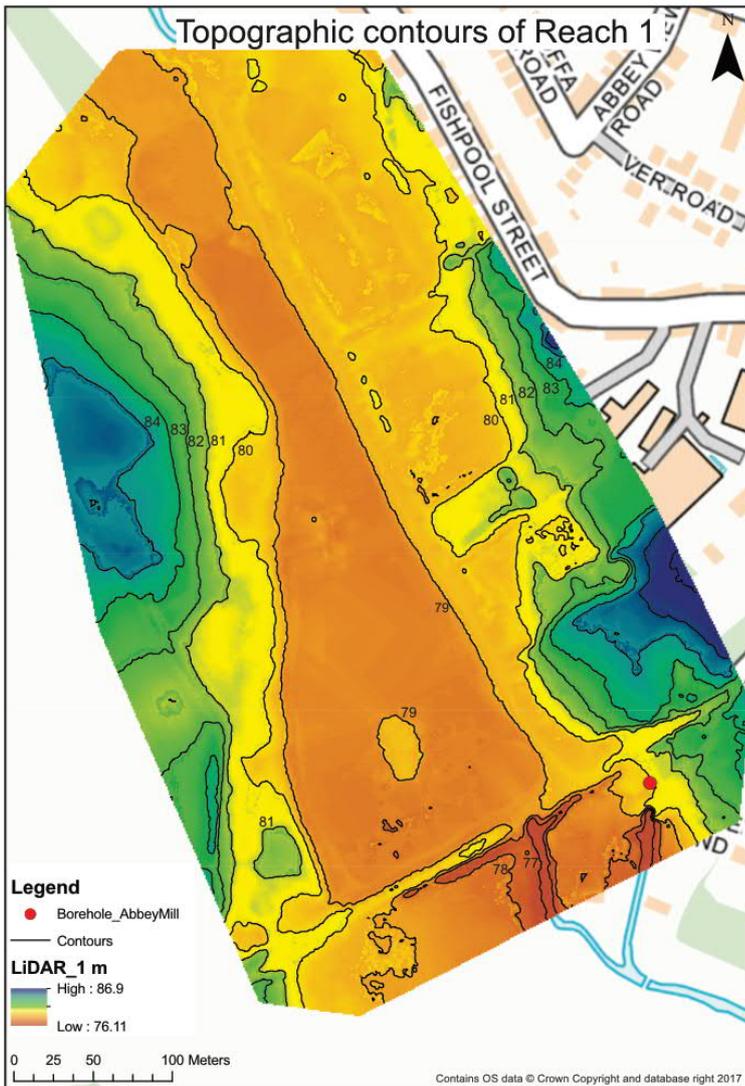
Land elevations in and around the Abbey Mill OBH and Verulamium Lake, from LiDAR data, are indicated in Figure 3.4 below. Hard bed elevations in the northern half of the lower lake were found to be around 77.7 m AOD and in the southern half they were around 77.6 m AOD (discussed above in the *Lake Bathymetry and Depth of Sediment* section). Groundwater levels under the lake would be expected to be lower than they are at the borehole, with the borehole being nearer the valley side and the lake being on the valley floor (the lowest point and original discharge point for groundwater), although the magnitude of any difference is not known. The above suggests that groundwater levels would be at least 1m below hard bed levels for at least 90% of the time.

Figure 3.4 Ground Elevations in and around Abbey Mill OBH (borehole)

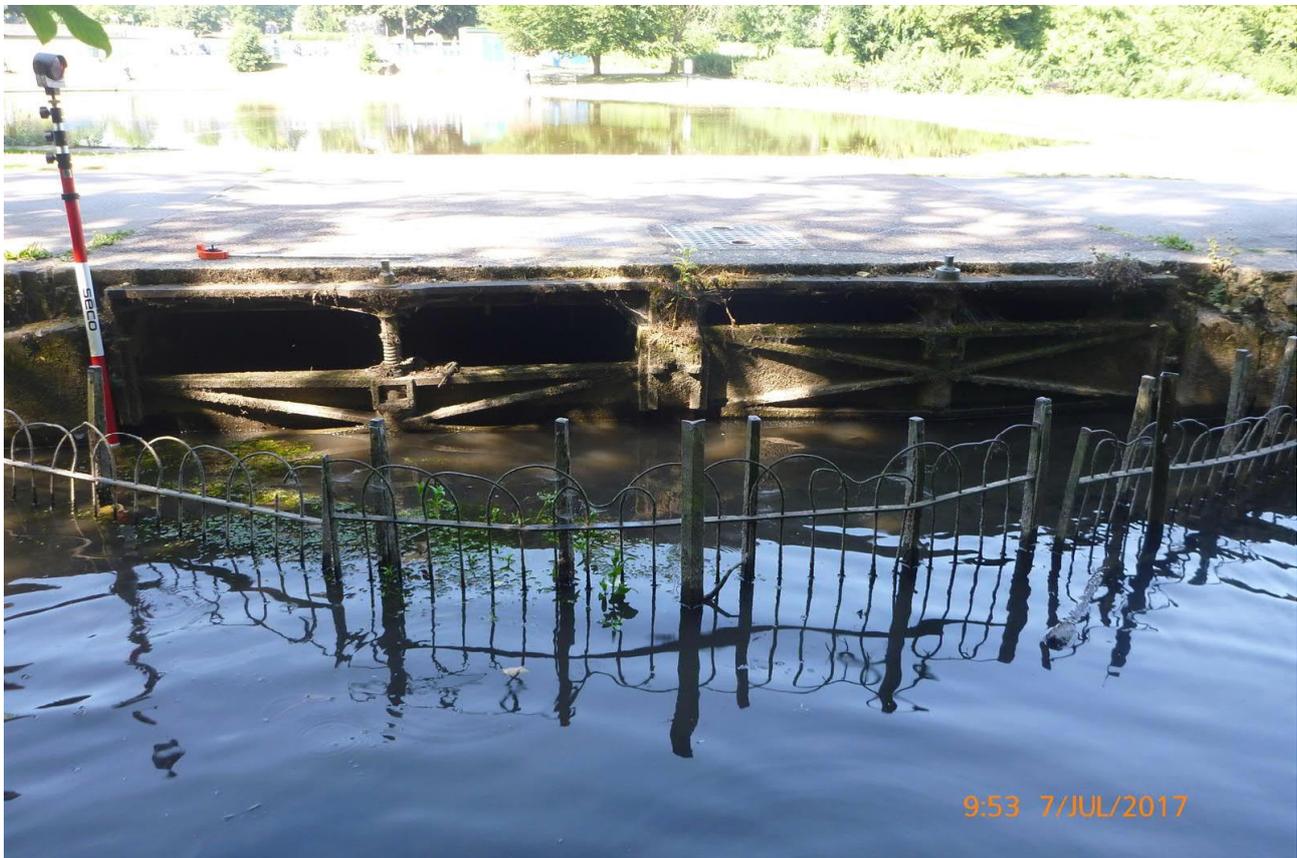
The inlet into the upper lake consists of two culverts with the connection between the river and lake being managed by a set of gates; a bottom fixed gate and a top moveable gate. Behind the bottom fixed gates is a concrete weir that obscures full vision and access to the bottom fixed gate. Plates 3.3 and 3.4 illustrate an external view of the culverts and an internal view of the weir and gates. Further information on the structure, including invert levels is discussed further within the modelling report (Appendix D). During the modelling we found that under the existing conditions flow into the lake was found to be 0 m³/s at times of low flow (Q₉₅), 0.008 m³/s at times of average flow (Q₅₀) and 0.08m³/s at times of high flow (Q₁₀).

Plate 3.3 External view of the culverts (looking from the River Ver towards the Verulamium Lake)

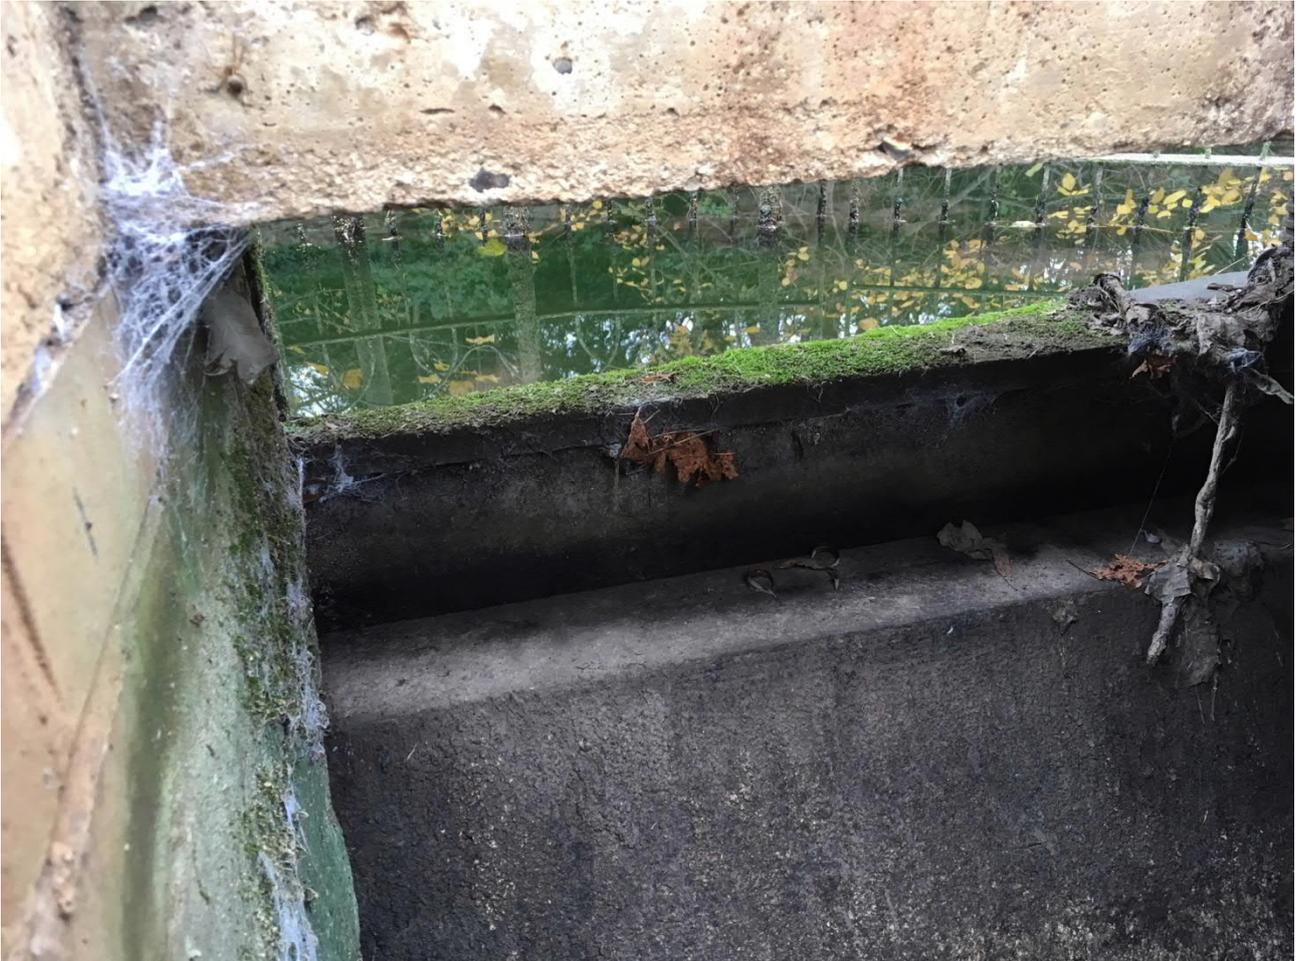
Plate 3.4 Internal view of the culvert gates (looking from Verulamium Lake towards the River Ver)

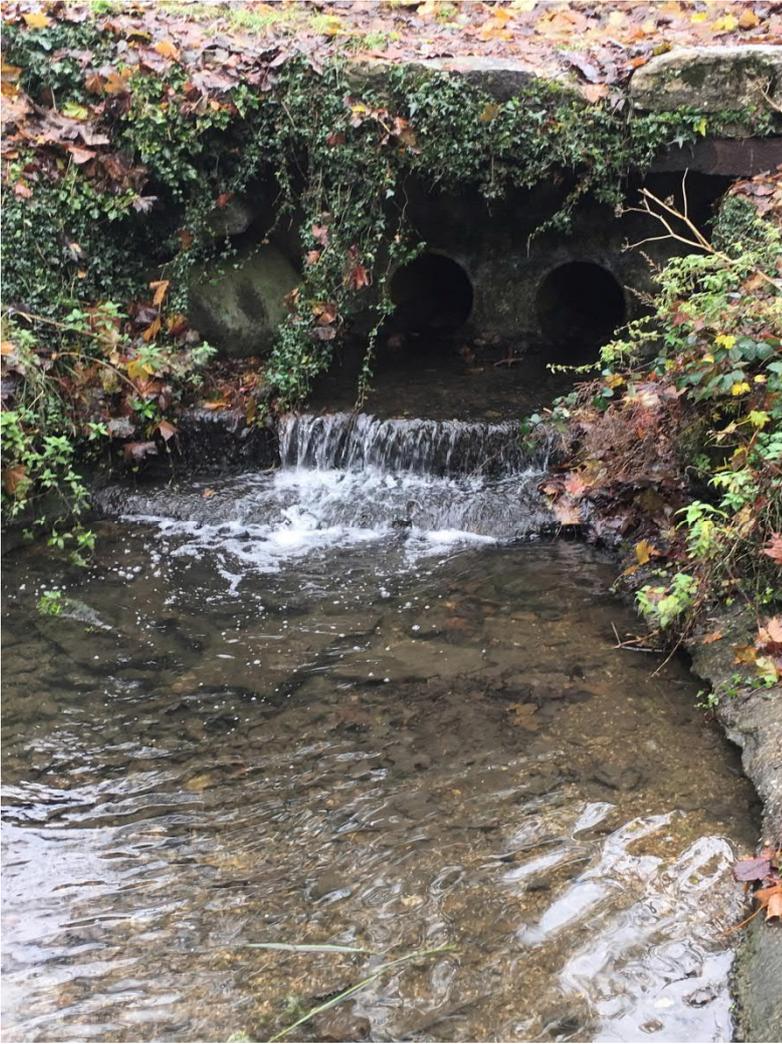
There is also a culvert that directs some flow from the River Ver/ mill leat under the southeastern corner of the lower lake. This joins the outflow from the lake prior to both joining the River Ver at the top of Reach 2. The combined outflow/ flow into Reach 2 is indicated in Plate 3.5 below.

Plate 3.5 Outflow from (the lower) Verulamium Lake into the River Ver at the top of Reach 2

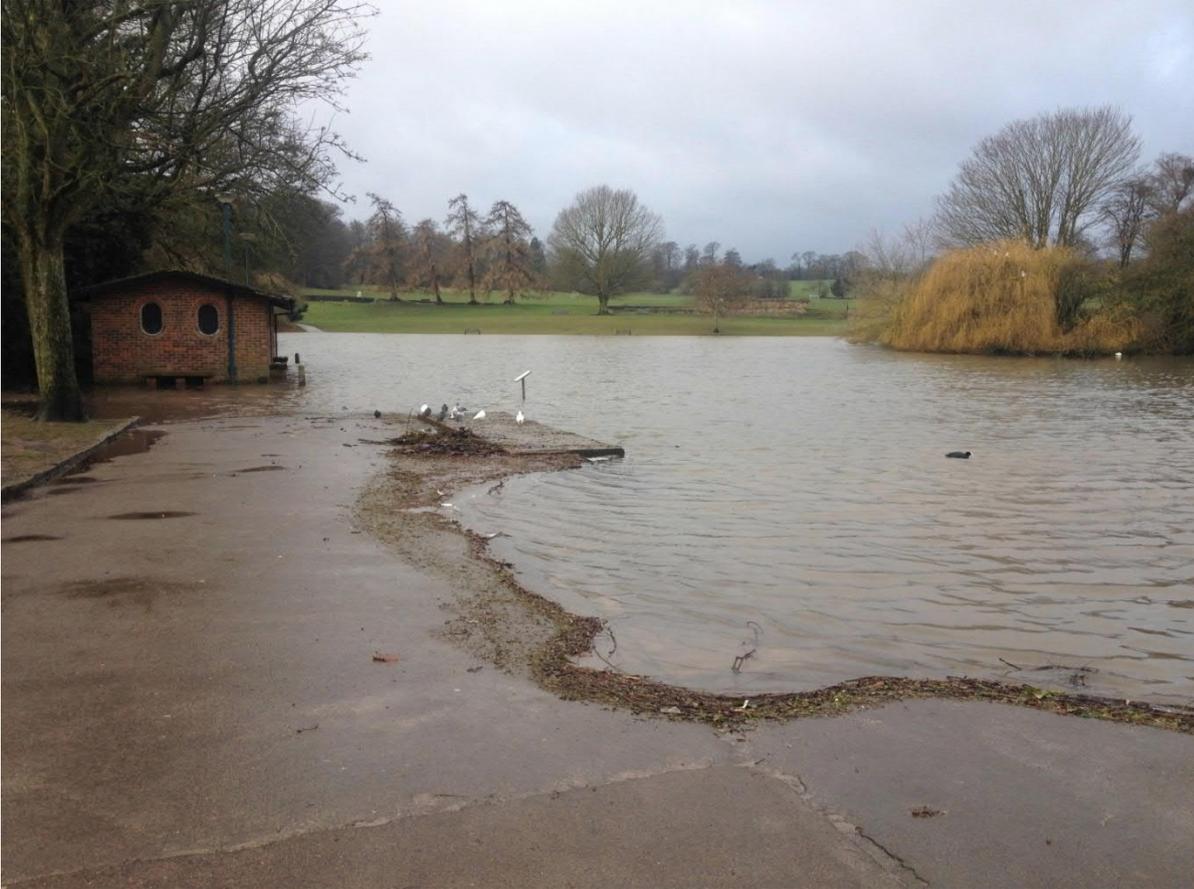
Plate 3.6 Overbanking of the lower lake (at its downstream end) following the February 2014 flood (bottom of Reach 1)

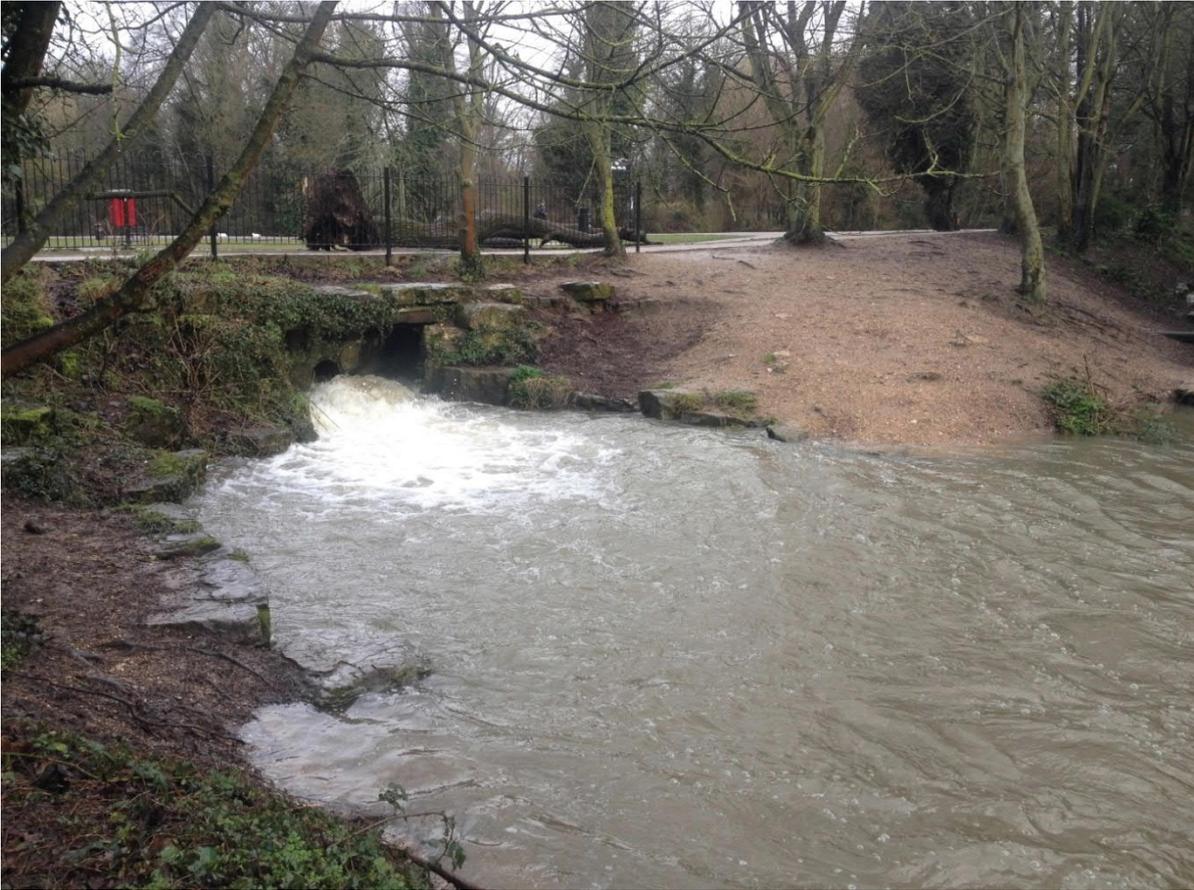
Plate 3.7 Flow from the lake following the February 2014 flood (top of Reach 2)

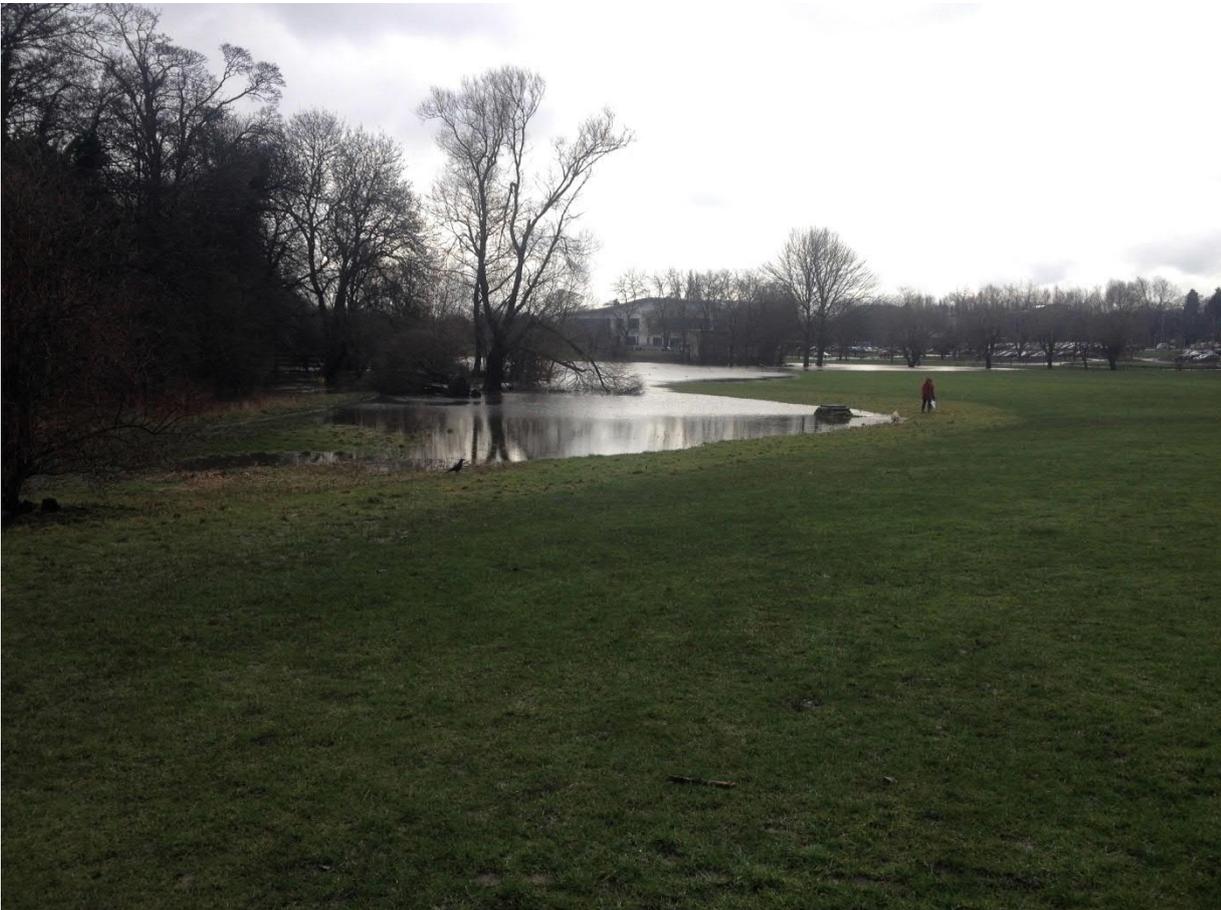
Plate 3.8 Flooding in Reach 2 following the February 2014 extreme flood (looking downstream)

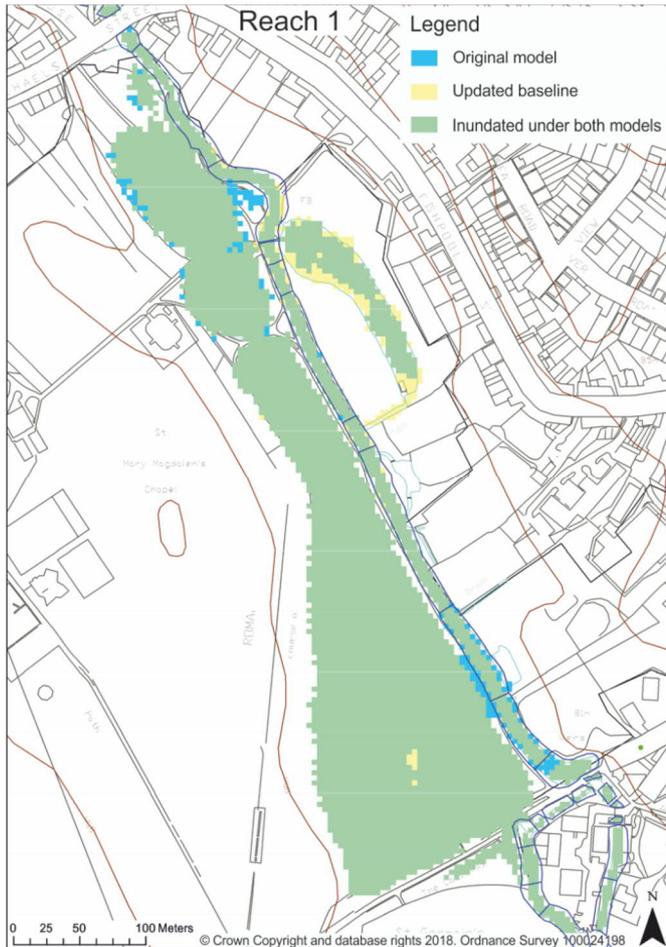
Figure 3.7 Extent of the 1 in 100 year flood (original (JBA) and Updated (AECOM) model) through Reach 1

AECOM were given this model by the Environment Agency and it was to be used to inform the outline design of the preferred option for each reach. As part of this the Environment Agency obtained additional topographical (additional cross sectional and structural surveys were undertaken throughout the study area) and bathymetrical surveys (of Lake Verulamium) and these were incorporated into the model. The baseline Ver JBA and updated baseline Ver flood risk extents for the 1 in 100 year flood events (1% chance of flooding each year) are provided in Figures 3.7 to 3.10 below.

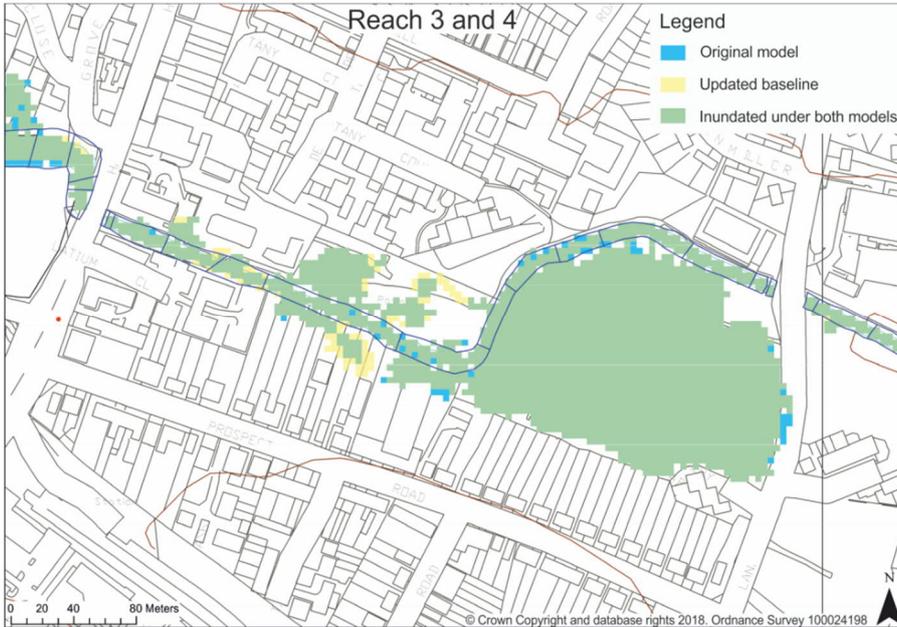
Figure 3.9 Extent of the 1 in 100 year flood (original (JBA) and Updated (AECOM) model) through Reaches 3 and 4

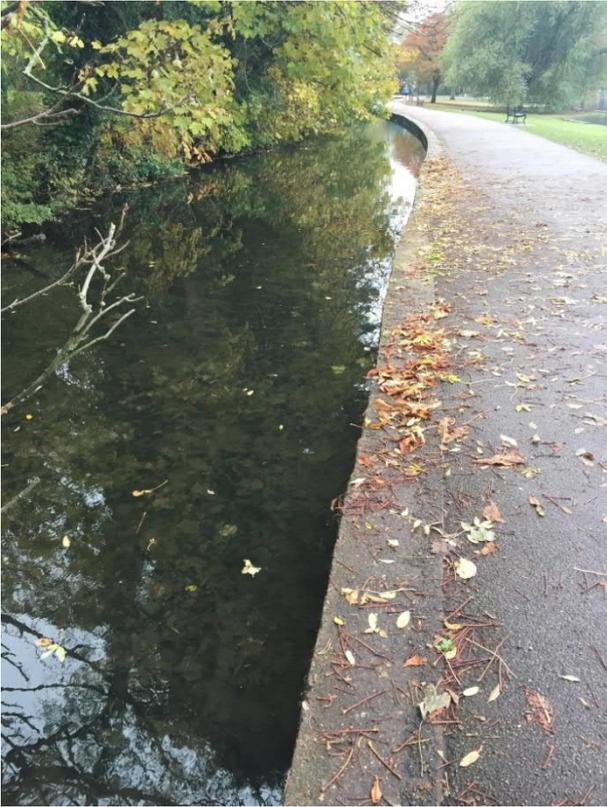
The River Ver through Reach 1 has a concrete lined right bank (Plate 3.9) adjacent to the pond and Lake as a result of historic channel straightening but with a natural left bank lined by trees adjacent to private gardens. The gravel bed is highly sedimented as a result of historic overwidening with fine sediment often depositing as lateral berms where the river has attempted to adjust to the overwide conditions by narrowing through lateral fine sediment deposits.

Plate 3.9 Fine sediment deposition, lateral berms and concrete lined right bank

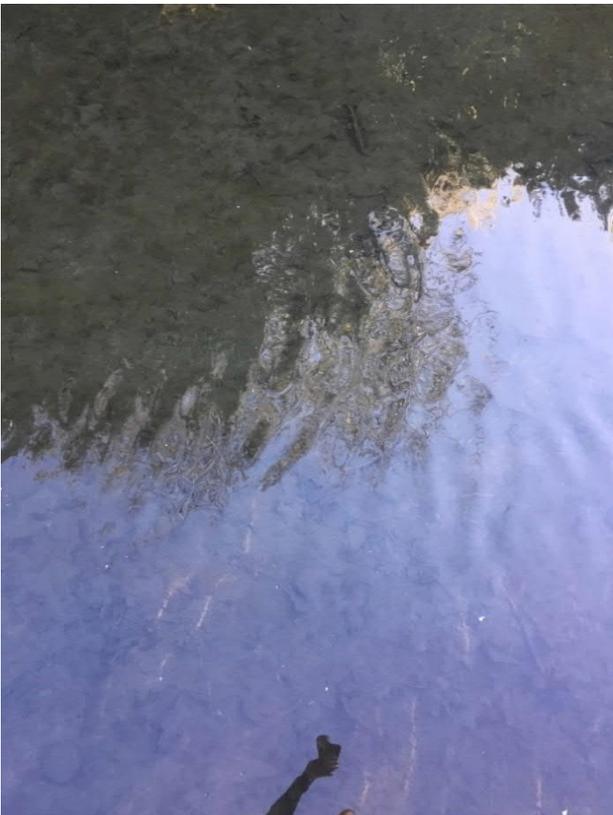
Fine sediment and organic deposition pressures (Plate 3.10) are further exacerbated by the influence of the weir that controls the flow split into the downstream fish pass (Plate 3.11) and through the mill leat channel. This reduces the channel slope and has created a monotonous, low energy, glide flow type along the majority of this reach with very little flow depth or width variation. The low energy and fine sediment pressures mean that there are very few zones of an exposed gravel bed.

Plate 3.10 Fine sediment deposition on channel bed through Reach 1

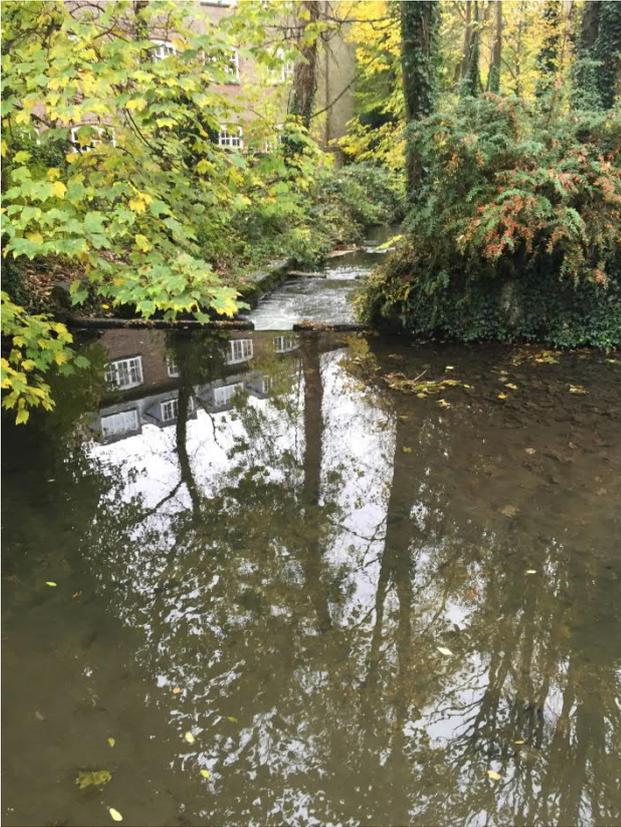
Plate 3.11 Impounding influence at downstream end created by weir and fish pass influence

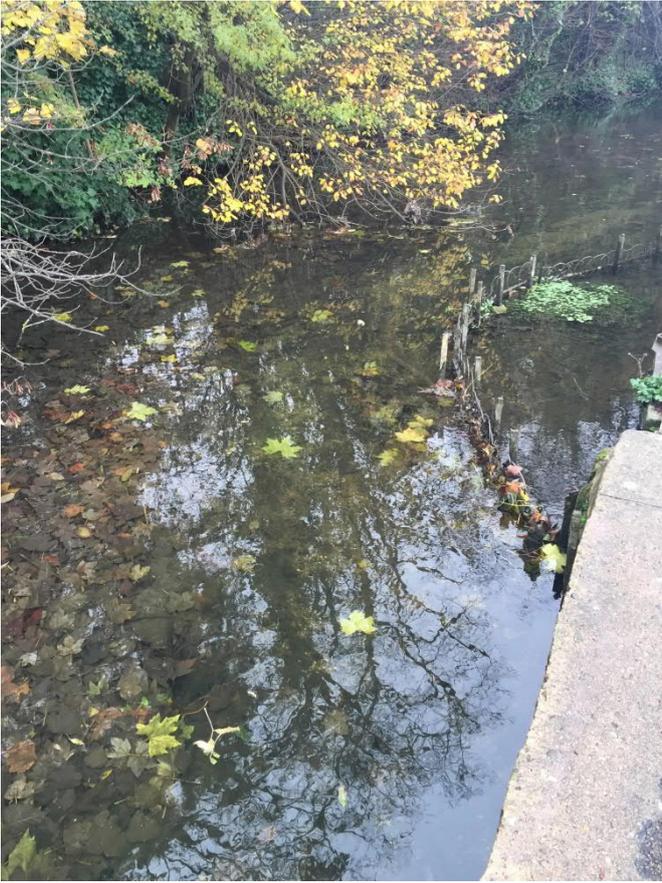
Low flows along the reach are also impacted by the various flow splits between the main channel and the lakes over the right bank (Plate 3.12) and various offtake channels over the left hand bank. These result in less concentrated flow within the main channel, again resulting in lower energy flows creating conditions prone to fine sediment deposition. The various flow splits have been considered as part of the development of restoration options for this reach.

Plate 3.12 Flow split into lakes from main channel

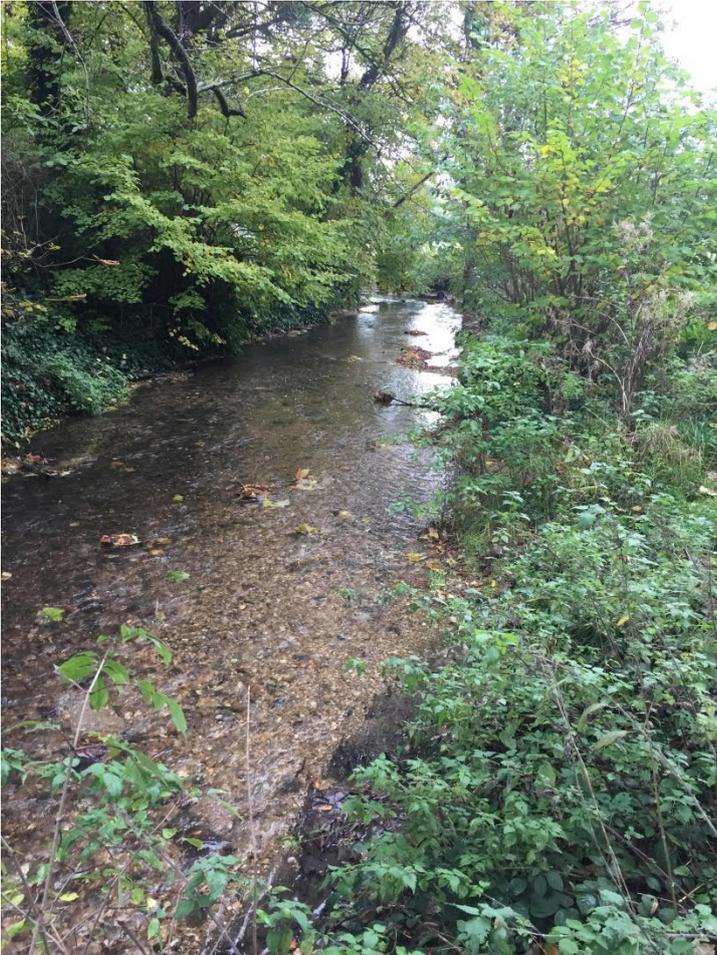
Gravel exposure is helped by the narrowed channel compared to main Reach 1 channel.

Plate 3.13 Improved gravel bed and riffles just downstream of fish pass

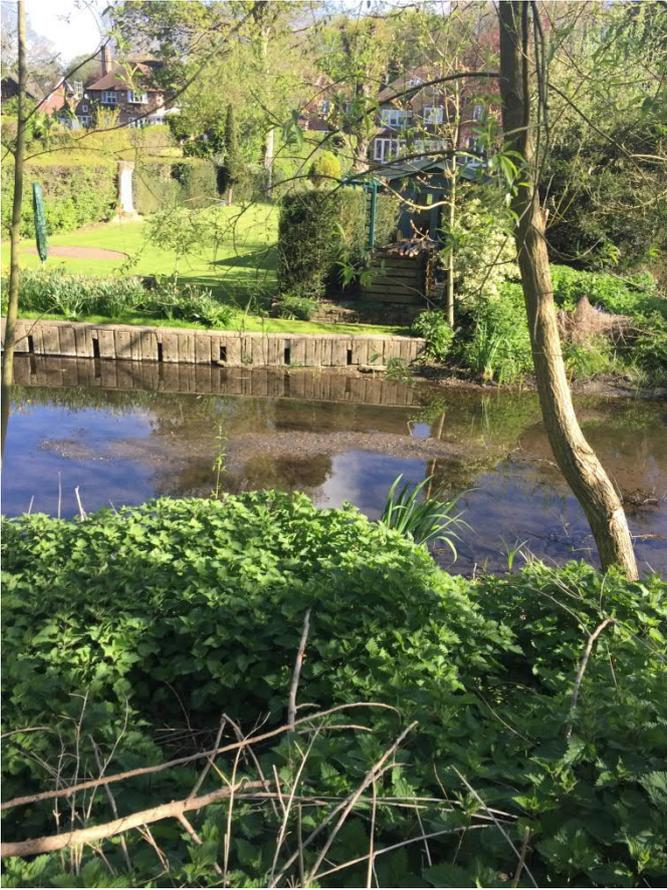
Downstream of this point the fine sediment pressures on the river bed return with historic over widening and deepening providing low energy flow conditions. This severely impacts the quality of the gravel bed and where lateral and mid channel berms (Plate 3.14) have formed, these have often consolidated and become vegetated over time (Plate 3.15). This indicates very infrequent high energy flows energetic enough to mobilise delivered fine sediments.

Plate 3.14 Fine sediment mid-channel berm through Reach 2

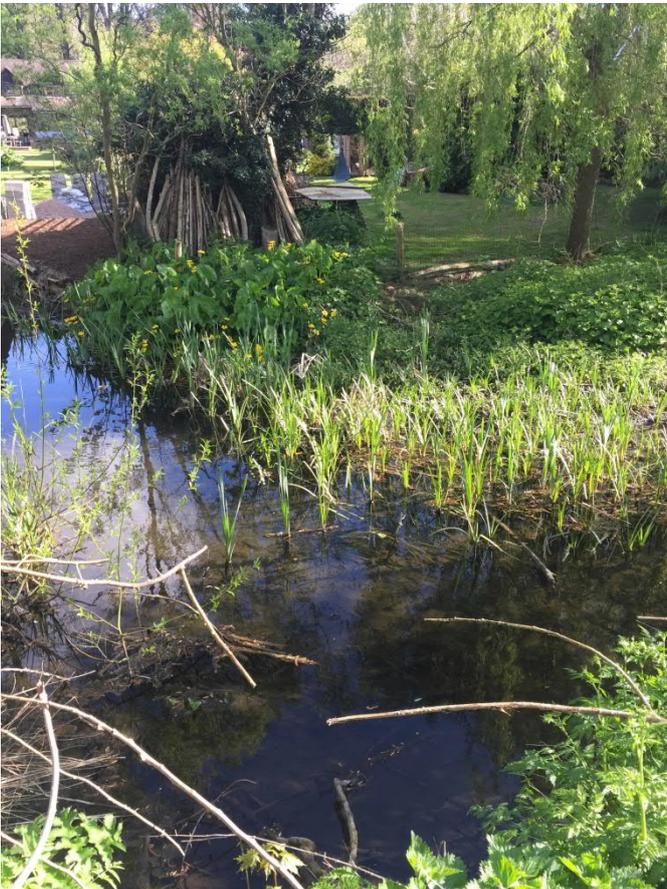
Plate 3.15 Vegetated fine sediment lateral berm

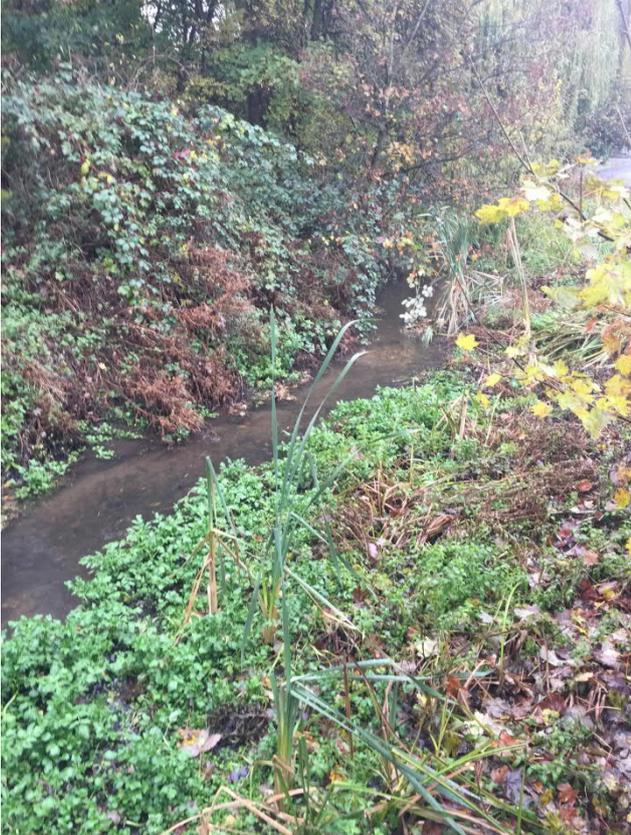
The river has narrowed itself towards the downstream end of the reach through lateral berm formation that has consolidated and become vegetated providing a flow width that is one third of the size of the channel width further upstream (Plate 3.16). This creates flow conditions energetic enough to expose an improved gravel bed and to keep fine sediment mobilised. This is an important feature that has been used to inform the restoration options for this reach.

Plate 3.16 Channel narrowing exposing an improved gravel bed

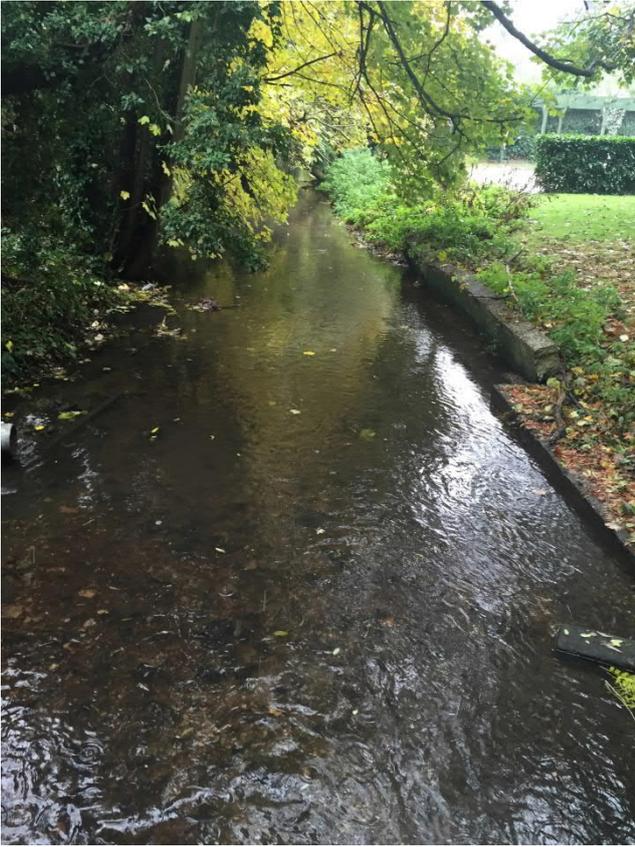
Reach 3 is a short straightened section of the River Ver that has a mixture of protected banks that are failing in places (Plate 3.17) and tree lined natural banks. The channel is again over wide as a result of the historic realignment and straightening and this has encouraged deposition of fine sediment as lateral berms and as a variable thickness layer of fine sediment across the gravel bed (Plate 3.18). A glide flow type generally persists throughout the entire reach (Plate 3.17) as a result of the over widening and low energy flow hydraulics. Where woody features have formed in the channel, for example close to the footbridge, the localised constriction created is energetic enough to expose a gravel bed and maintain fine sediment in motion. The flow width at this point is reduced by a minimum of 60% compared to the overall over widened channel through this reach (Plate 3.19).

Plate 3.17 Failing right bank hard protection and low energy glide flow type throughout Reach 3
