*River Ver
Restoration St
Albans*

With and on behalf of the Environment Agency

Document name	Ref	Prepared by	Date	Reviewed by	Approved By
River Ver Restoration St Albans	Final	Omar Sholi	25-1-2019	Nigel Pilkington	Omar Sholi
River Ver Restoration St Albans	Draft	Omar Sholi, Alex Deacon, Kate de Smeth, Seb Bentley, George Heritage, Tim Jones, Amy Jones	31-10-18	Nigel Pilkington	Omar Sholi

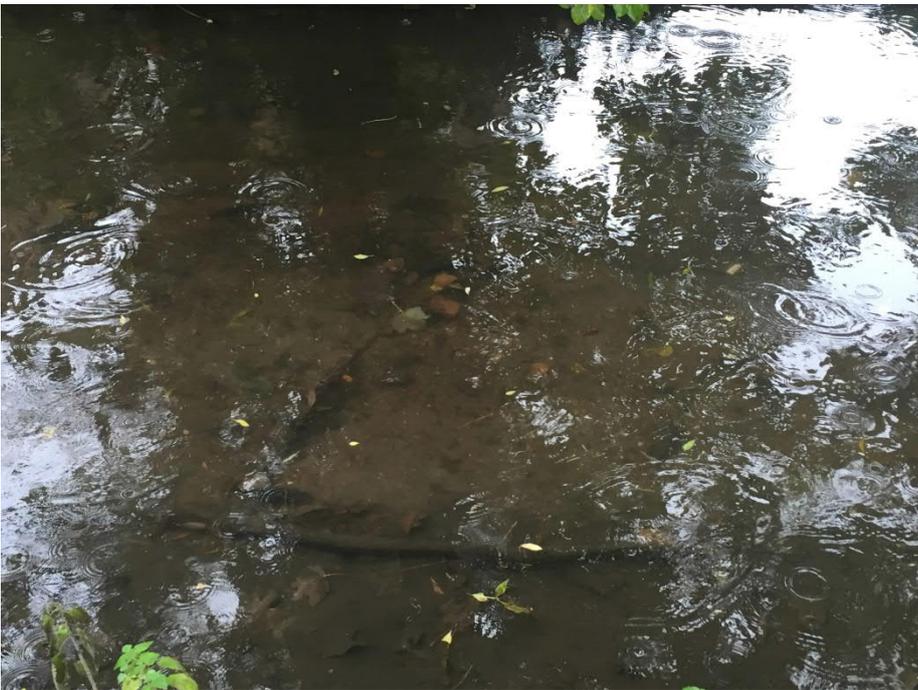
Plate 3.18 Fine sediment deposition across the gravel bed

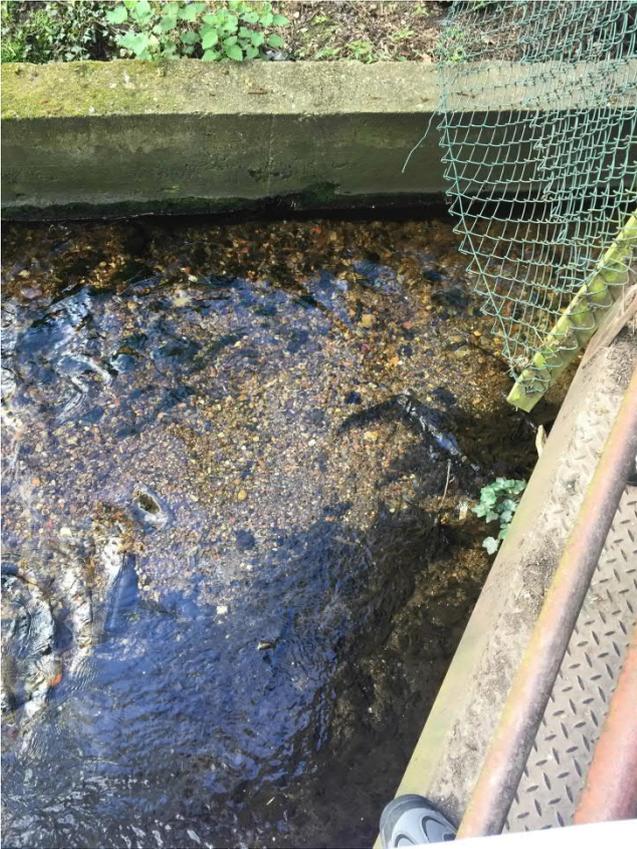
Reach 3 is a short straightened section of the River Ver that has a mixture of protected banks that are failing in places (Plate 3.17) and tree lined natural banks. The channel is again over wide as a result of the historic realignment and straightening and this has encouraged deposition of fine sediment as lateral berms and as a variable thickness layer of fine sediment across the gravel bed (Plate 3.18). A glide flow type generally persists throughout the entire reach (Plate 3.17) as a result of the over widening and low energy flow hydraulics. Where woody features have formed in the channel, for example close to the footbridge, the localised constriction created is energetic enough to expose a gravel bed and maintain fine sediment in motion. The flow width at this point is reduced by a minimum of 60% compared to the overall over widened channel through this reach (Plate 3.19).

Plate 3.19 Local channel narrowing created by woody feature exposing gravel bed

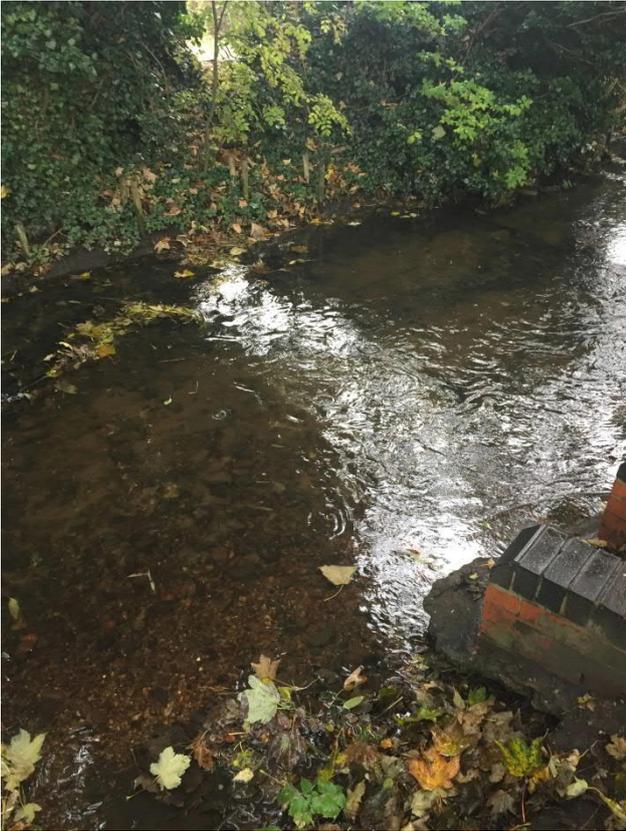
This reach flows adjacent to the allotments (situated on the right bank side of the river). It is known that some sections of floodplain here are lower in elevation than the river bed. This suggests the natural valley bottom runs through the allotments. The left bank is partly tree lined with the footpath close to the banktop. The right bank edge has ad hoc soft bank protection at numerous locations that is often failing and in a state of disrepair, although there is no evidence of significant erosion pressures at these points suggesting that this protection may not be required. Historic realignment of the channel has resulted in an over-wide channel, again resulting in widespread deposition of fine sediment (Plate 3.20) often as lateral berms and as a veneer across the gravel bed. There is very little gradient through this reach and the channel is over-shaded.

Plate 3.20 Fine deposition and lateral berms

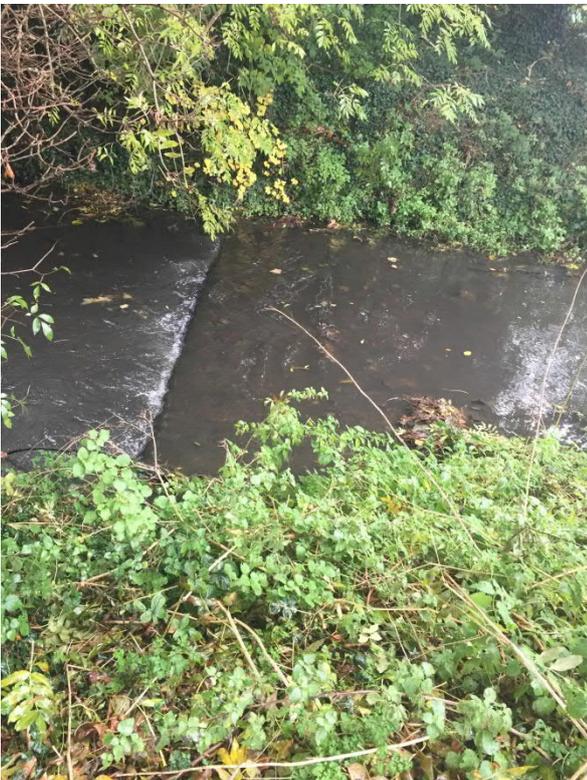
There is a small weir crossing the river bed close to the downstream extent of the reach. This impacts sediment transport locally (Plate 3.21). It is possible that this is a service crossing although we have received conflicting service information on this.

**Plate 3.21 Small weir at downstream extent of Reach 4
Reach 5 and 6**

A small weir is located immediately upstream of the Cottonmill Lane road crossing at the downstream end of the reach. The head difference across the structure is around 0.1 m, resulting in a small downstream pool and upstream silt accumulation behind the weir structure. A full passability assessment was not undertaken, however the diminutive nature of the structure is unlikely to pose a threat to stronger swimming riverine species (for example brown trout, dace and chub), but could limit certain life stages of the less stronger swimming (for example roach, perch, bullhead and minnow). Suitable riverine fish habitat is very much limited throughout Reach 4.

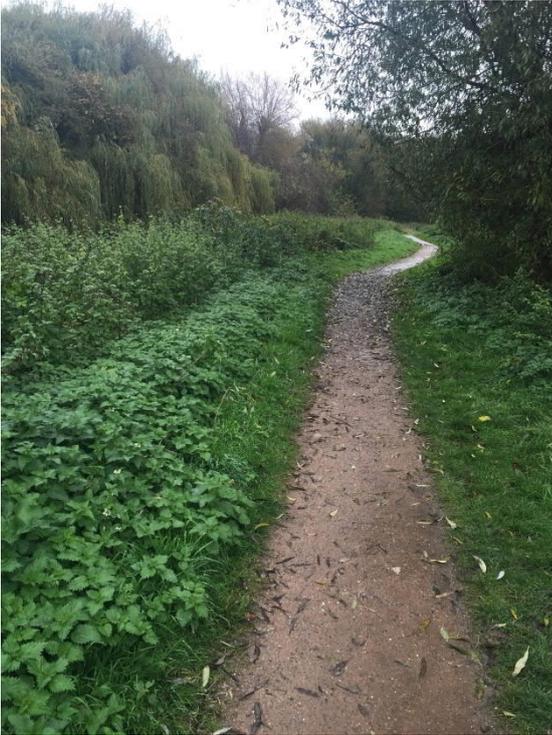
Plate 3.22 Right bank dredged material

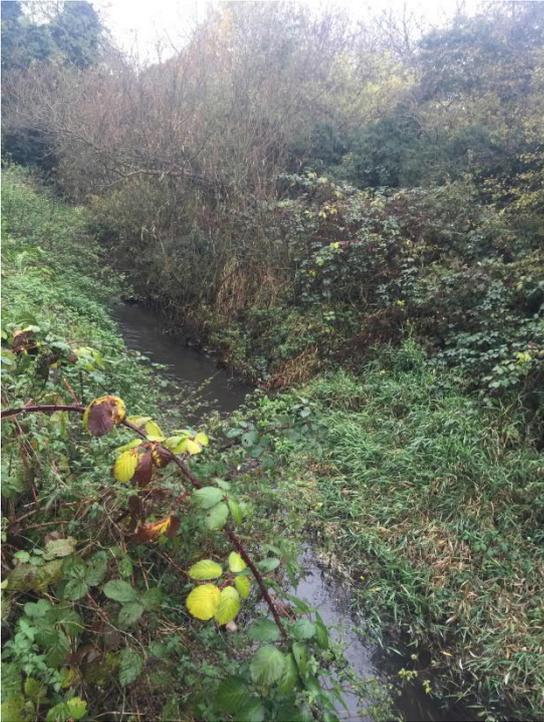
Plate 3.23 Channel narrowing created by vegetated lateral berms

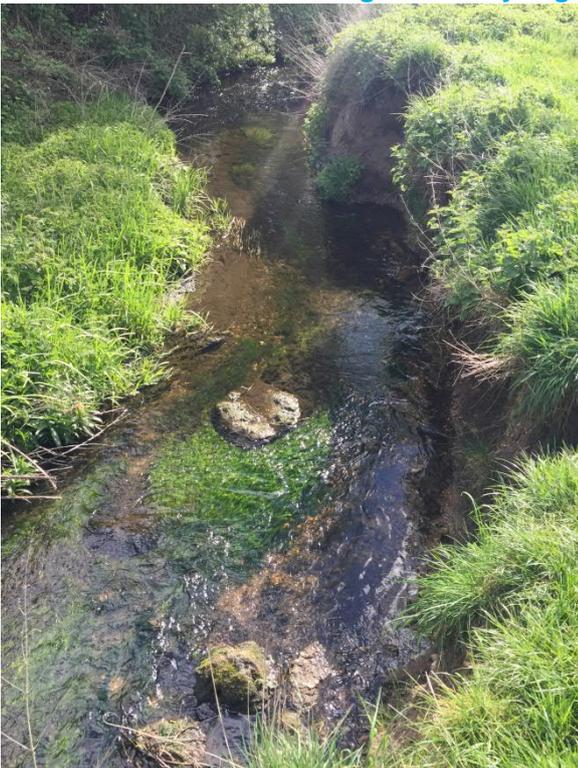
The river through both reaches has been historically moved and straightened and it is likely the natural valley bottom would have been over the right hand bank, within the floodplain. As a result of the historic realignment, the river is over wide and over deep, particularly towards the downstream end, creating a disconnected floodplain that is exacerbated by dredged material being dumped on the right bank top throughout both reaches (Plate 3.22). Reach 5 in particular has reacted to the overwide channel form by depositing delivered fine sediment as lateral berms and consolidated point bars that have often become vegetated (Plate 3.23). This has narrowed the channel significantly in places (to around 50% of the previous width) and, combined with a slight increase in hydraulic gradient, has created flow hydraulics energetic enough to expose an improved gravel bed (Plate 3.24). At a couple of locations, flows have become energetic enough to create some localised minor bank erosion (Plate 3.24) providing a rare habitat.

Plate 3.24 Sediment shoaling and vegetative colonisation creating conditions for local bank erosion

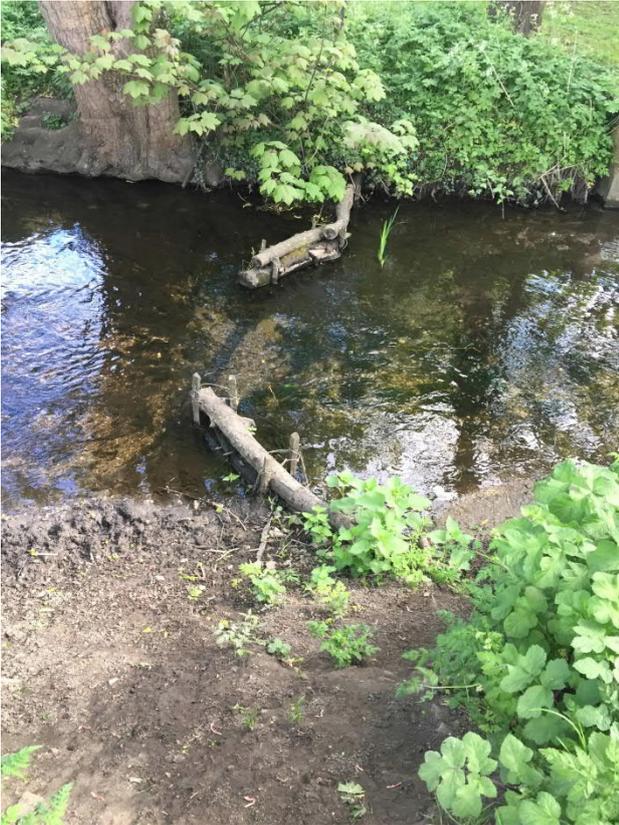
The flow deflectors seen along both reaches are generally not functioning as intended encouraging only limited scour and deposition (Plate 3.25). However, the degree of channel narrowing created by consolidated fine sediment berms and bars seen elsewhere has been a lot more successful in creating elevated flow velocities under normal flows and these are capable of exposing a gravel channel bed and creating an improved diversity of hydraulic habitat. This narrowing and associated features offer useful analogue information that has been used to inform the restoration optioneering for the project.

Plate 3.25 Ineffective flow deflector

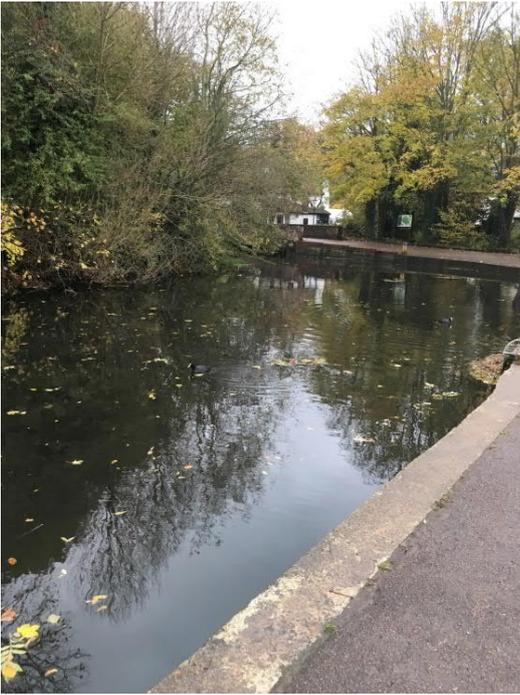
The hydromorphology of the reach was described in Section 3.4 above. The majority of this reach is a mill leat, with water levels held up by weir structures and with a very low gradient. This results in a reach with low hydromorphological diversity (Plate 3.26) and has contributed towards the large amounts of fine sediment deposition throughout the reach. This limits the spawning and recruitment potential for lithophilic riverine species (for example brown trout, chub and dace). Overhead cover is limited to areas of overhanging riparian tree cover and submerged root systems along the left hand bank. The right hand bank bordering the footpath between the lake and the river is made up entirely of concrete for much of the reach, providing very little marginal cover for fish. Around 10-15 chub between 15-35 cm (in length) were observed beneath overhanging tree cover on the left hand bank during the site walkover assessment (Plate 3.27). In the absence of suitable spawning sites for the species within Reach 1, chub are likely to have originated from the spawning population recorded in surveys shortly upstream at Gorehambury Mill.

Plate 3.26. Downstream view of the over-wide, impounded River Ver shortly upstream of Abbey Mill

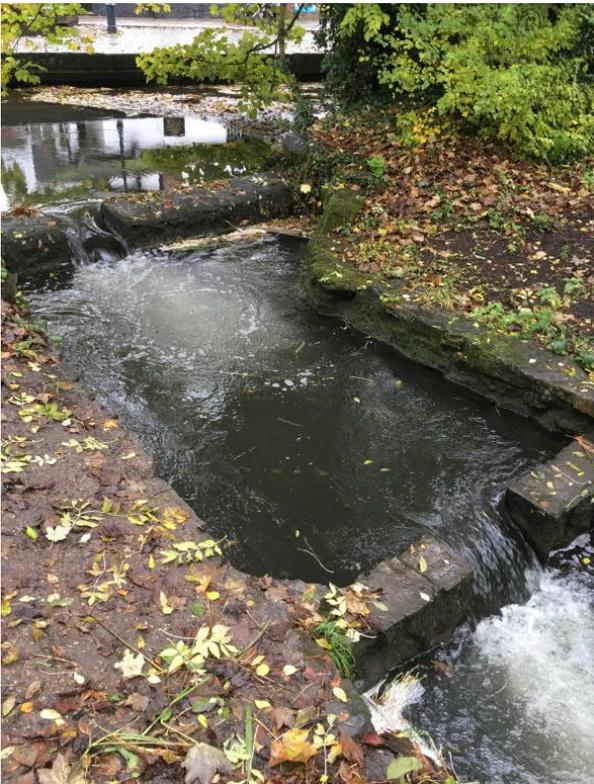
A pool and traverse fish pass (Plate 3.28) is located at the downstream end of the reach with the aim of providing fish passage between the Abbey Mill and Verulamium Lake obstructions. A formal fish passage assessment of the structure was not undertaken during the site walkover assessment. The fish pass is considered to be ineffective for providing passage for the various life stages of trout and coarse fish associated with the Ver²⁰.

Plate 3.28. Upstream extent of the fish pass structure in Reach 1

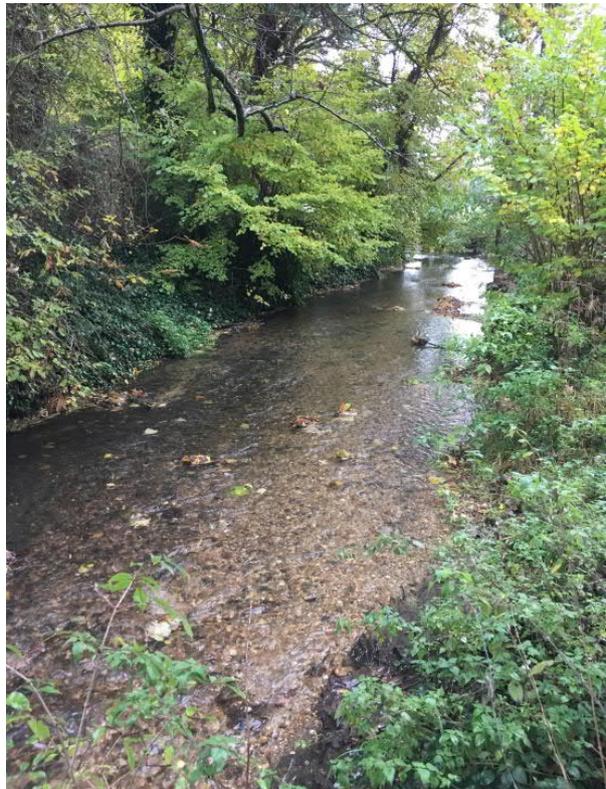
Plate 3.29. Downstream view (from Reach 2) of the gravel riffle feature located shortly downstream of the confluence of the Lake discharge and fish pass

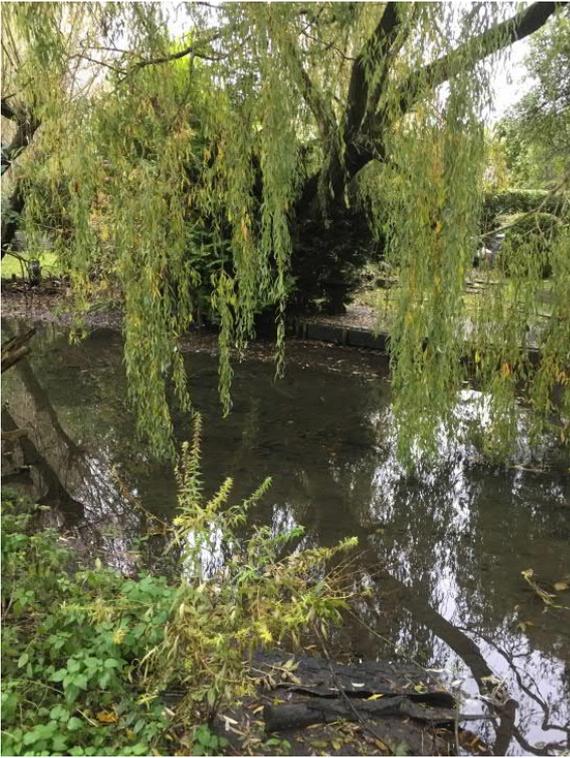
Plate 3.30 Upstream view of the heavily shaded, over-wide nature of the River Ver throughout much Reach 2

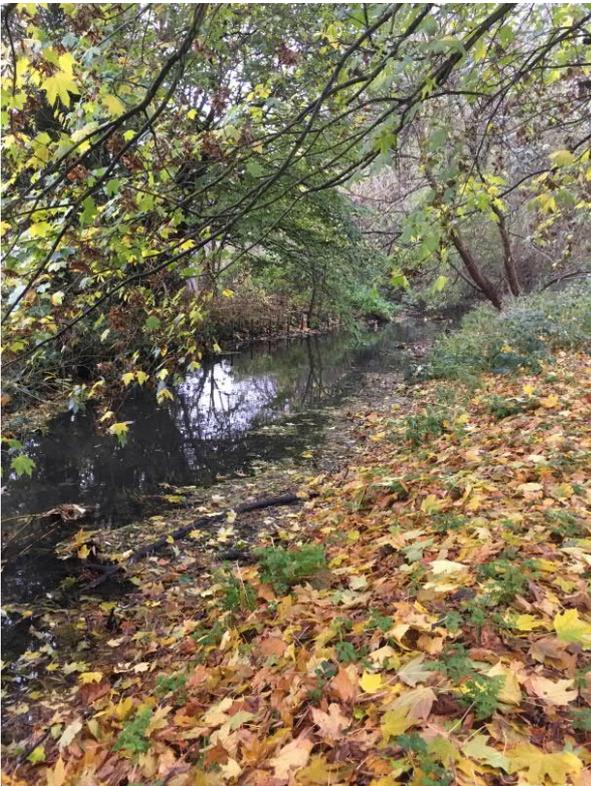
Plate 3.31 Upstream view of the heavily shaded, artificial bank structure and heavily silted river bed typical of the Ver throughout Reach 3

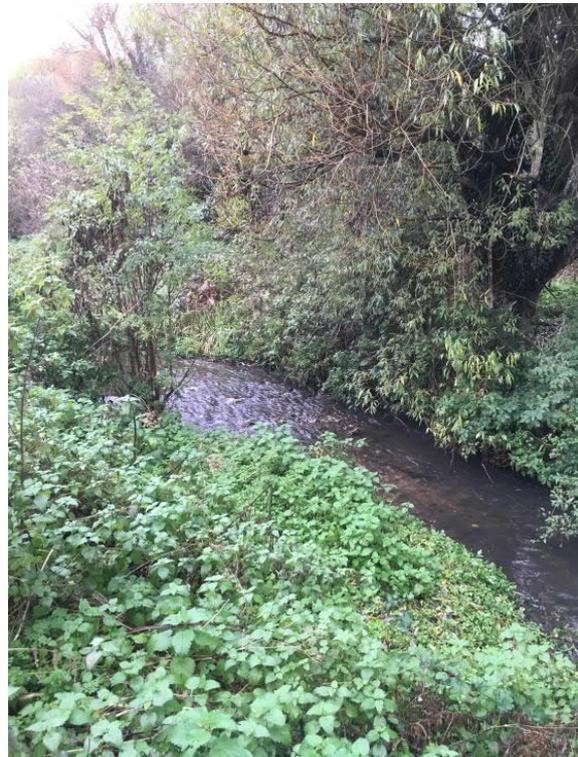
Plate 3.32 Downstream view of the River Ver through Reach 4 illustrating the heavy accumulation of leaf litter in and around the margins of the watercourse

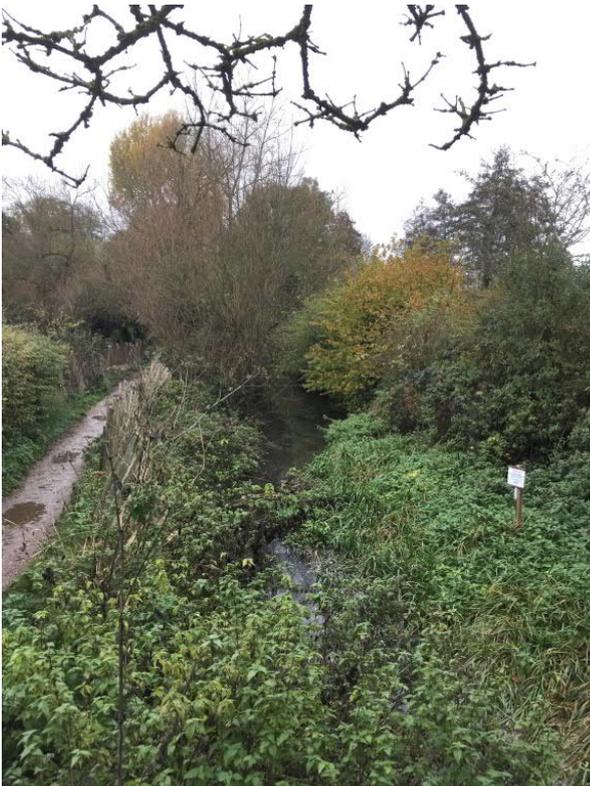
Plate 3.34 Upstream view of the River Ver through Reach 6 illustrating the heavily incised, overgrown channel course

The effects of historic dredging practices and channel re-alignment continue into Reach 6, however as a result of increased riparian vegetative cover along the course of the left hand bank (Plate 3.34), channel shading increases and instream macrophyte growth is limited to very small areas. Consequently, the channel takes on a much more homogenous morphology, with habitat for fish scarce throughout. Much of the right hand bank riparian zone consists of heavily overgrown scrub vegetation. Substrate shifts from the clean gravel bed recorded in Reach 5, to a largely fine sand/ silt based composition in Reach 6. At the downstream extent of the reach, a large gravel riffle area is present beneath the old railway bridge, however the gravel appears heavily compacted and unsuitable for lithophilic spawning species.

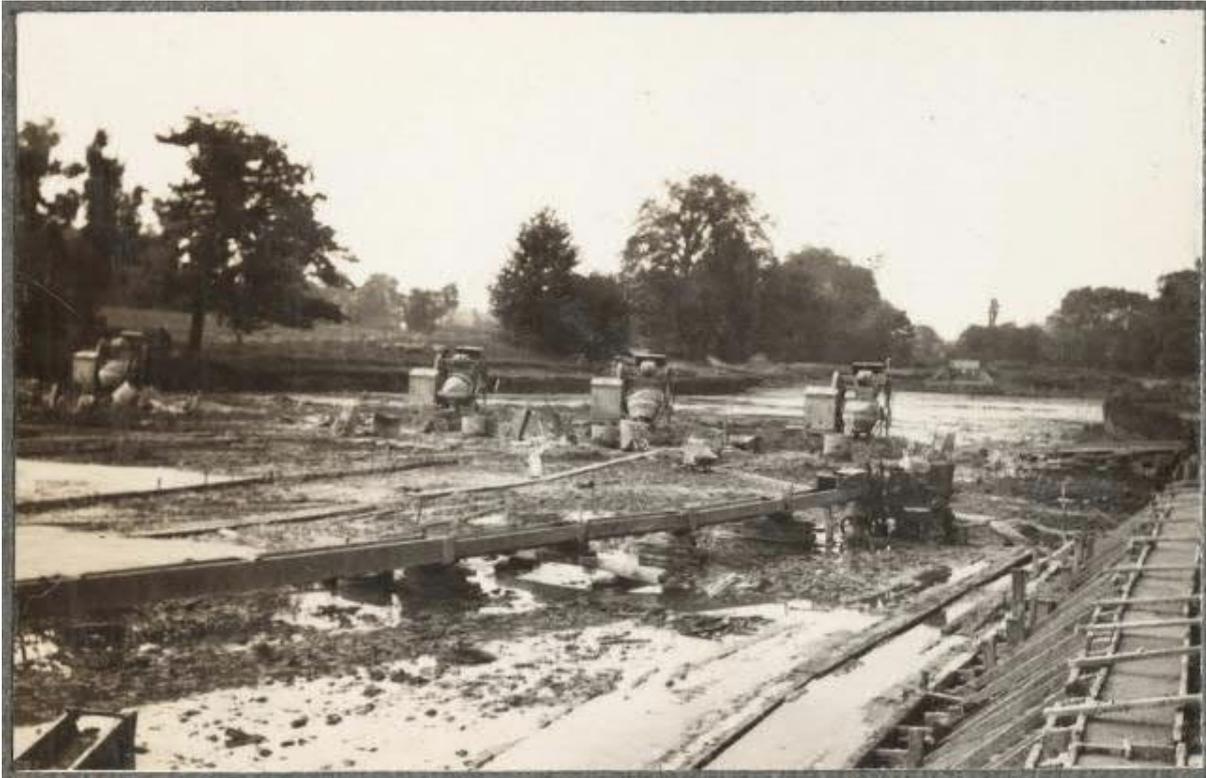
Plate 4.1 – shows the concrete base of the lake under construction

Plate 4.1 (top left) Concrete lake bed at the margins of the upper lake; Plate 4.2 (top right) Exposed sediment downstream of the weir between the upper and lower lake; Plate 4.3 (bottom left) Exposed sediment at the southwestern corner of the lower lake; Plate 4.4 (bottom right) Algal accumulations on the surface of the lower lake

The lakes in Verulamium Park were constructed between 1929 and 1932 partly to give much needed work to unemployed people during the depression. The lakes were lined with hand poured concrete and are no more than around one metre deep.

Concrete lining and banks	The concrete lining and banks of the lakes restrict the establishment of plants that would help to balance the levels of nutrients in the water.	Plants cannot establish and the benefits of having a plant rich lake are not available.
Silt / sediment	More organic material enters the lakes than can be processed naturally. This builds up as silt on the lake bed. It is nutrient rich and adds to the issue of eutrophication (excessive nutrients) The organic matter that forms silt comes from amongst others, wildfowl and fish waste, rotting uneaten food, leaf litter and decaying algal matter. Some sediment also comes from the Ver inflow.	When the water level is low sediment protrudes above the surface. This represents a hazard to wildlife, people and dogs that walk onto it. The silt itself is not hazardous, but it is unsightly and can be very smelly in warm weather. The build-up of silt creates even shallower conditions in an already shallow lake environment. This reduces water quality and makes the lakes warm up faster in hot weather.

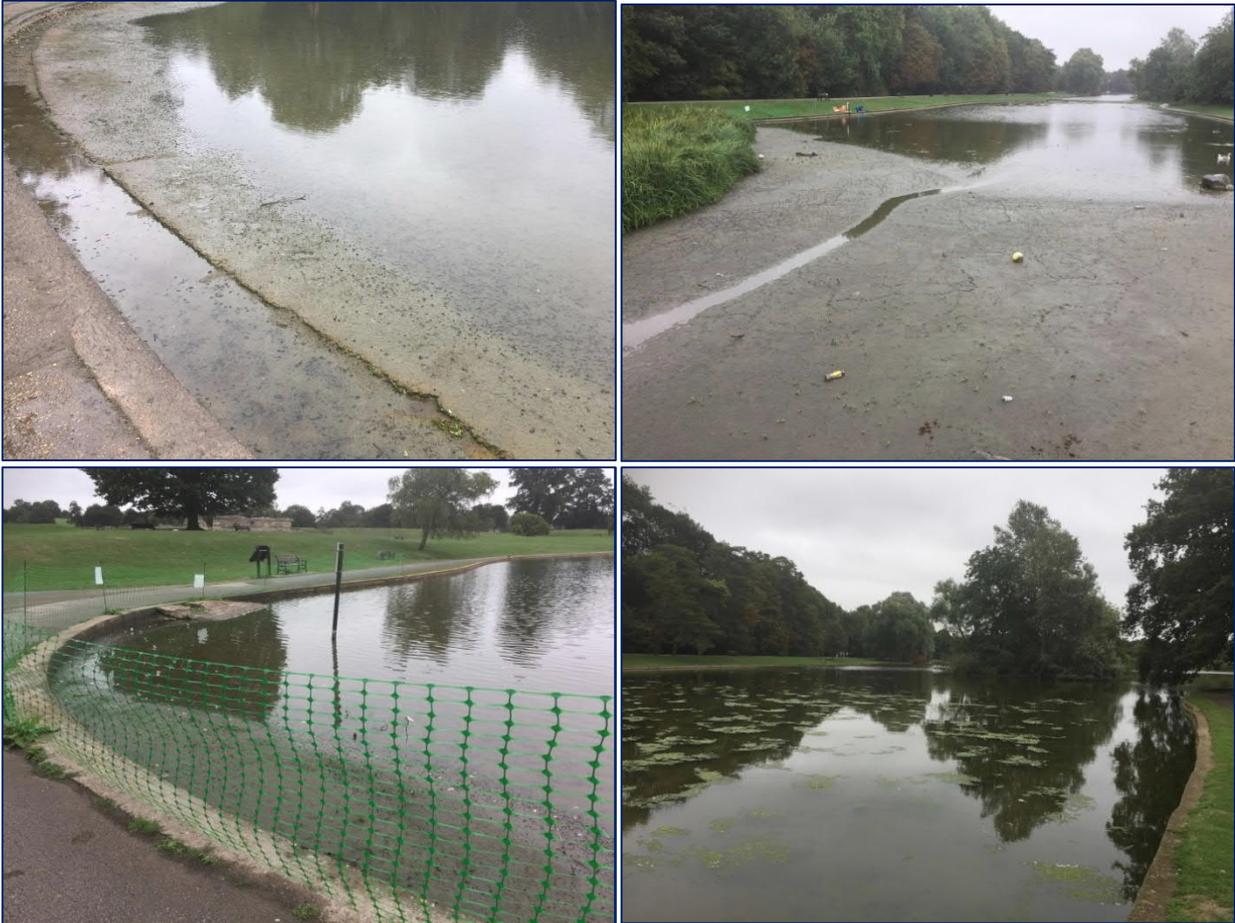
Bottom-feeding fish	The fish in the lake are predominantly non-native species such as carp. These are bottom-feeding fish which stir up sediments at the bottom of the lake creating cloudy water conditions as they cause the silt to be re-suspended in the lake water.	Turbid, or cloudy, water restricts light penetration which means that aquatic plants struggle to grow. Re-suspension of silt and its associated nutrients contributes to the eutrophication issues mentioned earlier.

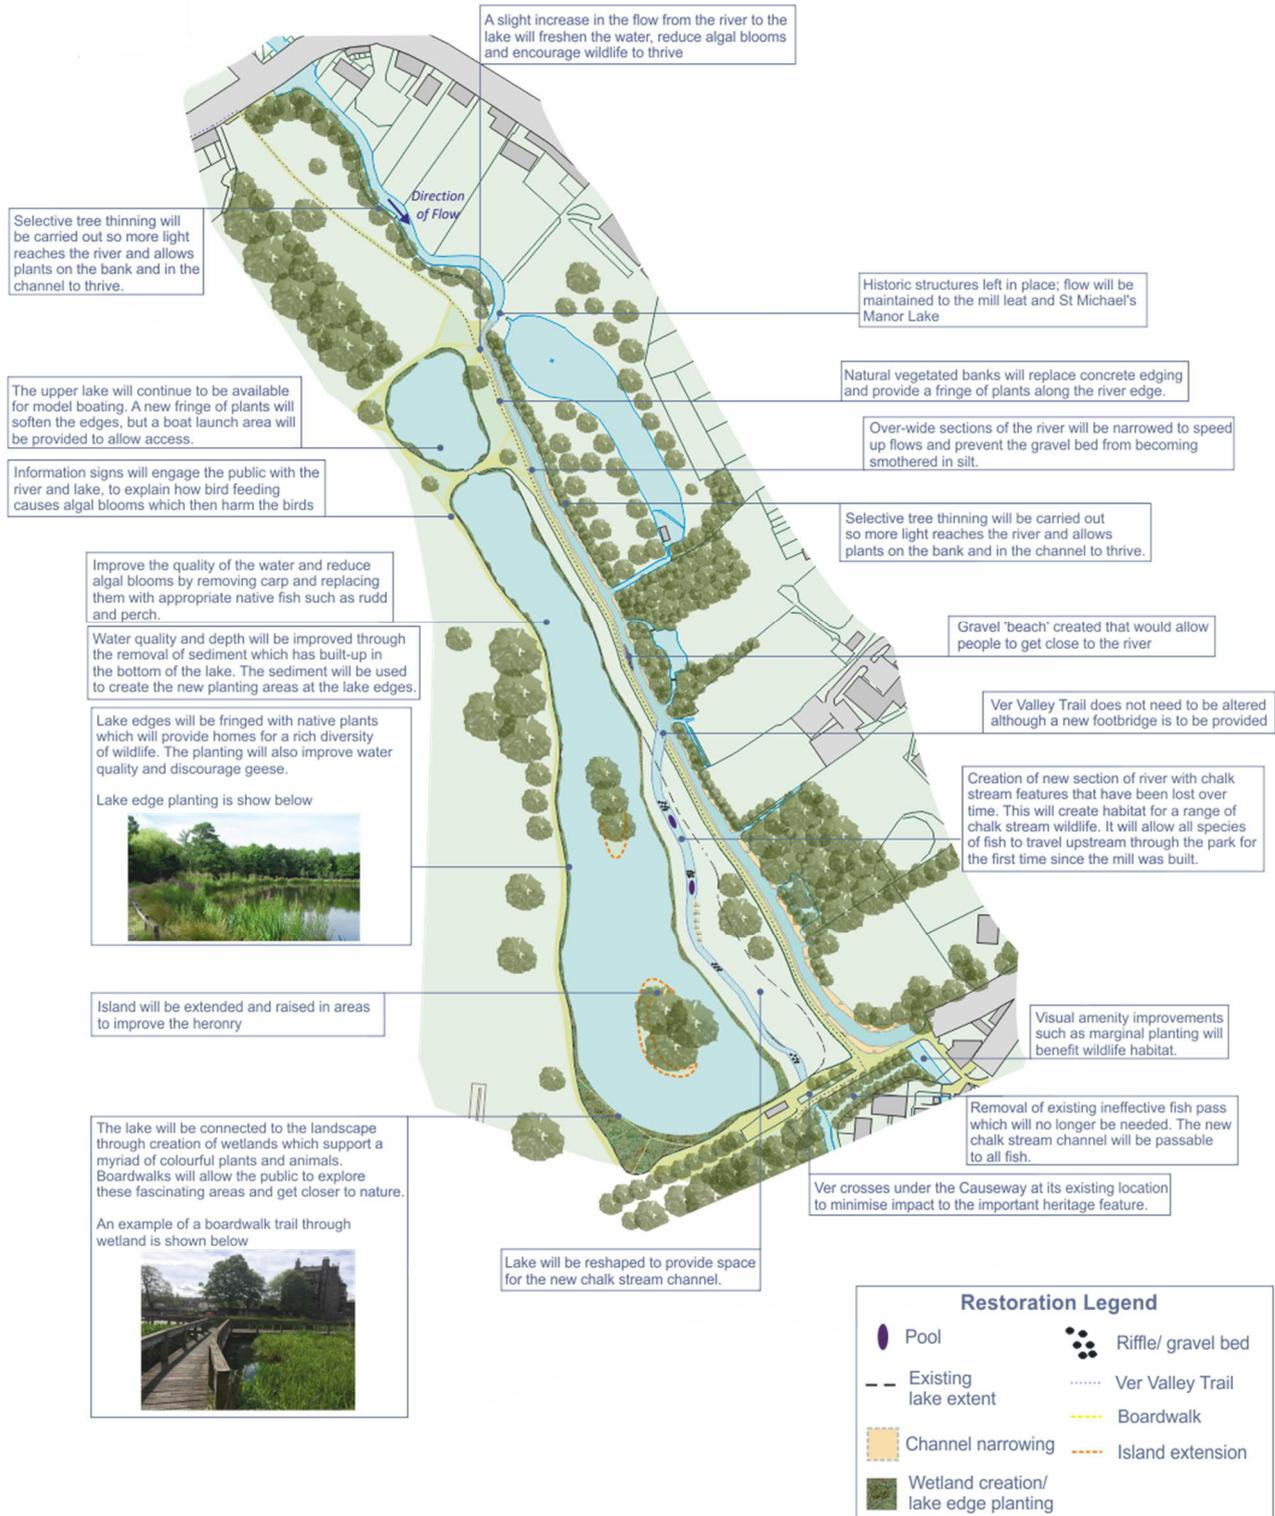
Figure 4.3 Reach 1 Preferred Option/ Outline Proposals (prior to engagement)

The Reach 1 preferred option/ outline proposals, prior to engagement, are summarised in Figure 4.3.

The following outlines the rationale for the features that were included within the outline design (shown in Figure 4.3).

- Loose gravel bed; seeding of gravel along the entire reach will further supplement low gravel supplies to the system, there is a likelihood that these sediments will become choked with fines unless catchment diffuse inputs are moderated.

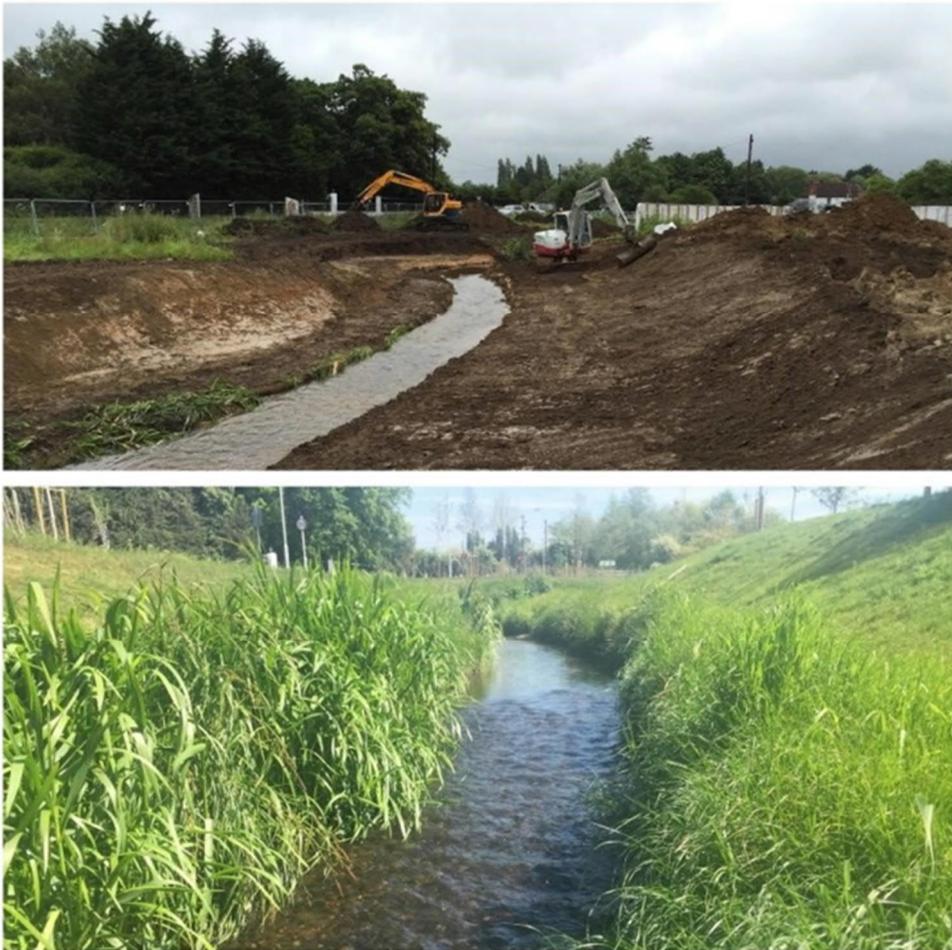
These features provide habitat for chalk stream flora and fauna such as mayfly and brown trout with a suitable source of habitat. Berm (low sections of banks next to the river) features would also be incorporated, adding further diversity to the river form, providing the ideal conditions for wetland grasses and flowering plants such as yellow flag iris. An example of a similarly restored river channel is provided in Plate 4.5 below.

Plate 4.5 An established section of restored river channel on the River Bulbourne, Hertfordshire, with vegetated berms developing in the margins (Photo courtesy of Five Rivers Ltd)

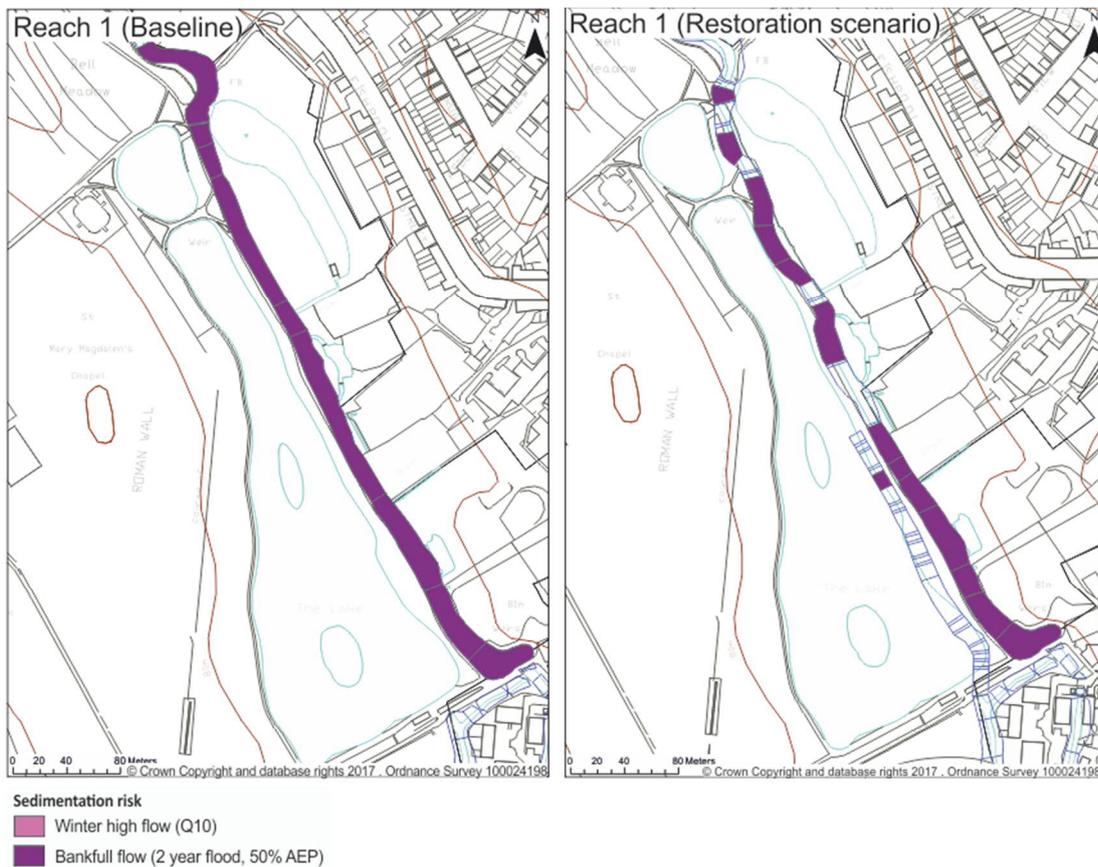
Figure 4.6 Sedimentation risk at Reach 1 under baseline and proposed restoration scenarios

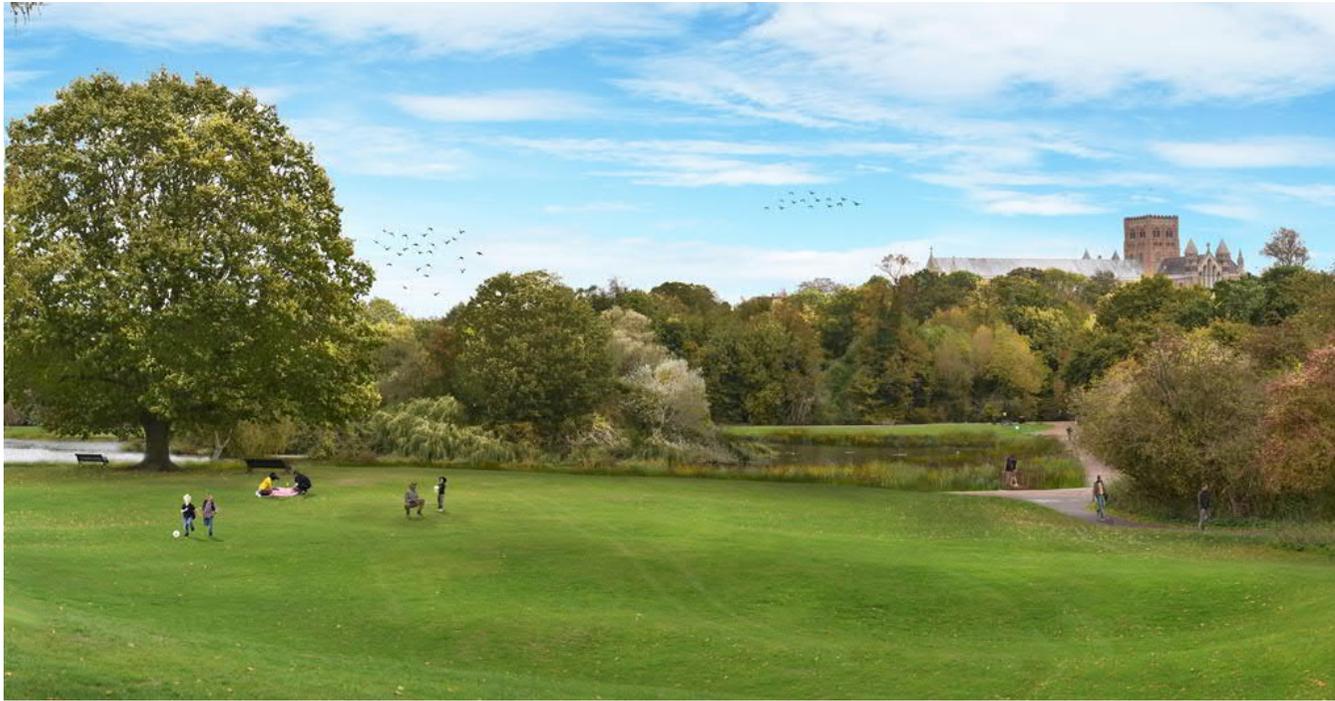
Figure 4.9 Reach 1 Visualisation - looking eastwards towards the lake and Cathedral.

Following engagement we have revised the plans for Reach 1. The final outline restoration plans for Reach 1 are provided in Figure 4.8. Two indicative visualisations of the scheme have been included as Figures 4.9 and 4.10.

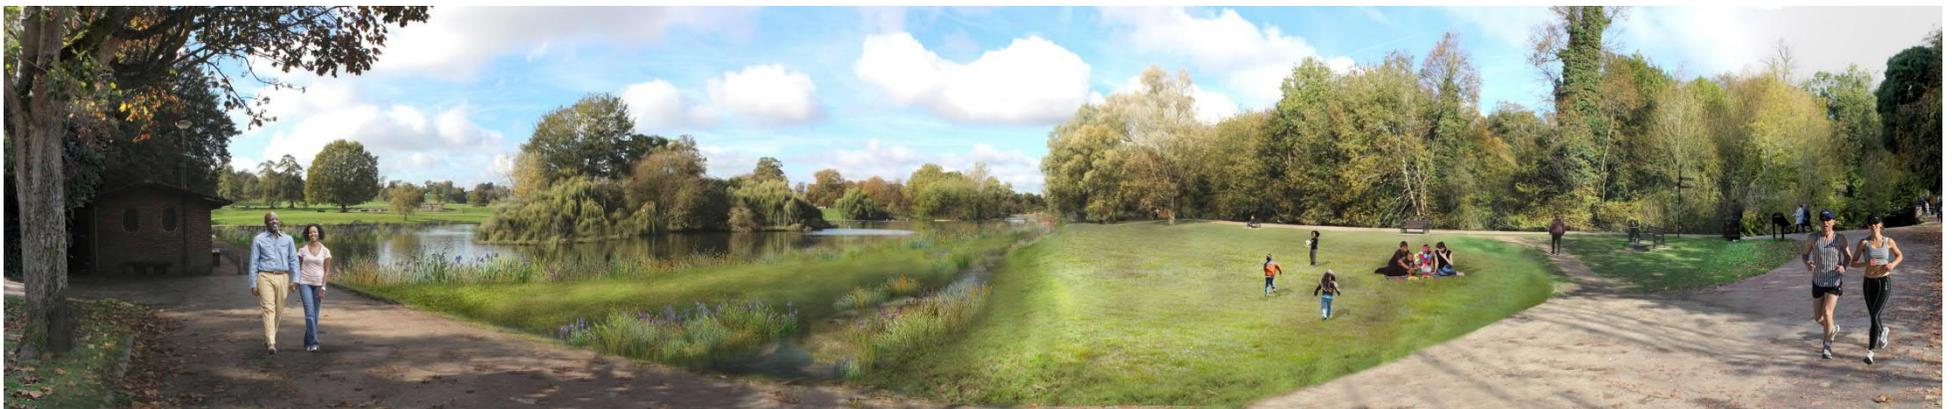
Figure 4.10 Reach 1 Visualisation - looking northwards from the Causeway.

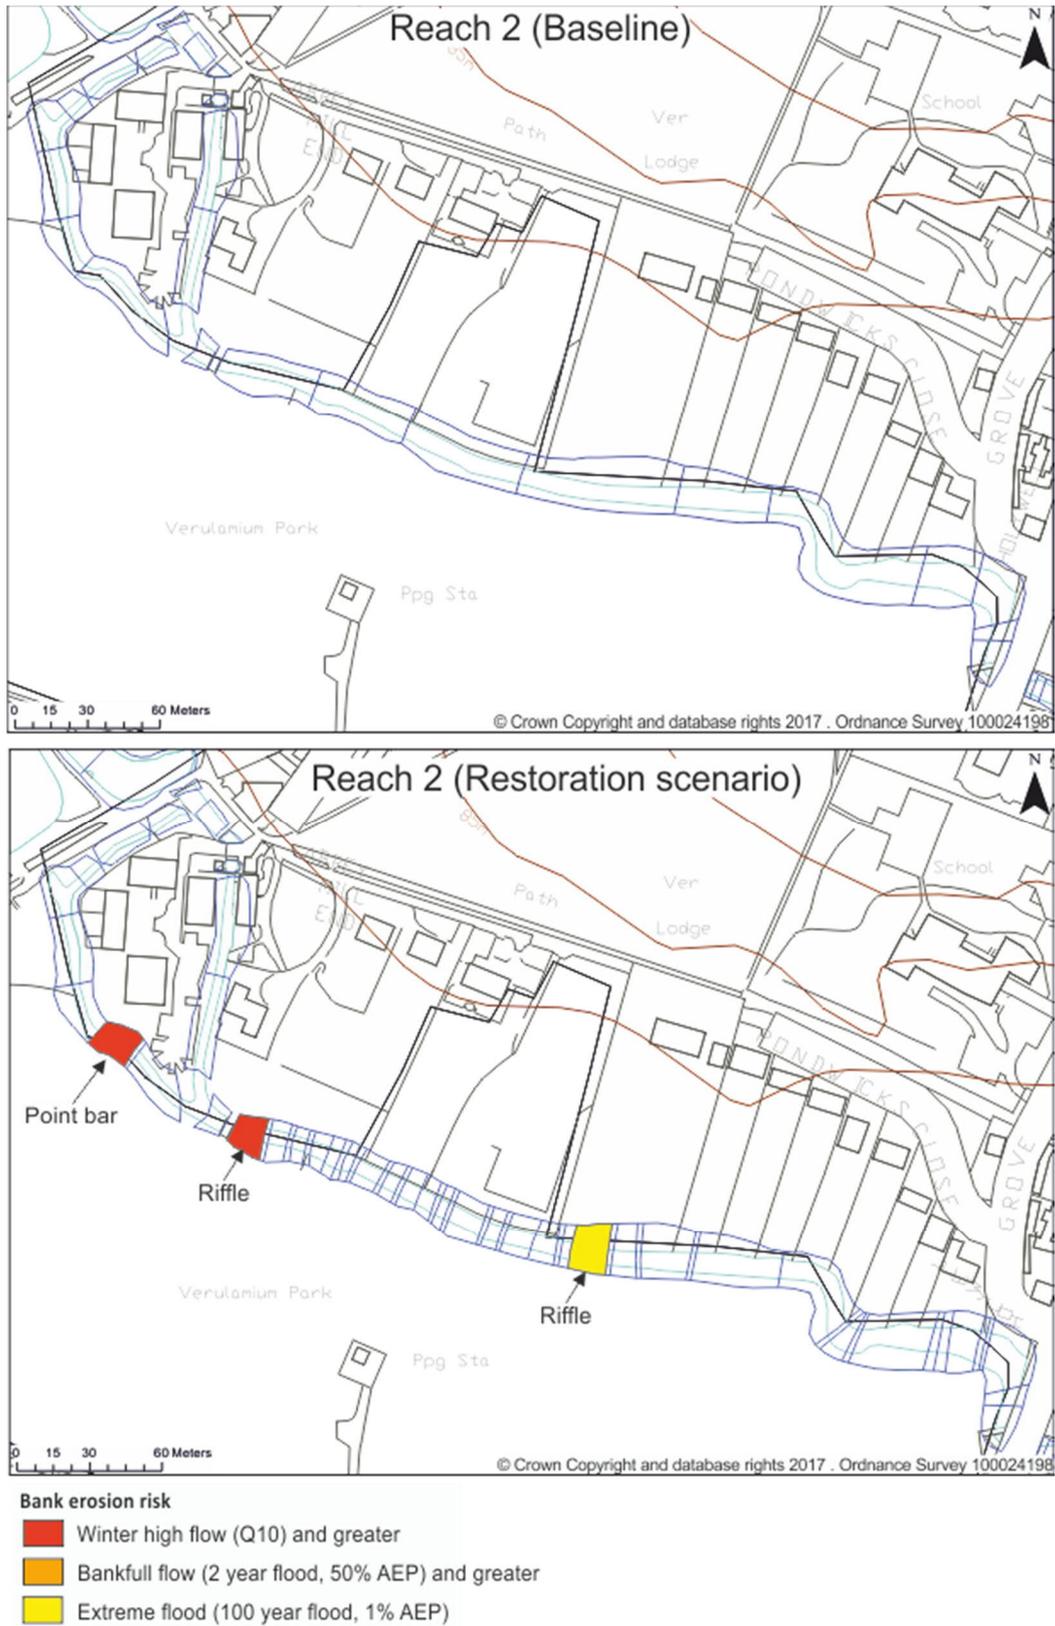
Three features were linked to potential bank erosion (see Figure 5.4). One of these is predicted during the 100 year flood when erosion is normally to be expected. Erosion at the other two areas, upstream, would occur under winter high flows which although erosion can be viewed positively (in that it helps create a varied habitat). Bank erosion at these locations, and through the reach in general, should be considered further during detailed design. No increased erosion should occur within the margins of the Scheduled Monument and this should be confirmed during detailed design (as advised by Historic England during consultation).

Figure 5.4 Bank erosion risk at Reach 2 under baseline and proposed restoration scenarios

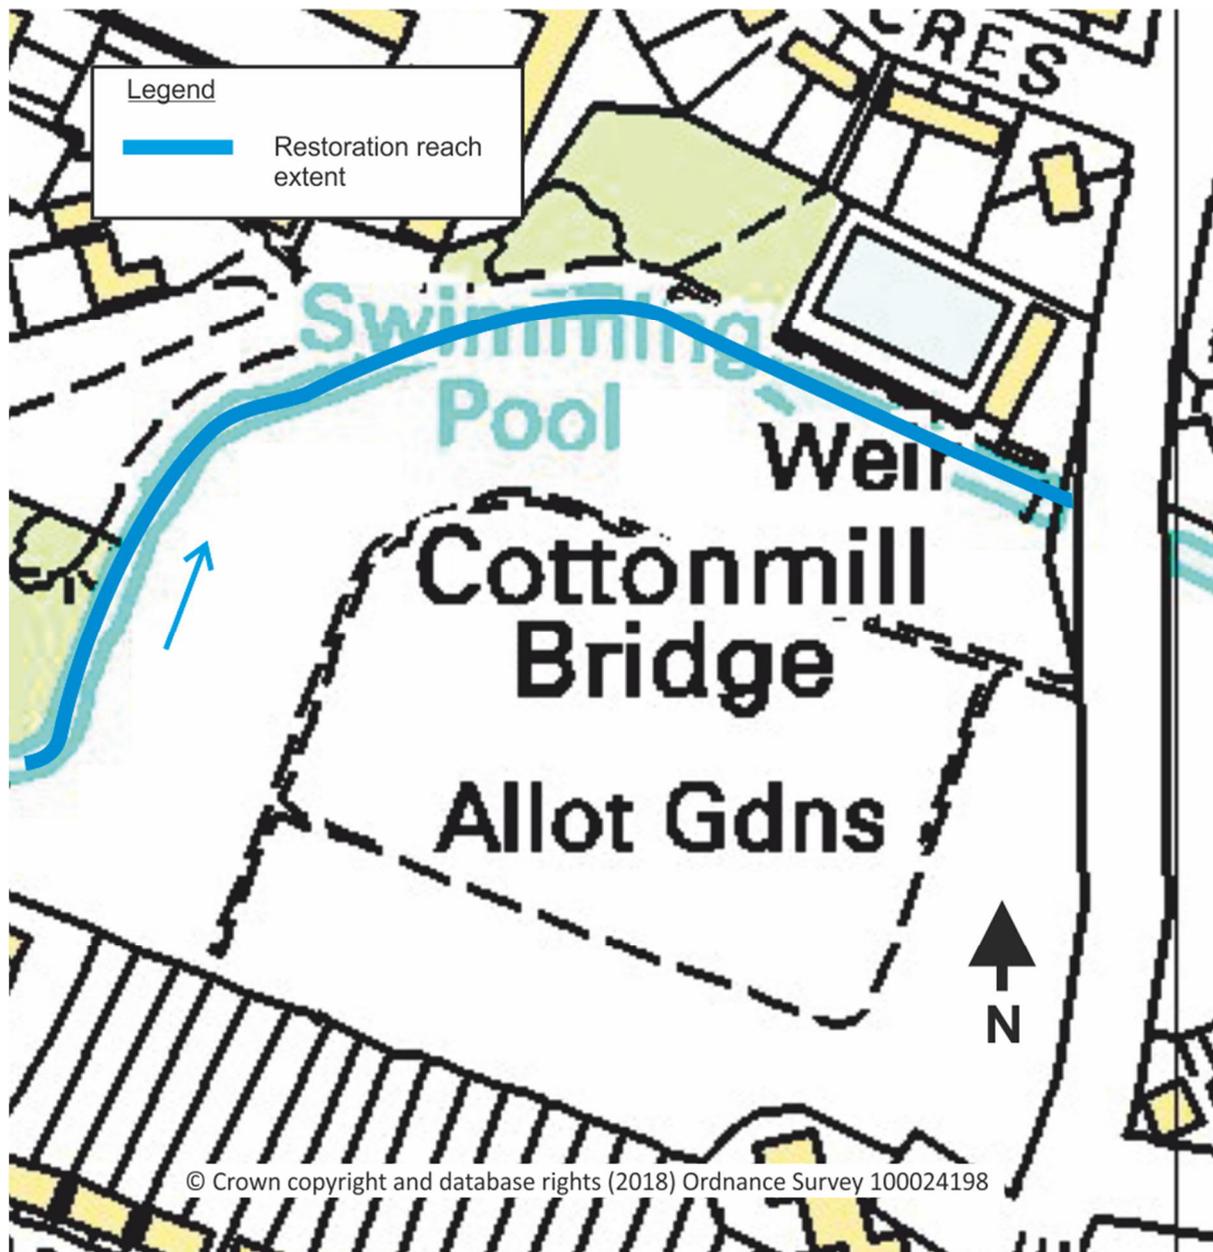
Figure 7.1 Reach 4 of the study area (Cottonmill Lane Allotments to Cottonmill Lane)

Reach 4 covers the River Ver along the Cottonmill Lane Allotments to Cottonmill Lane (see Figure 7.1 below).

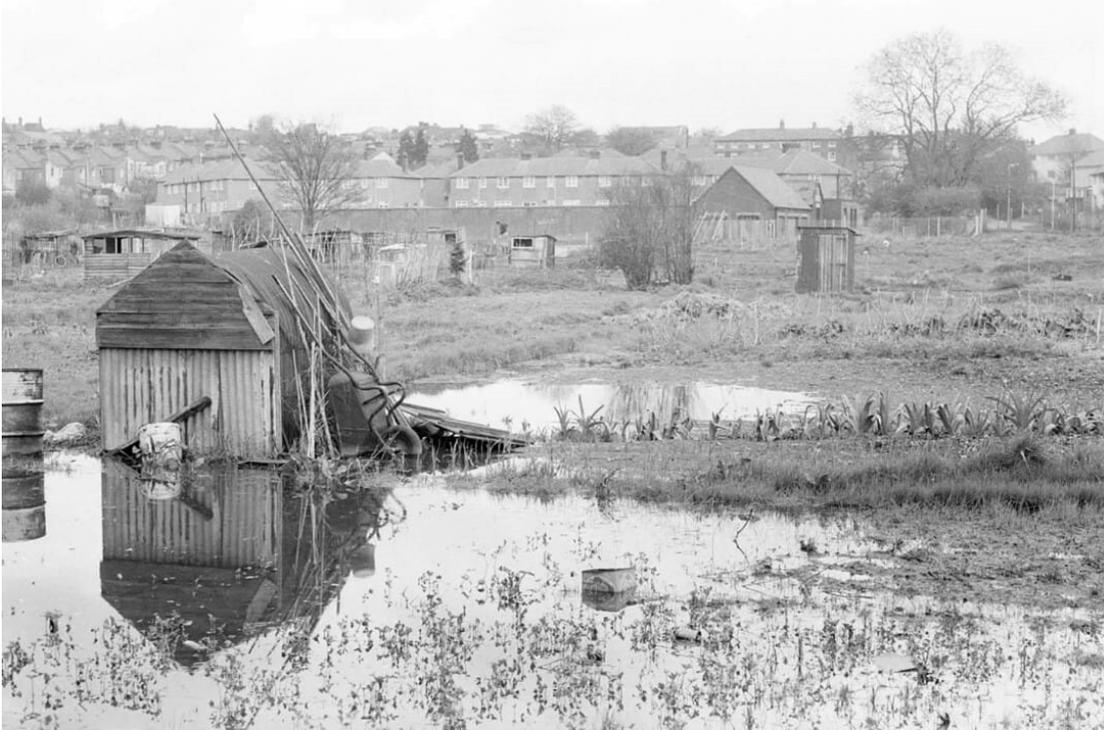
Plate 7.1 Flooded Cottonmill Allotments in 1979. Courtesy of St. Albans Museum

This reduction will mean that groundwater will most likely re-emerge to more natural levels in the allotment site and it will be wetter more frequently. As a result, some parts of the site will become unsuitable for use as allotments in the future. The allotments are already prone to groundwater flooding (see Plates 7.1 and 7.2).
