*River Ver
Restoration St
Albans*

With and on behalf of the Environment Agency

Document name	Ref	Prepared by	Date	Reviewed by	Approved By
River Ver Restoration St Albans	Final	Omar Sholi	25-1-2019	Nigel Pilkington	Omar Sholi
River Ver Restoration St Albans	Draft	Omar Sholi, Alex Deacon, Kate de Smeth, Seb Bentley, George Heritage, Tim Jones, Amy Jones	31-10-18	Nigel Pilkington	Omar Sholi

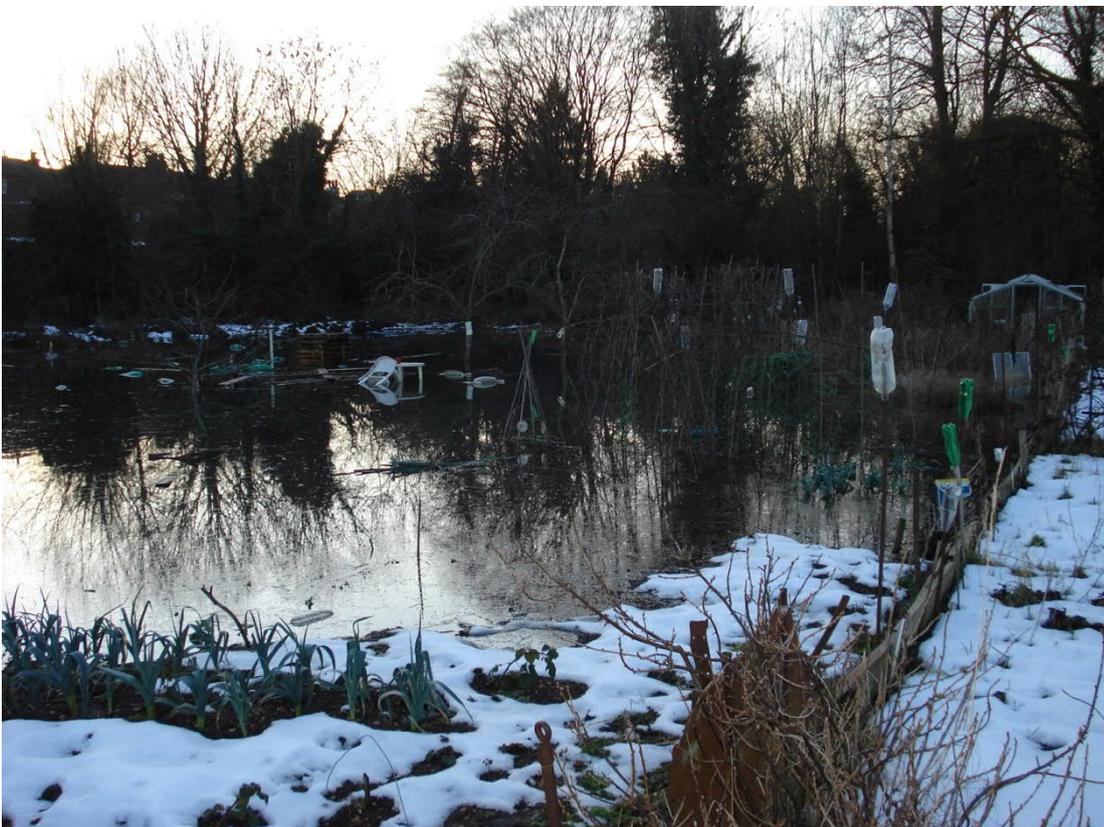
Plate 7.2 Flooded Cottonmill Allotments in 2009

This reduction will mean that groundwater will most likely re-emerge to more natural levels in the allotment site and it will be wetter more frequently. As a result, some parts of the site will become unsuitable for use as allotments in the future. The allotments are already prone to groundwater flooding (see Plates 7.1 and 7.2).

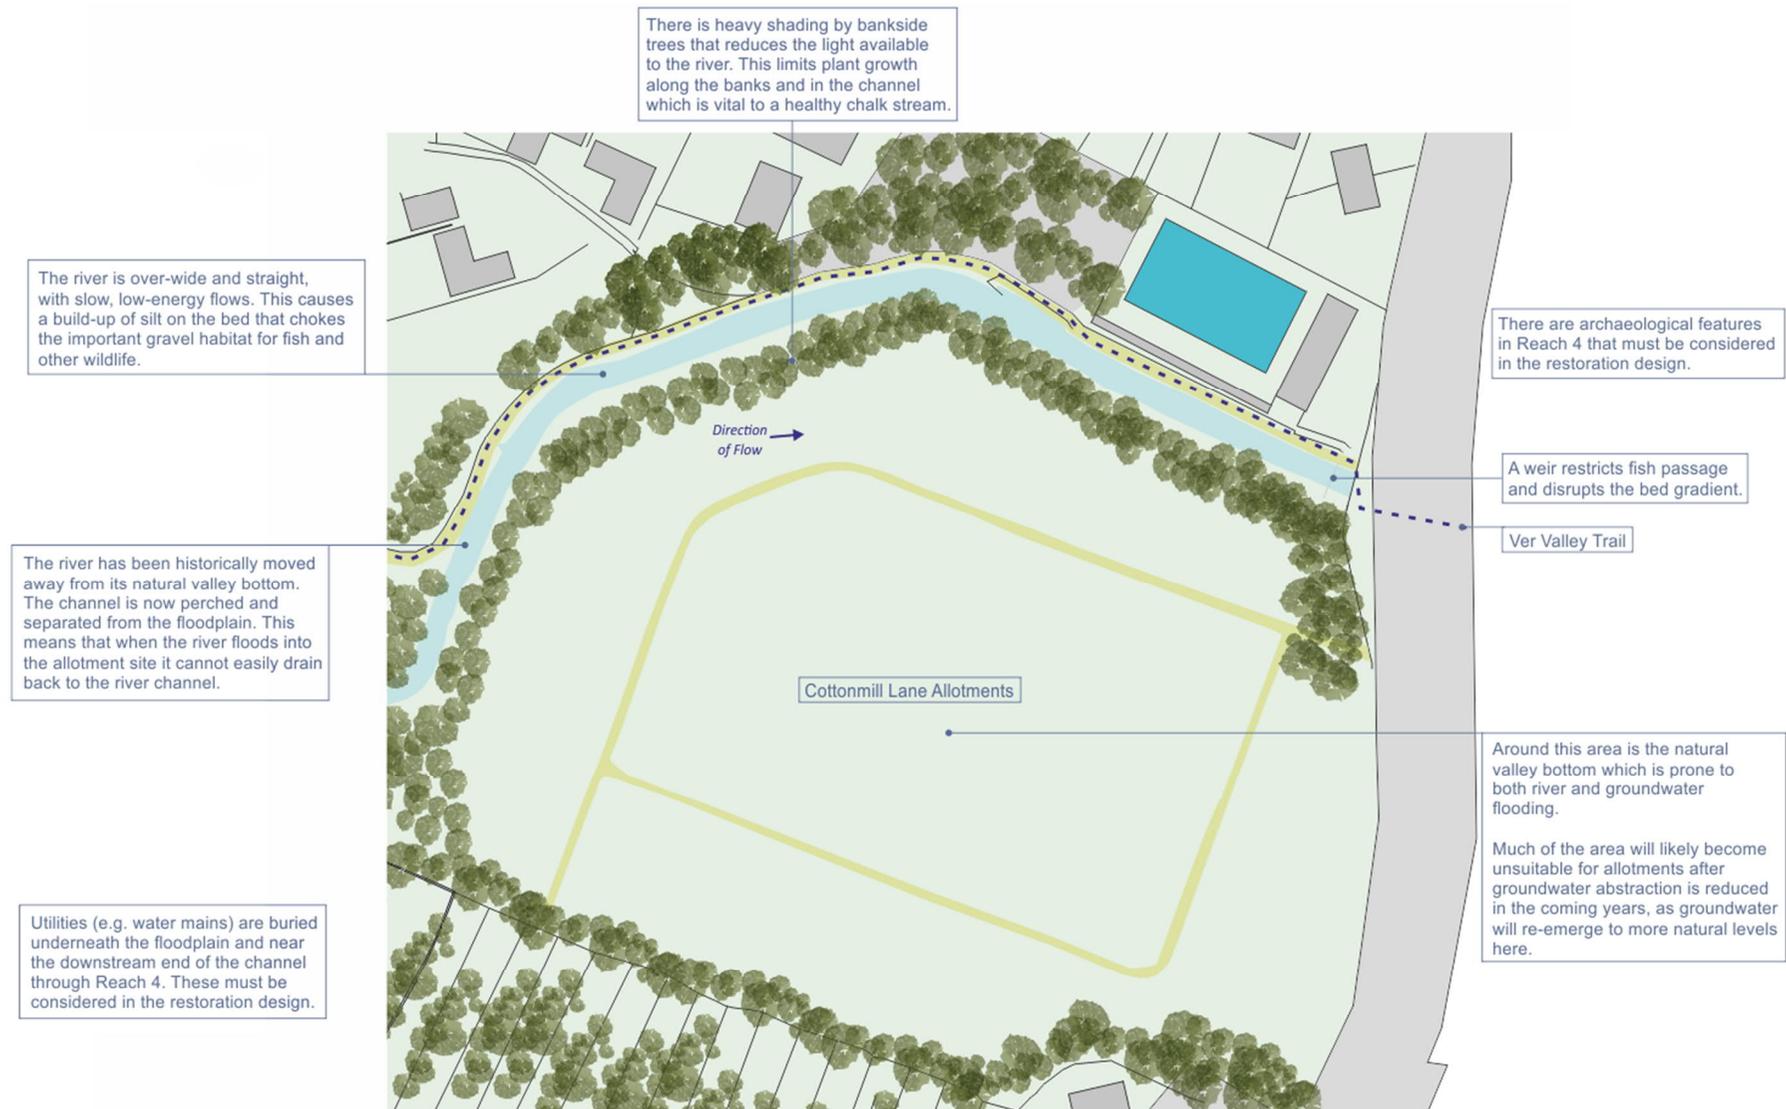
Figure 7.2 Reach 4 Issues and Constraints Overview

Figure 7.2 presents a visual summary of the issues within Reach 4.

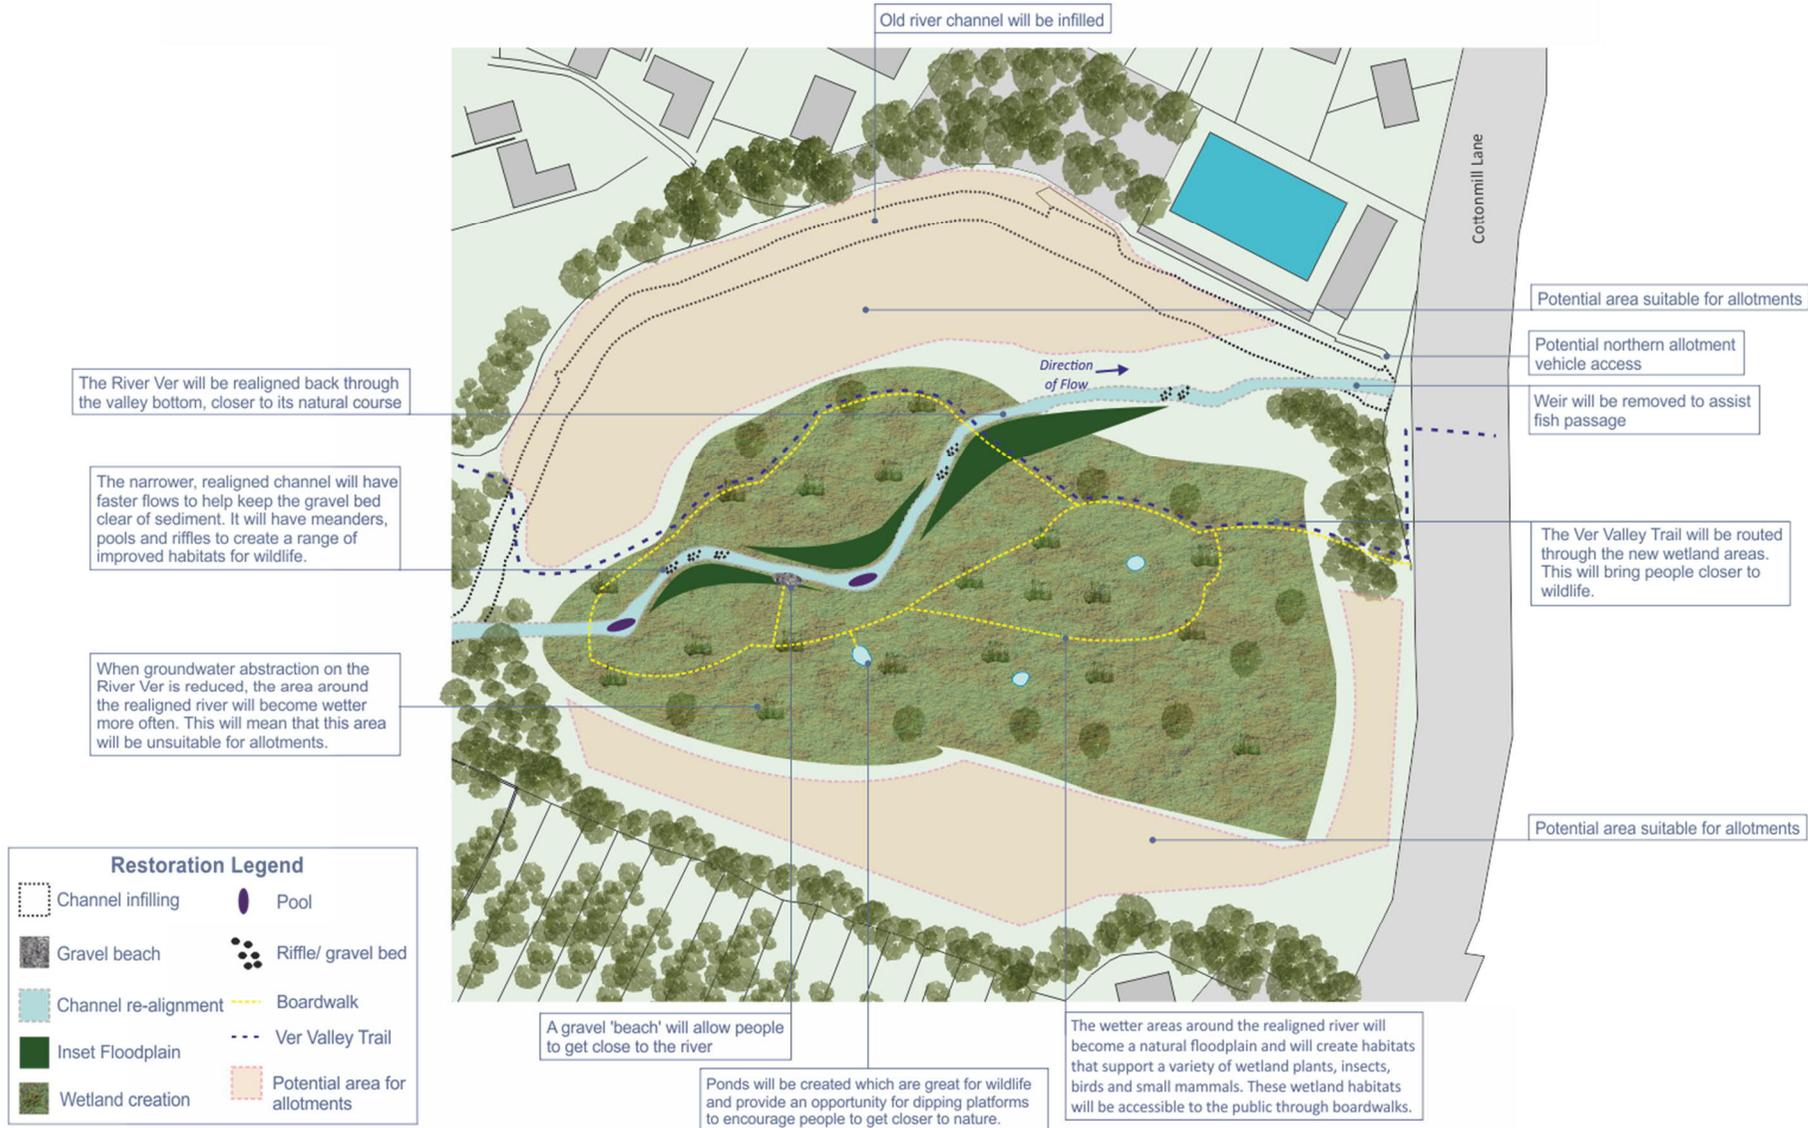
By reconnecting the river with the floodplain, these proposals will address the flooding issues in the area that will only get worse when nearby groundwater abstraction is reduced. However, we do not underestimate the impact that these measures would have on allotment tenants in Cottonmill Lane. St Albans City and District Council are committed to providing replacement allotments locally to all allotment tenants affected by these proposals, with no loss overall. No tenants would be expected to move before 2021. The proposals seek to maximise the number of allotments that can remain on site in areas not affected by groundwater re-emergence and flooding.

Figure 7.3 Reach 4 Preferred Option/ Outline Proposals (prior to engagement)

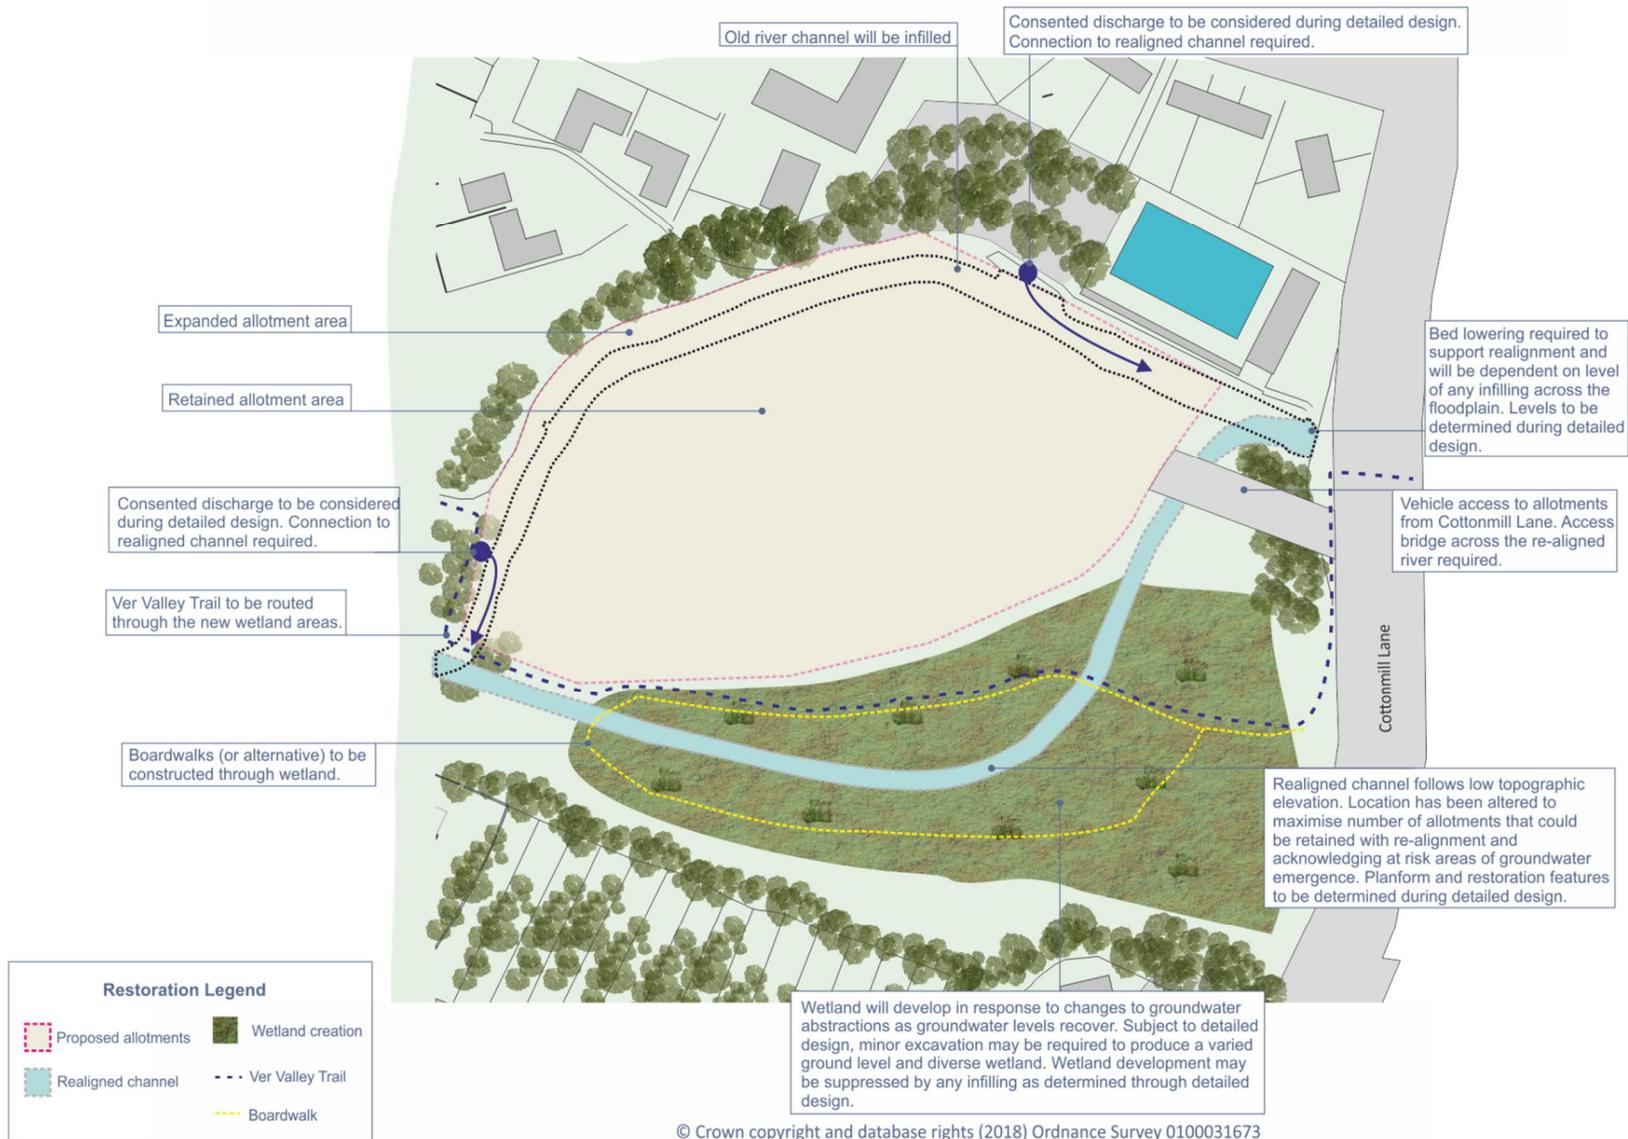
Figure 7.4 Reach 4 Final Outline Proposal Plan (post engagement)

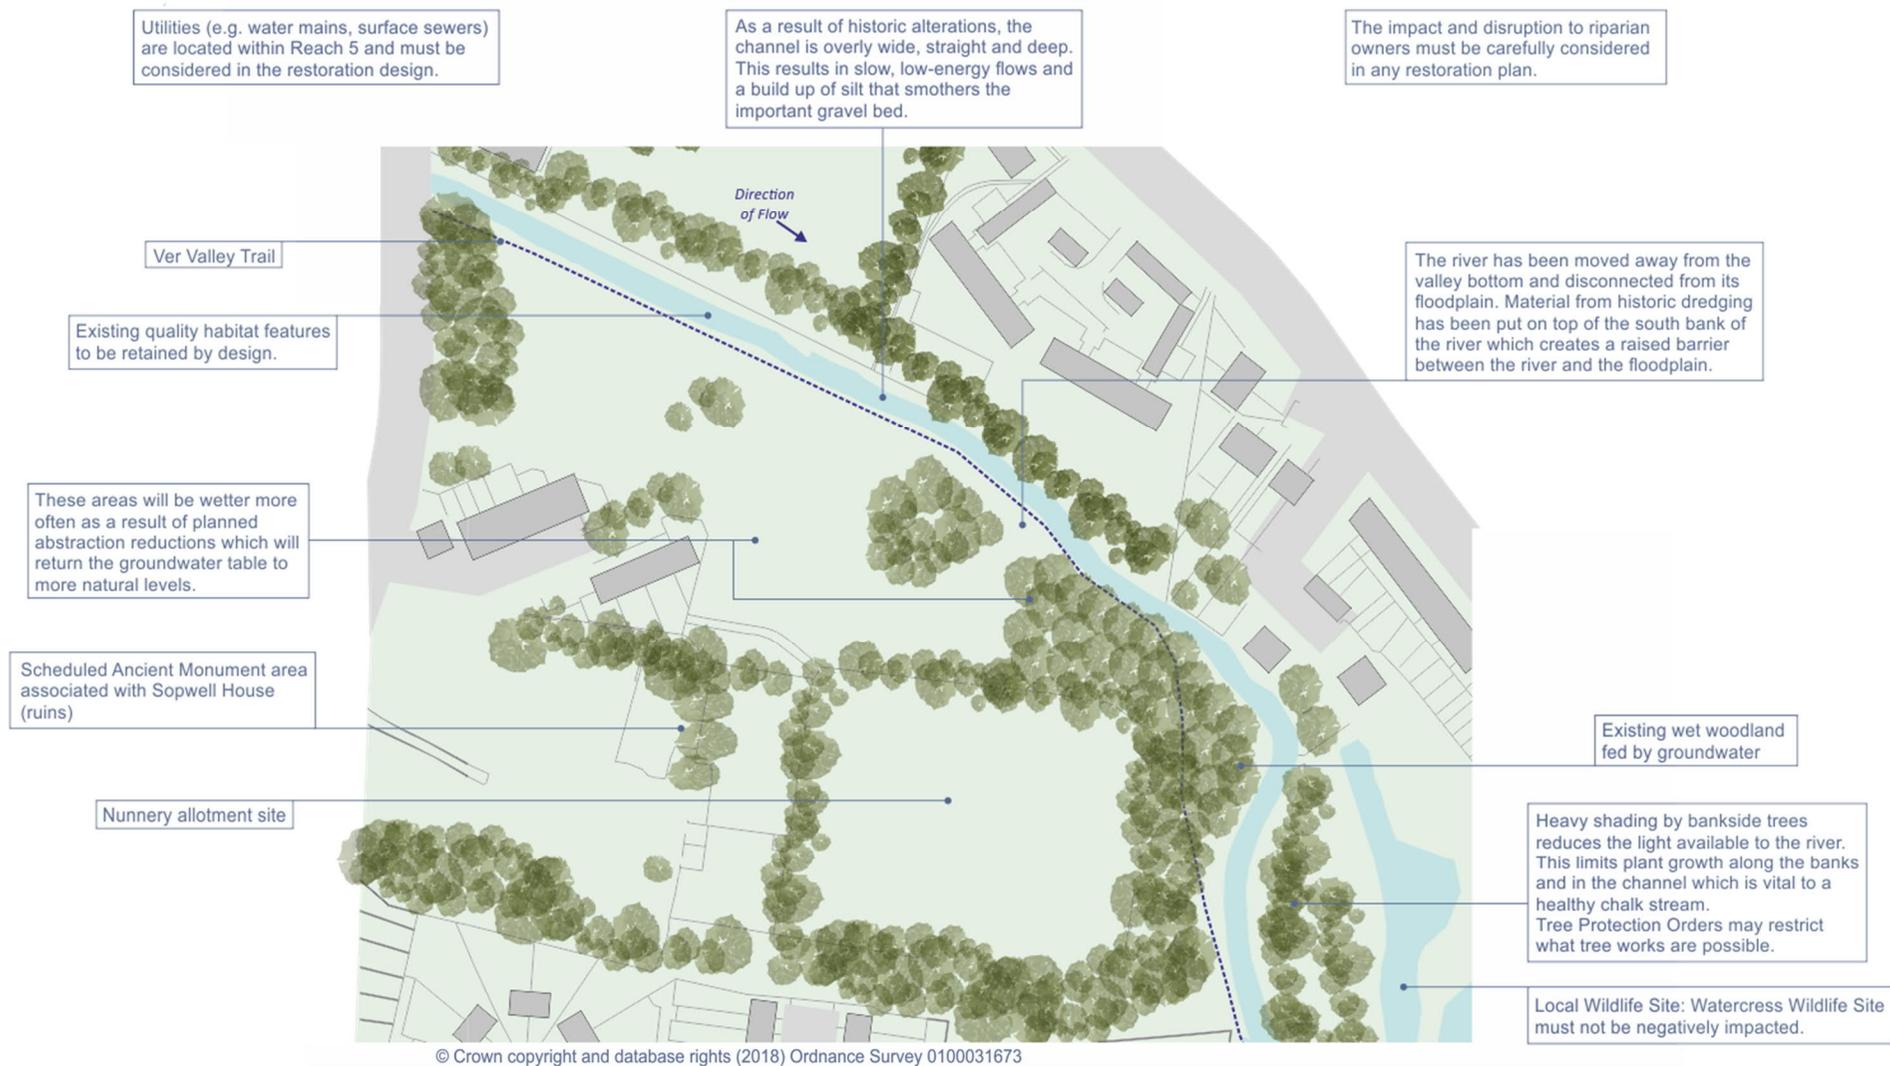
Figure 8.2 Reach 5 Issues and Constraints Overview

Figure 8.2 presents a visual summary of the issues within Reach 5.

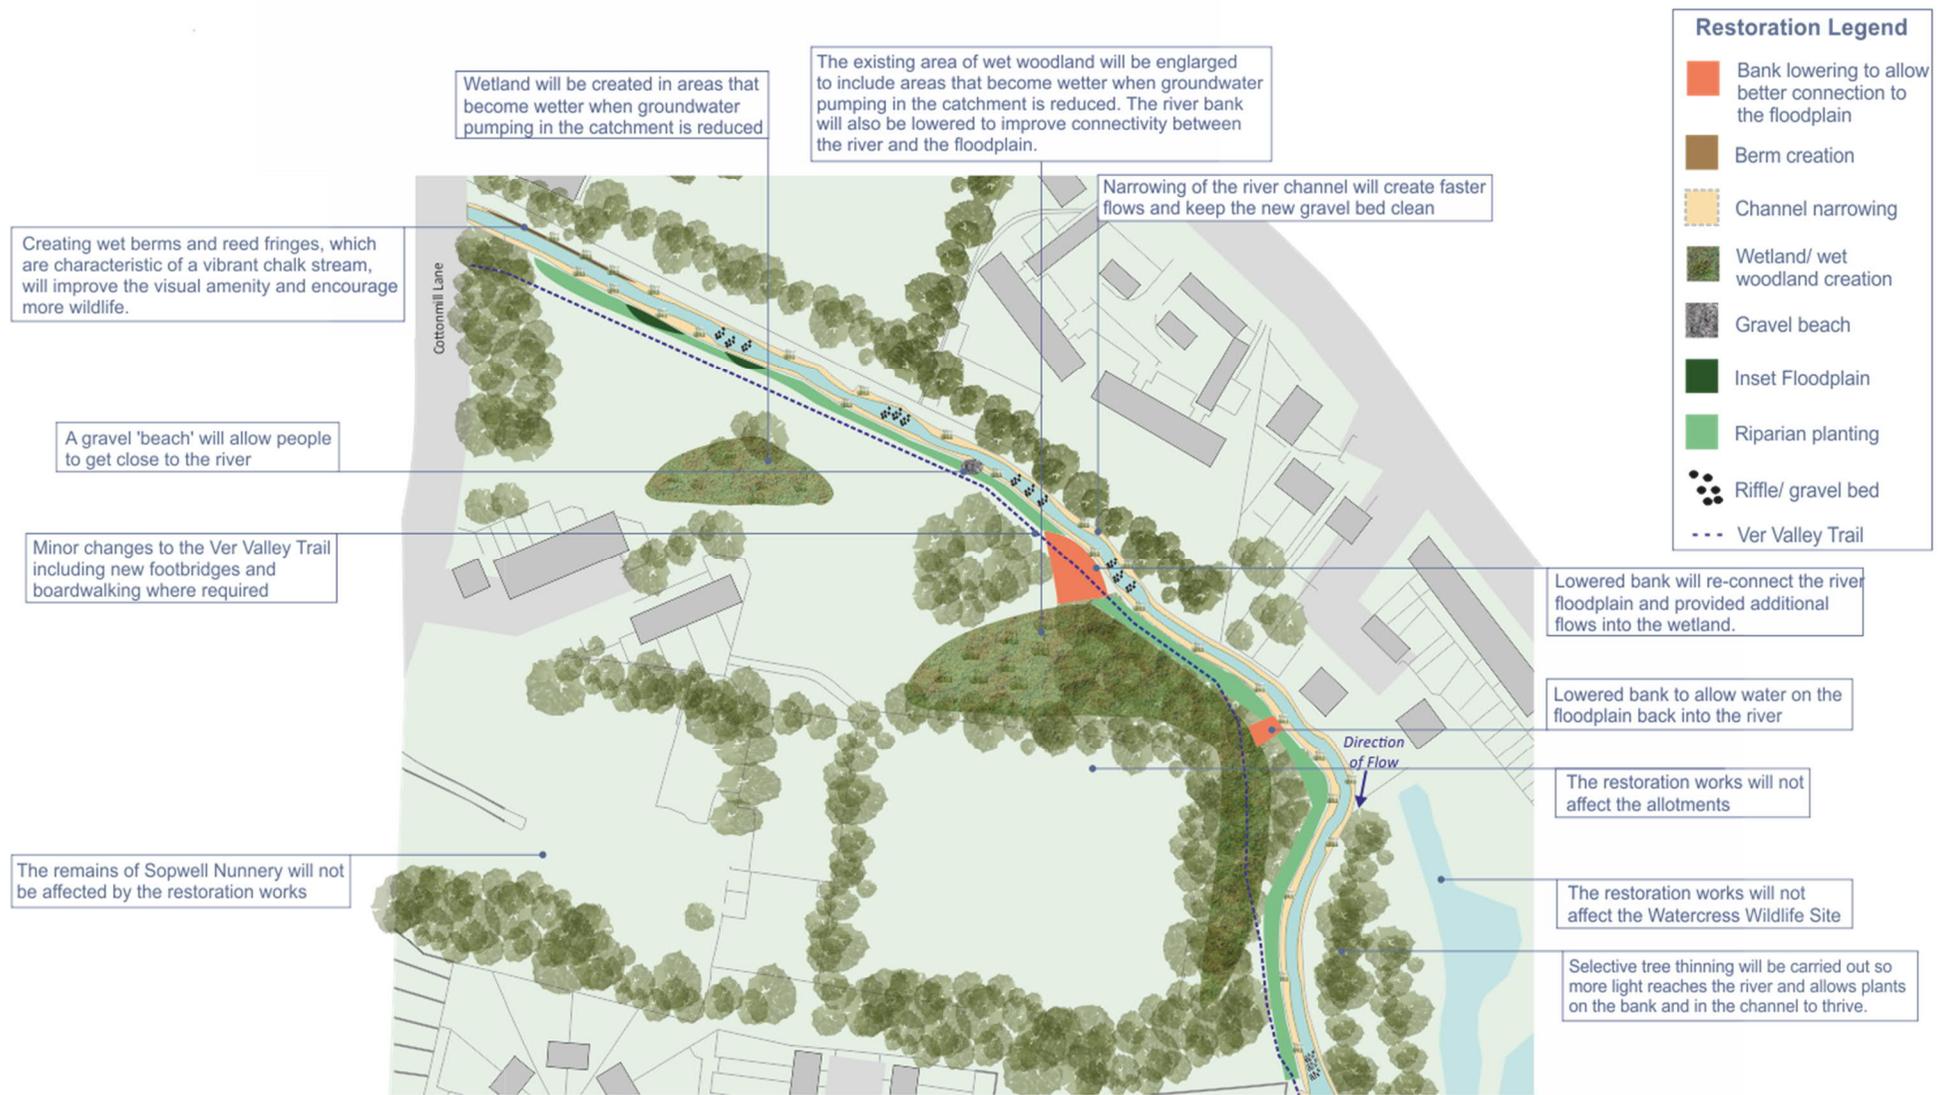
Figure 8.3 Reach 5 Preferred Option/ Outline Proposals (prior to engagement)

The Reach 5 preferred option/ outline proposals, prior to engagement, are summarised in Figure 8.3.

The following outlines the rationale for the features that were included within the outline design (shown in Figure 8.3). Reach 5 is a moderate gradient reach with limited sinuosity, the gradient is steep enough to support functional riffles. The likely sequence would be pool-riffle and pools have been left to develop naturally behind constructed riffles. Riparian connectivity is poor and can be enhanced using in-inset floodplain units. Floodplain enhancement is possible through the development of a wet woodland or wetland reintroducing more appropriate species. This will be enhanced through groundwater emergence on the right bank.

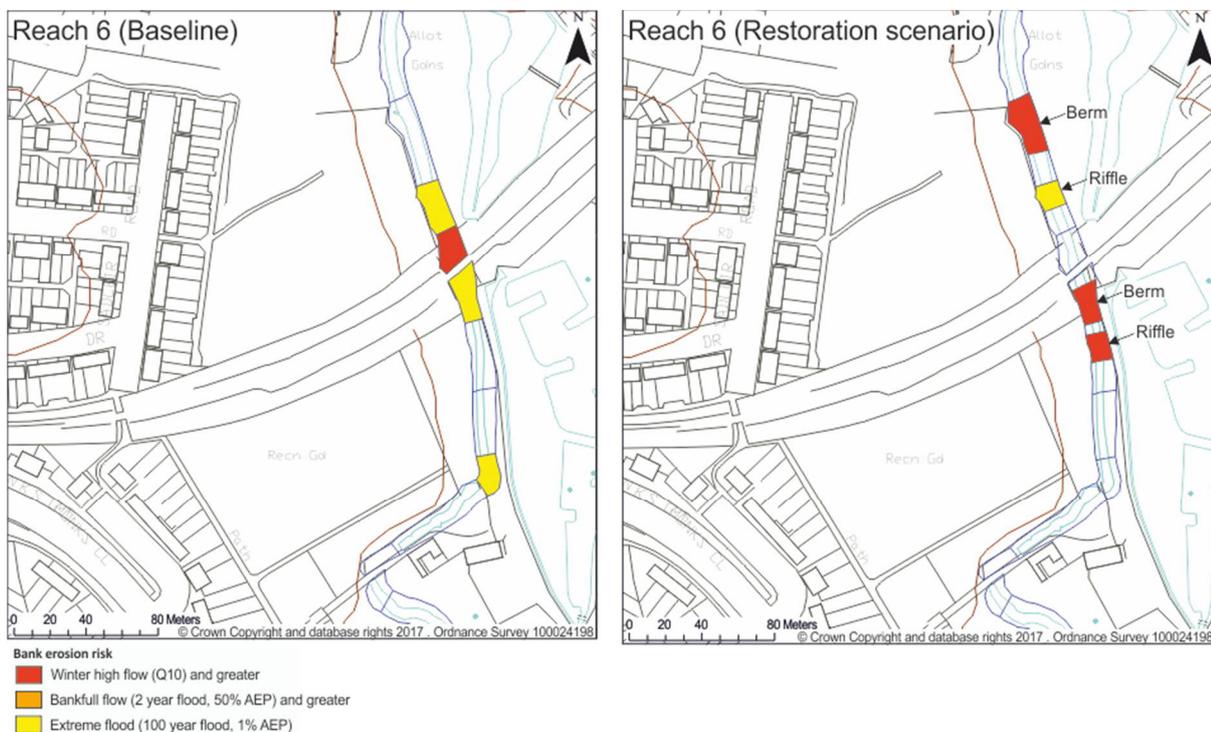
Bank erosion (Figure 9.4) looks to be a possibility at some berm and riffle locations but will be minor and in keeping with the new naturalised channel. No protection is suggested although appropriate bank edge planting would reduce any bank loss and should be considered at the detailed design stage.

Figure 9.4 Bank erosion risk at Reach 6 under baseline and proposed restoration scenarios

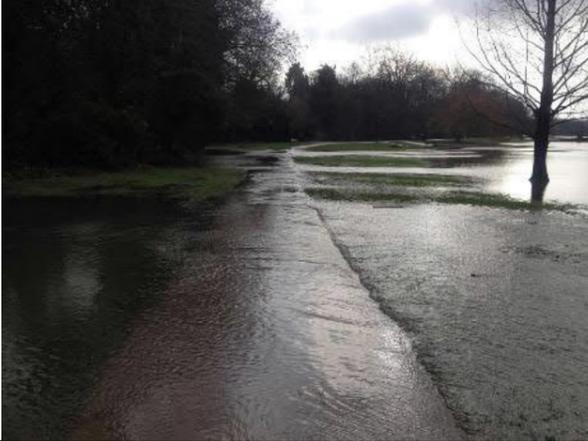
Disconnected from floodplain	<p>Raised banks or an over-wide, over-deep or perched channel mean the river is disconnected from its floodplain. This photo was taken facing east through Verulamium Park. It shows the perched River Ver in flood conditions where the water is flowing downhill from the river (on the left) to the valley bottom (on the right) where the lakes now are.</p>

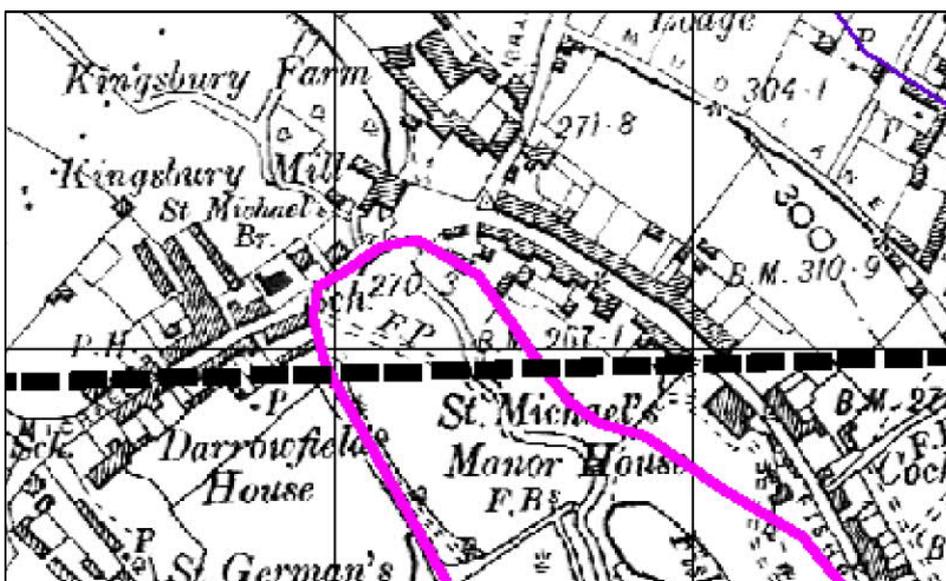
The northern part of the study area around St Michael's street has been built-up since before the commencement of abstraction. Figure 2 shows the 1899 Ordnance Survey (OS) map. The River Ver flows along the eastern side of the study area (shown in pink), with a mill, public house and farm adjacent to it. The river flows south easterly and a fishing pond is evident.

Figure 2 St Michael's street area 1899 OS map

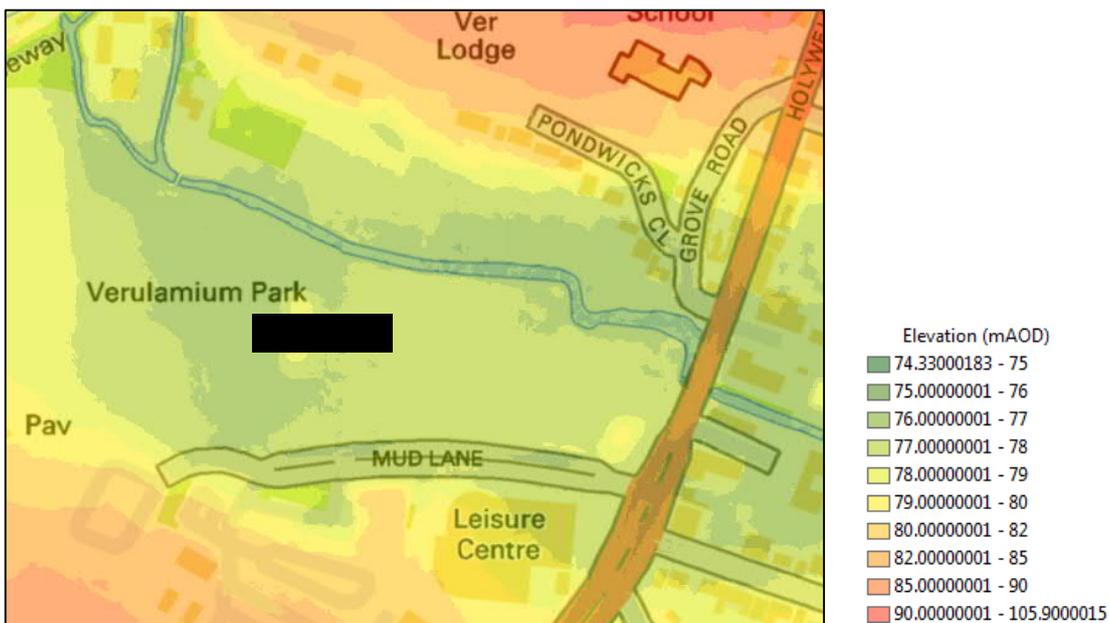
In Verulamium Park [redacted] there are areas lower than the present river indicating a possible river meander or shallow depression that may have been filled with water at higher groundwater level periods in this area. However the historical maps show the straightened river and no indications that this ground was wet prior to abstraction commencing. The straightening is likely to relate to Abbey Mill leat and therefore would pre-date OS mapping. Due to the low elevation and imperfect historical record it is an area of potential concern for flooding. This area is now used for recreation.

Figure 7 Low lying area whose shape indicates a possible river meander in Verulamium Park

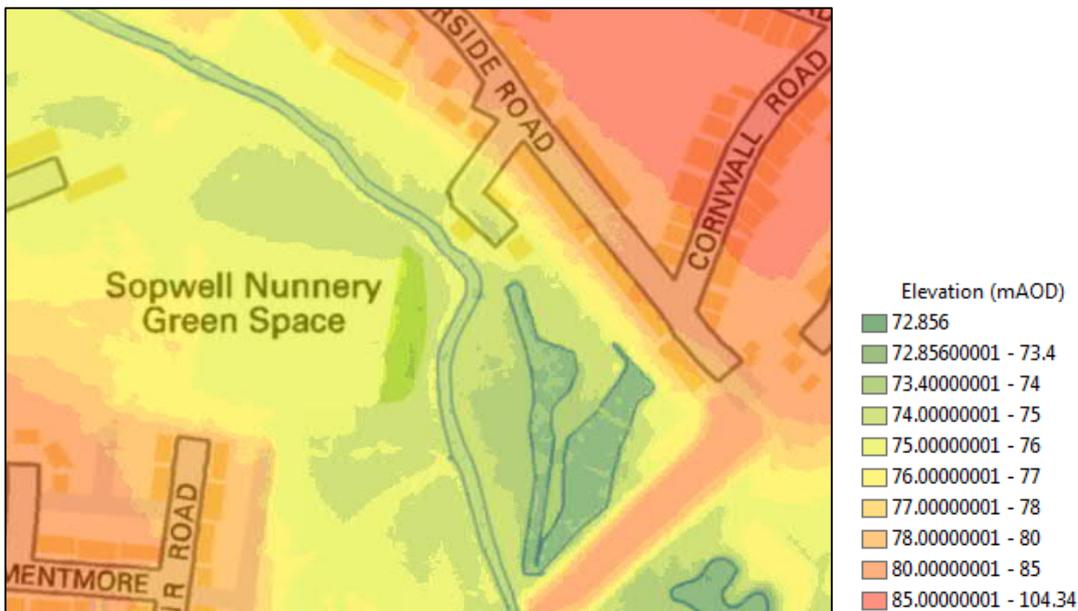
Beyond the allotments the river flows east before turning south at the Sopwell Nunnery Green Space, in the area of the ruins of a medieval nunnery. LiDAR shows low lying areas away from the river channel encroaching on the recreation space which correlates with the historical mapping indicating marshy land in the this area (Figure 4). The low lying area of the former watercress beds is also evident. The historic ruins are on the high ground in the area.

Figure 9 Low lying areas around the Sopwell Nunnery (lower lying areas in green)

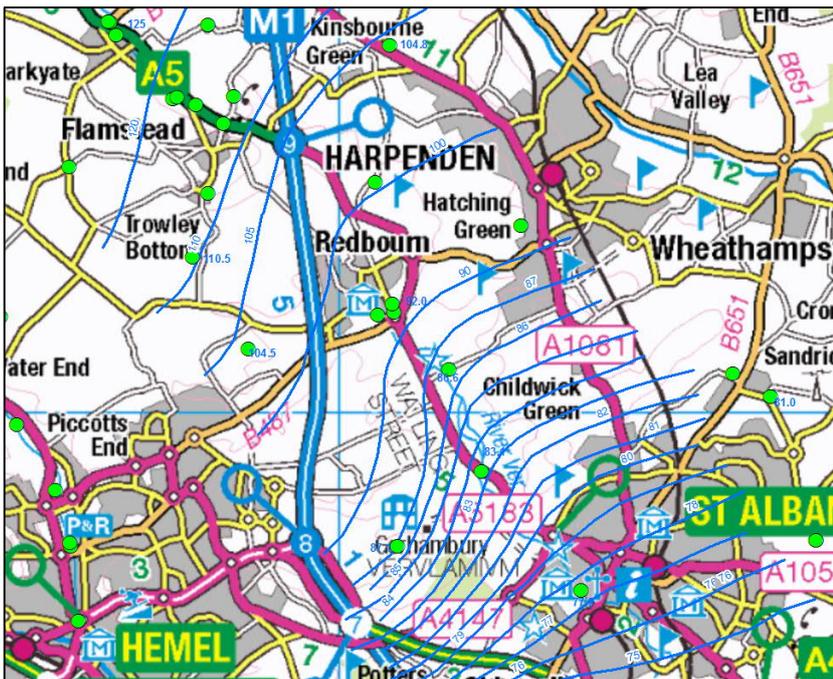
Figure 12 Peak groundwater level interpretation February - March 2001

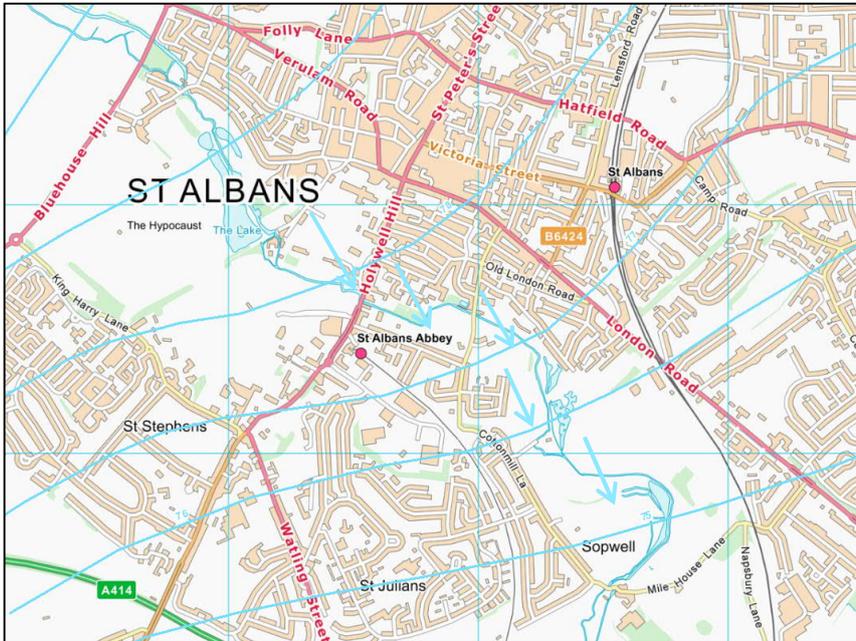
Figure 16 Interpreted February-March 2001 groundwater levels with reduced abstraction at [REDACTED] Abstractions

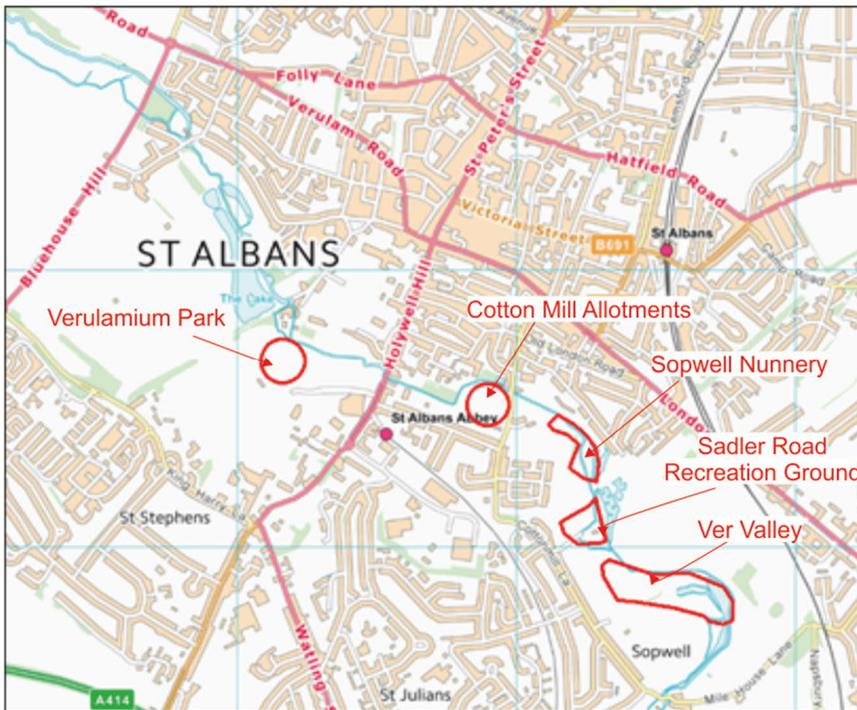
Five areas are illustrated on Figure 17; from west (upstream) to south east (downstream) these are: Verulamium Park, Cotton Mill Allotments, Sopwell Gardens Green Space, Sadlers Road Recreation Ground and Ver valley.

Figure 17 Areas Predicted to be at Risk of Flooding When Abstraction is Reduced

Groundwater levels during the very high water table recorded in 2000-1 are estimated to be approximately 1 m above ground level at Verulamium Lake, indicating that if the lake was not lined with concrete, and being the likely location of the original stream, then groundwater would discharge to the lake rather than the current stream location in the Mill Leat. LiDAR and Abbey Mills groundwater levels indicate that groundwater would only discharge through this reach at high groundwater levels, with most winter groundwater levels not reaching lake bed (or the current river bed) assuming these are 1 m below ground level.

Therefore there is a low flood risk in the lake area, and also limited potential for the lake water level to be maintained by groundwater discharge (if it were not sourced from river water). A summary map of areas of potential flood risk is given below with detailed area maps following.

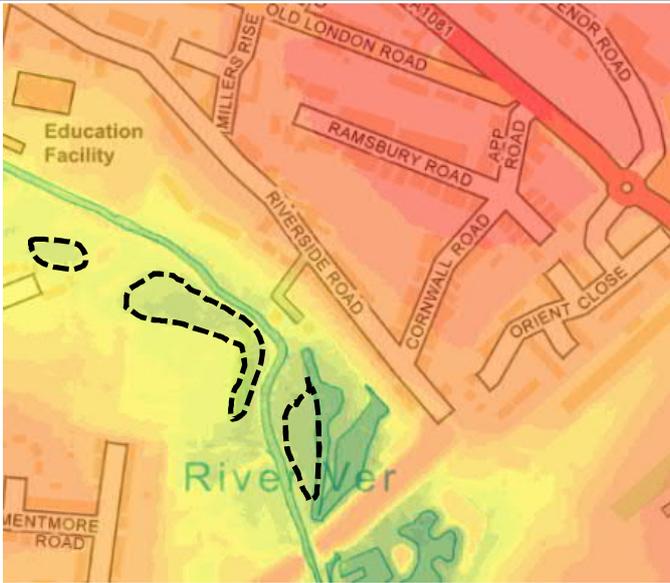
Confidence	High, historic mapping showing marshy ground
Frequency	Most winters – nearby Abbey Mill groundwater level is above ground level here most winters
Other Comments	<p>Flooding dependent on pathway through aquifer to surface, high baseflows in local river reach during signal test.</p> <p>Potential flooding as well as high baseflows.</p> <p>Historic buildings at Sopwell Nunnery not considered to be at risk as they pre-date abstraction.</p>

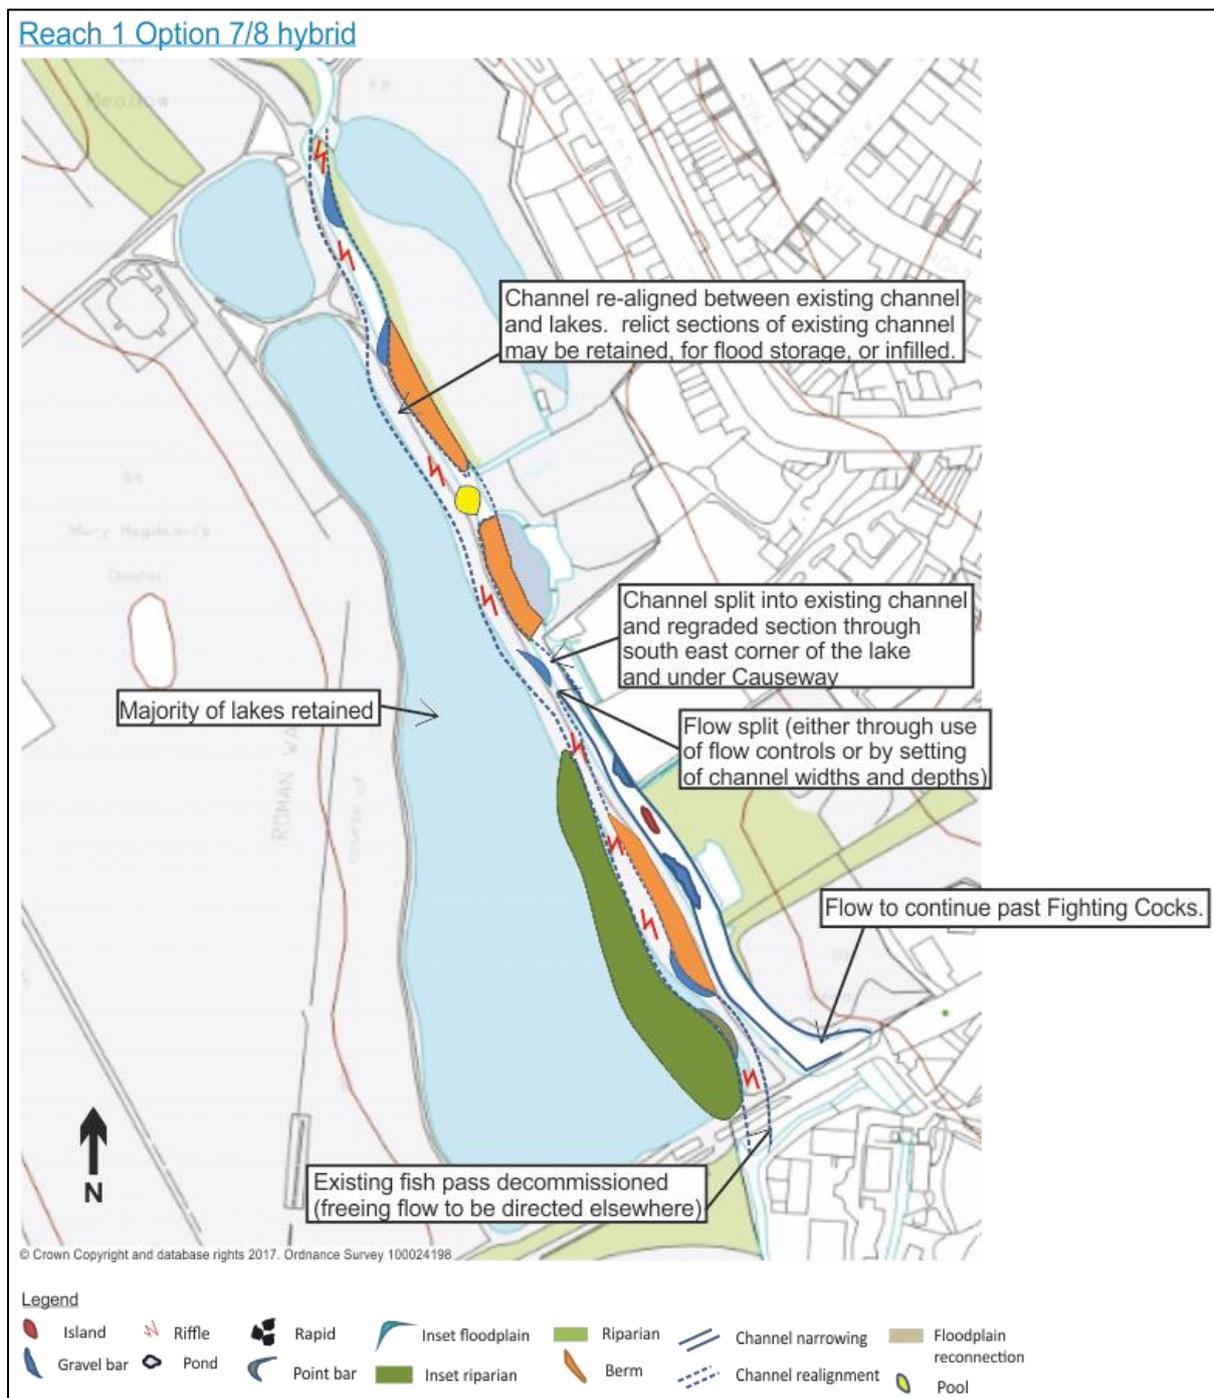
Figure 5. Restoration scenario for Reach 1 (Option 7/8 hybrid)

Under this proposed restoration scenario a second channel is created to bypass the existing fish pass. The bypass channel was created in the 1D domain, replicating bed levels in the existing main channel to maintain a reasonable flow split between the bypass and main channel through to the mill weir and so that this replicated the baseline condition flow split as much as possible (see Results section for flow split information). The constraint imposed on the restoration to maintain flow to the mill leat channel generates an unnaturally steep section in Reach 1. To accommodate this we have used a set of coarser riffle units. These would not normally be seen on a chalk system but will provide excellent higher energy habitat.

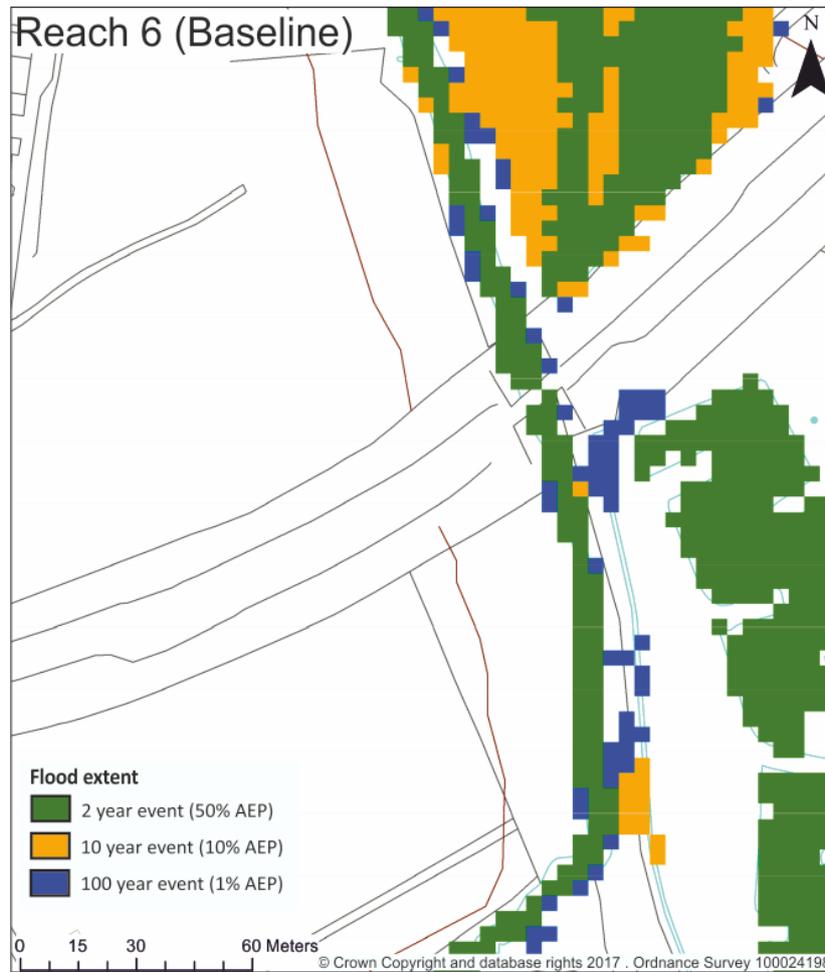
For Reach 6 (Figure 19), model results indicated flows would remain in channel for the 2 year event. Minor overbanking was produced under the 10 year and 100 year flood events but was limited in extent and no overbank connection with the fishery was observed. No private property appeared to be affected.

Figure 19. Baseline model results at Reach 6 for 2 year, 10 year and 100 year flood events (increased areas of yellow indicate increased flood extent at the 2 year RP flow and increase in blue area is related to increased flood extent at the 100 year RP flow)

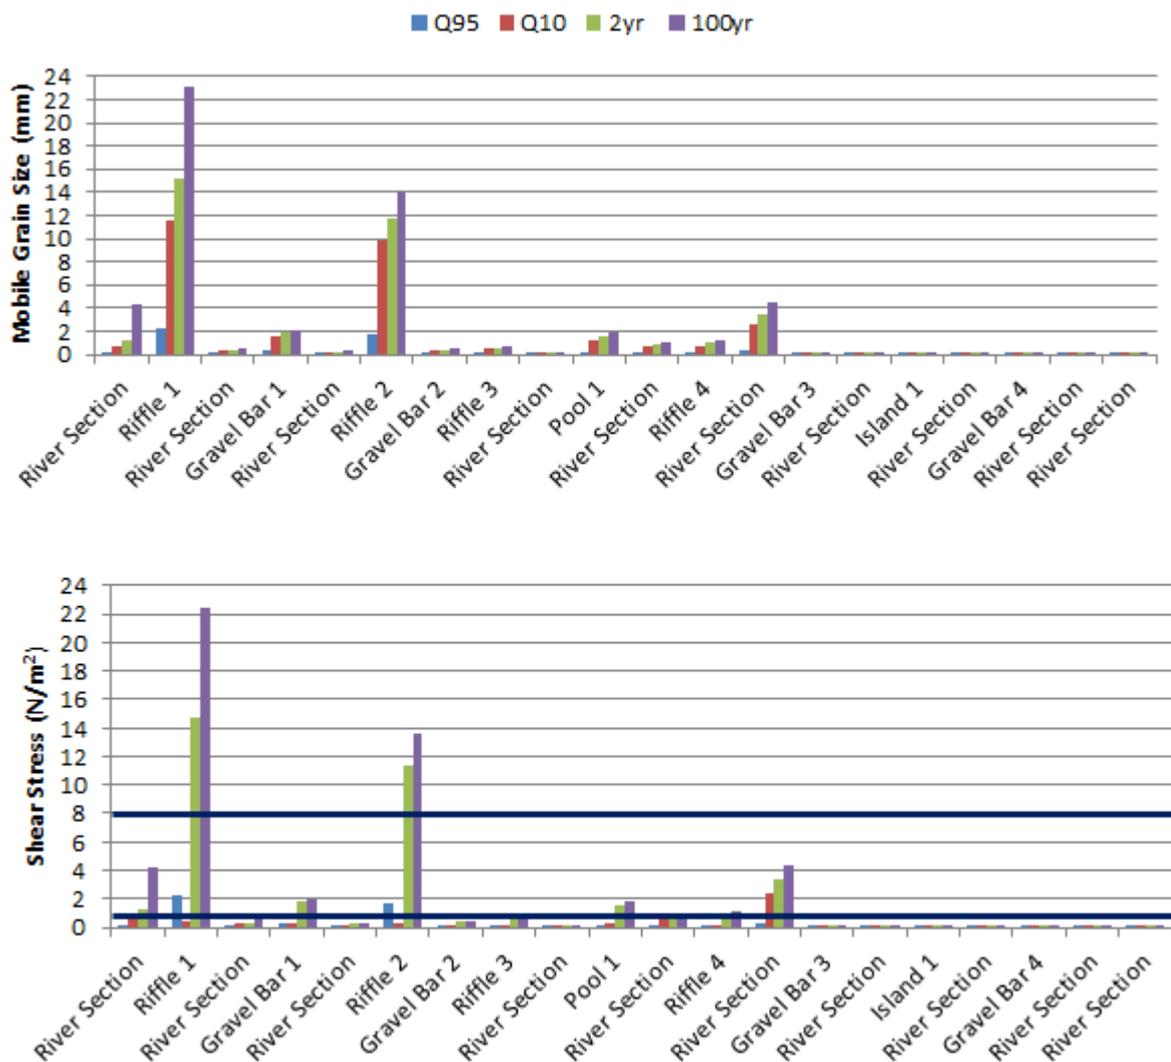
Figure 27. Summary shear stress values and implications for sediment transport, erosion and deposition through Reach 1 bypass channel. Key shear stress thresholds of sedimentation (1 N/m^2) and bank erosion (8 N/m^2) are marked.
