*River Ver
Restoration St
Albans*

With and on behalf of the Environment Agency

Document name	Ref	Prepared by	Date	Reviewed by	Approved By
River Ver Restoration St Albans	Final	Omar Sholi	25-1-2019	Nigel Pilkington	Omar Sholi
River Ver Restoration St Albans	Draft	Omar Sholi, Alex Deacon, Kate de Smeth, Seb Bentley, George Heritage, Tim Jones, Amy Jones	31-10-18	Nigel Pilkington	Omar Sholi

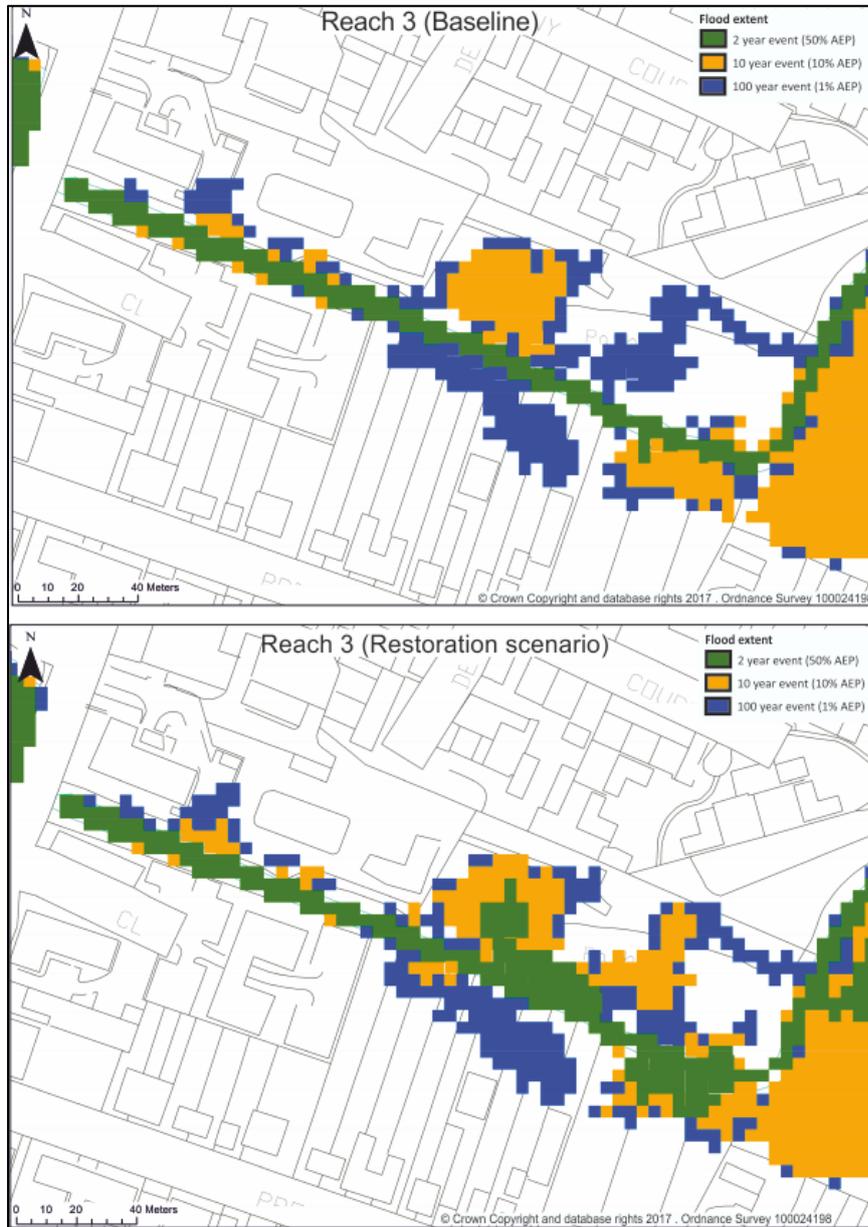
Results show that the restoration plan produced an increase in flood extent during winter high flow conditions (and larger flow events) over the right bank in the section before the bend into Reach 4. This area consists of private residential properties and the increase in flood extent and depth was restricted to gardens only. Depth of flooding during winter high flow conditions is <0.1 m, increasing to 0.15 m under the 2 year event and 0.25 m at the 10 year flood. The detailed design process could explore the creation of a raised flood bank on the right side of the channel to protect these properties or lowering of the immediate left bank.

Figure 36. Flood modelling results at Reach 3 under baseline and proposed restoration scenarios (increased areas of yellow indicate increased flood extent at the 2 year RP flow and increase in blue area is related to increased flood extent at the 100 year RP flow)

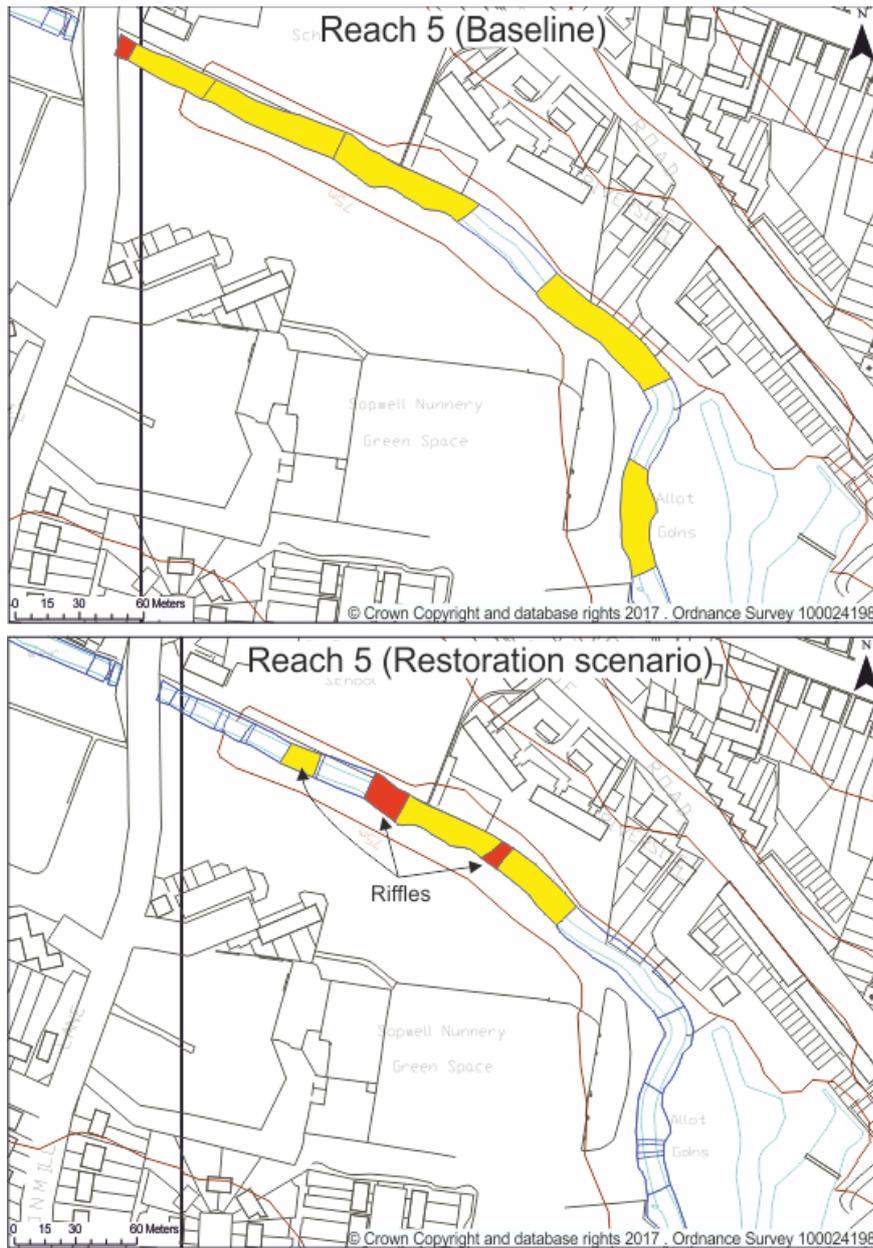
Figure 48. Sedimentation risk at Reach 5 under baseline and proposed restoration scenarios.
Note: Model results also indicated low shear stress values under summer low flow conditions, however this is not likely to result in such widespread sedimentation given the low volume of flow and reduced sediment volumes being transported within the low flow channel. As such, only sedimentation risks associated with a winter high flow or bankfull flow have been identified.

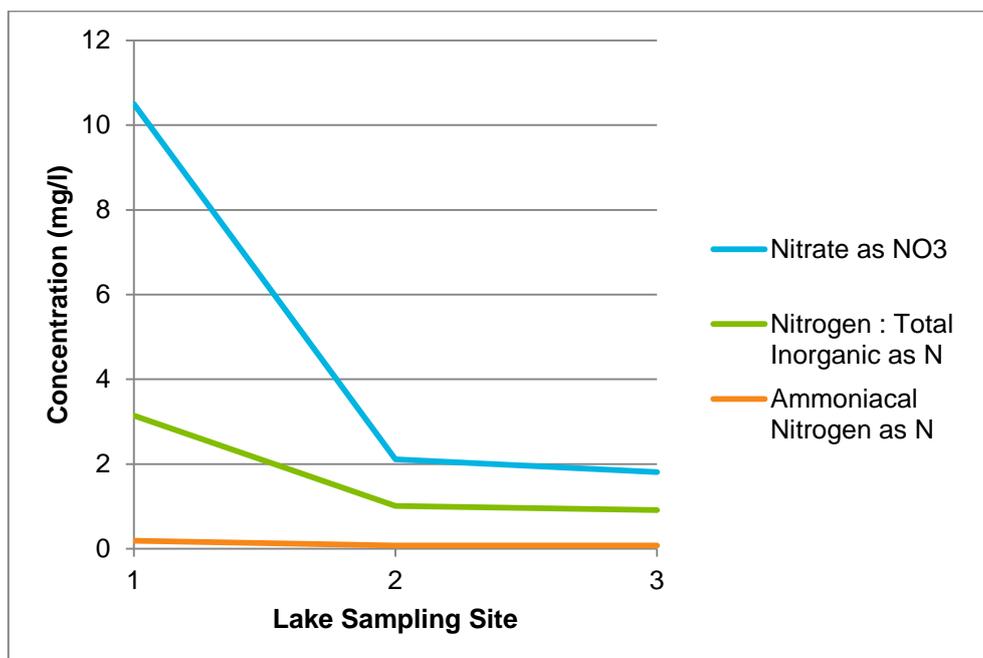
Figure 2 Variability in concentration of example water quality parameters across the three lake sampling sites (VLW-1 = 1 and is closest to the inlet; VLW2 = 2; VLW-3 = 3 and is closest to the outlet).

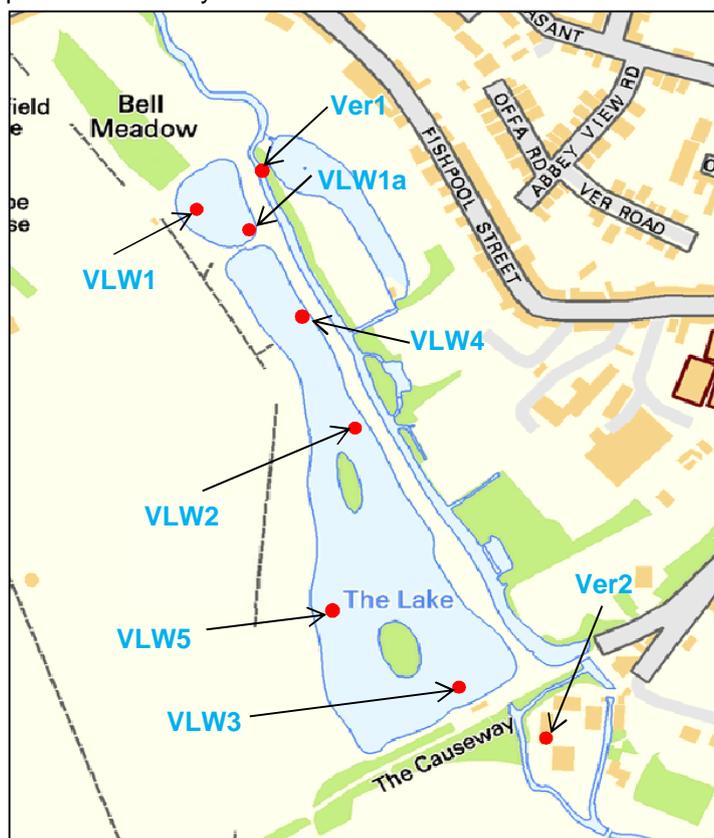
Figure 1 Sampling locations in Verulamium Lake (Basemap © Ordnance Survey, 2018)

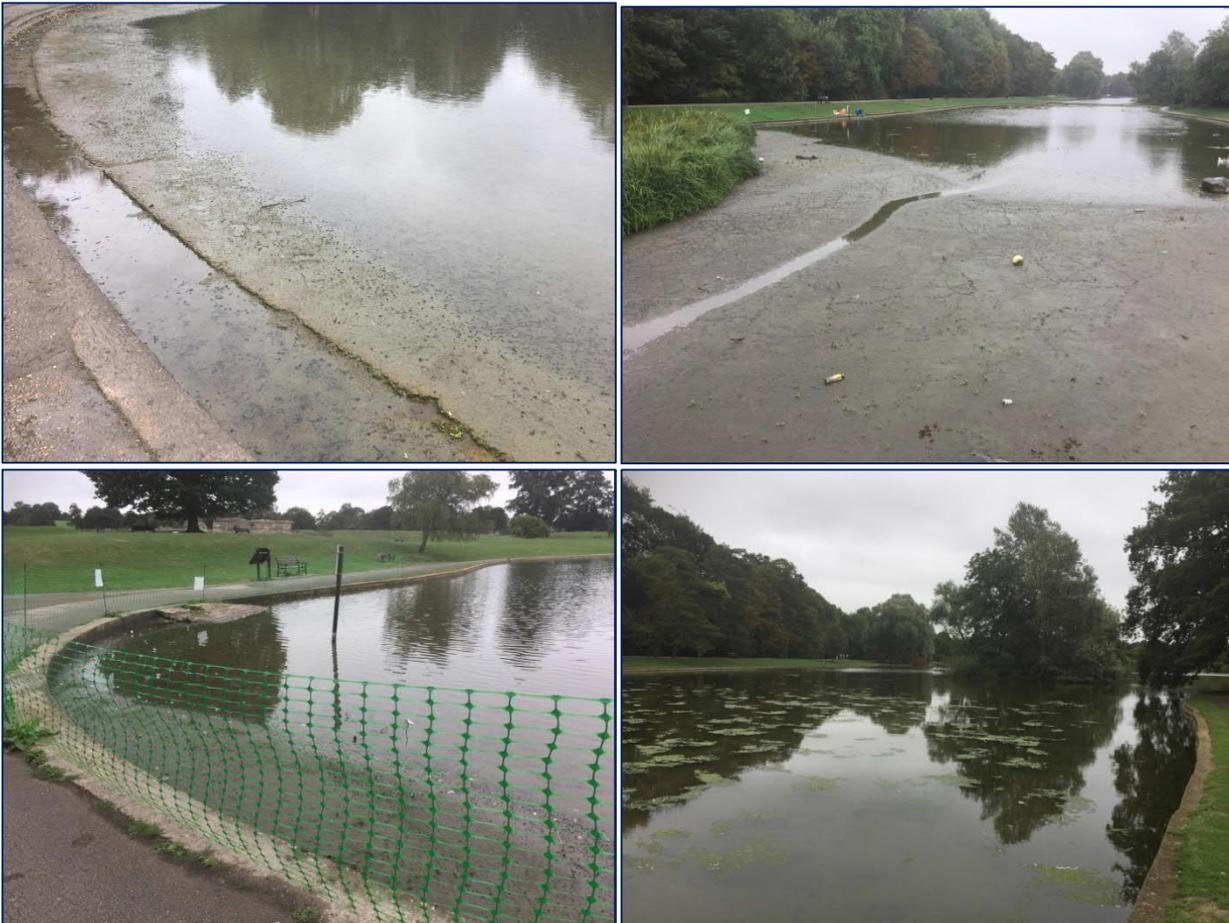
Photo 1 (top left) Exposed sediment at the margins of the upper lake; Photo 2 (top right) Exposed sediment downstream of the weir between the upper and lower lake; Photo 3 (bottom left) Exposed sediment at the southwestern corner of the lower lake; Photo 4 (bottom right) Algal accumulations on the surface of the lower lake

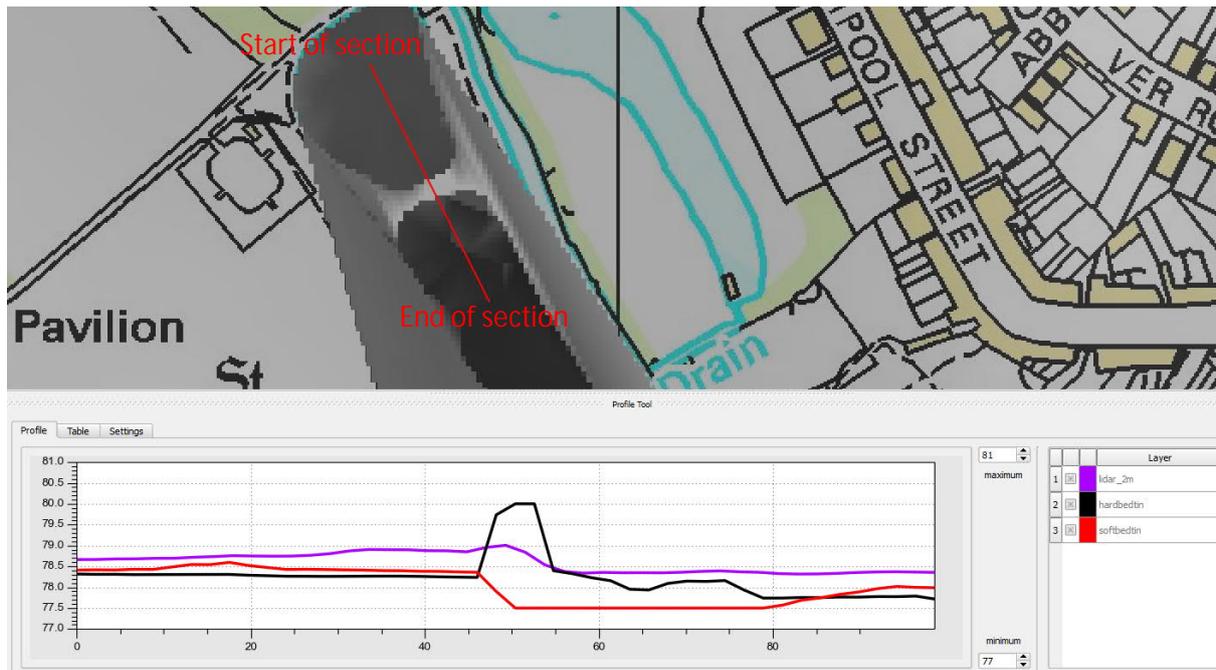
Figure 1 Illustration of error in received soft bed TIN layer (absence of bridge)

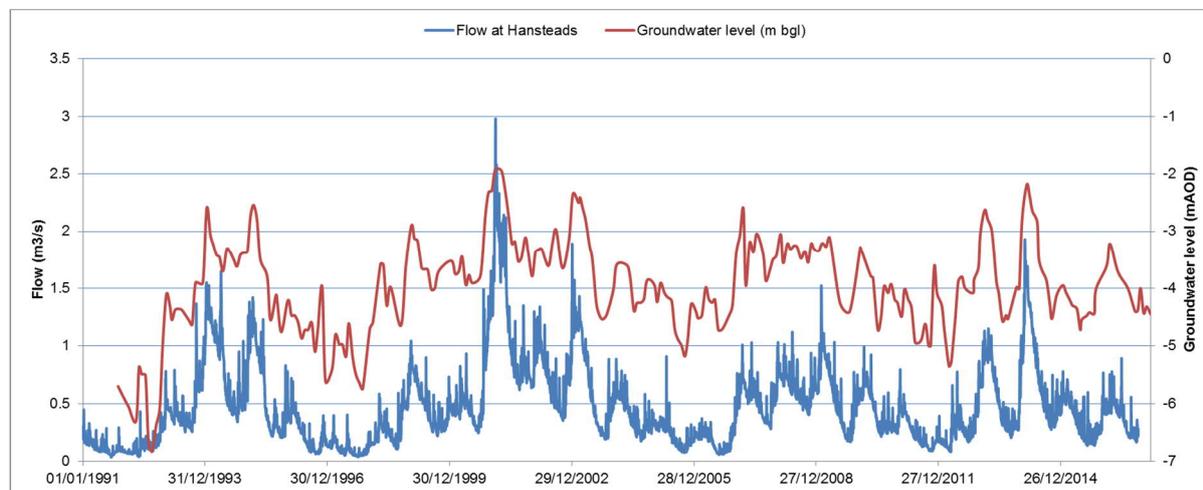
Figure 4 Time series of flow in the Ver and groundwater levels at Abbey Mill OBH (with respect to ground level)

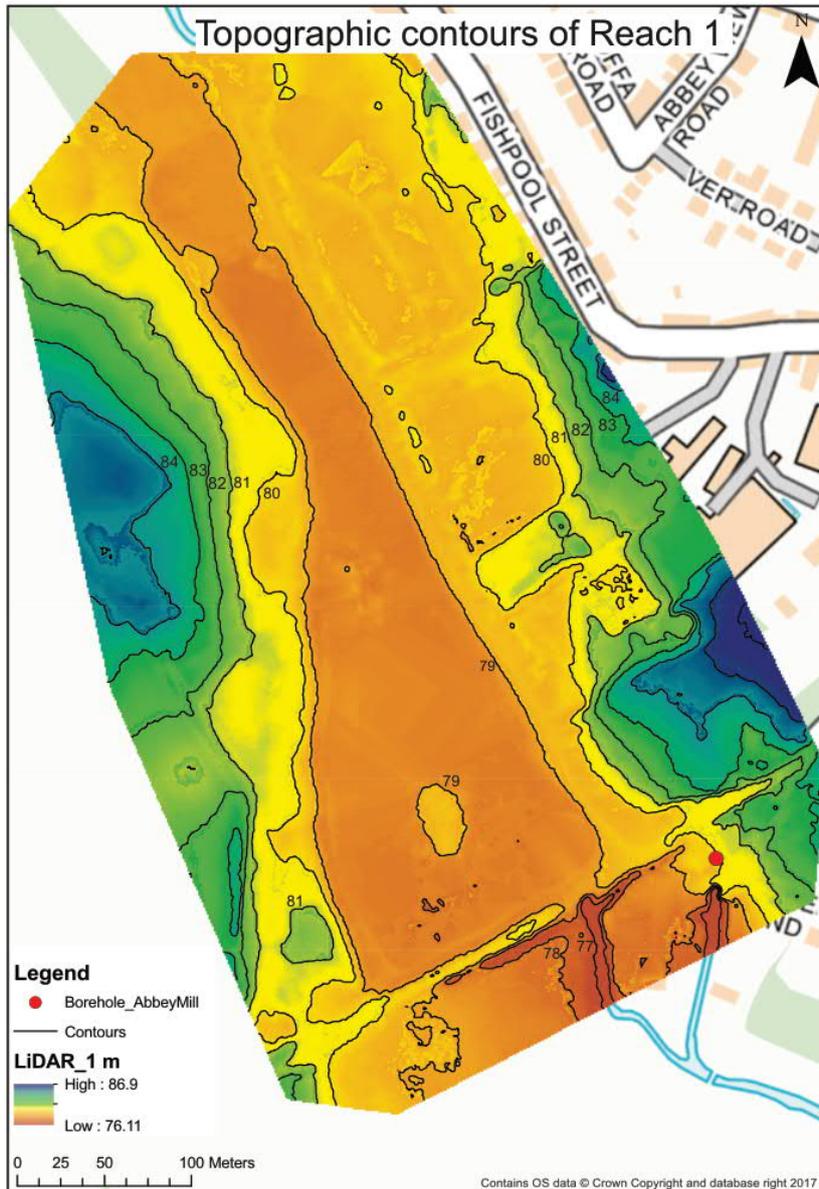
Figure 5 Ground Elevations in and around Abbey Mill OBH (borehole)

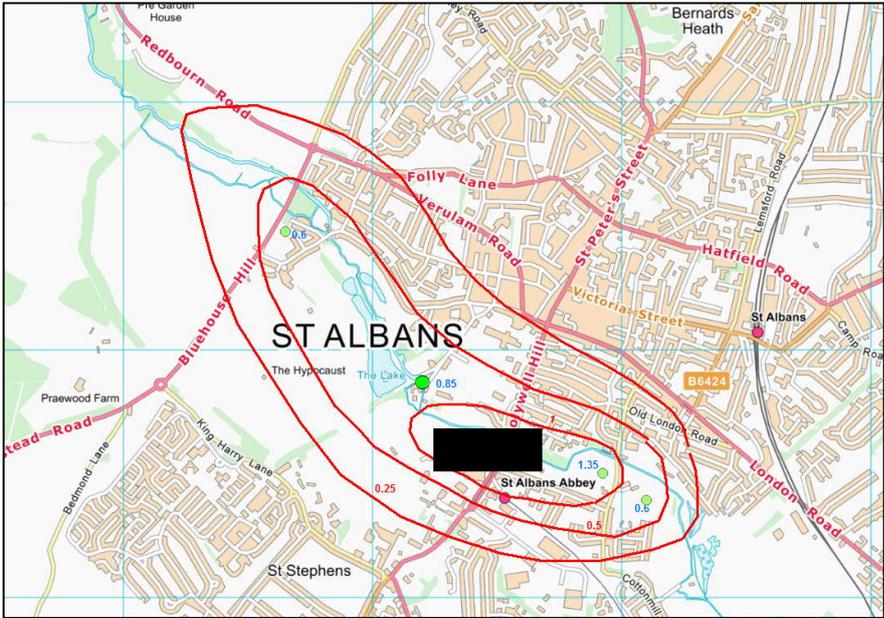
Figure 6 Interpreted groundwater level rebound after reductions in abstraction

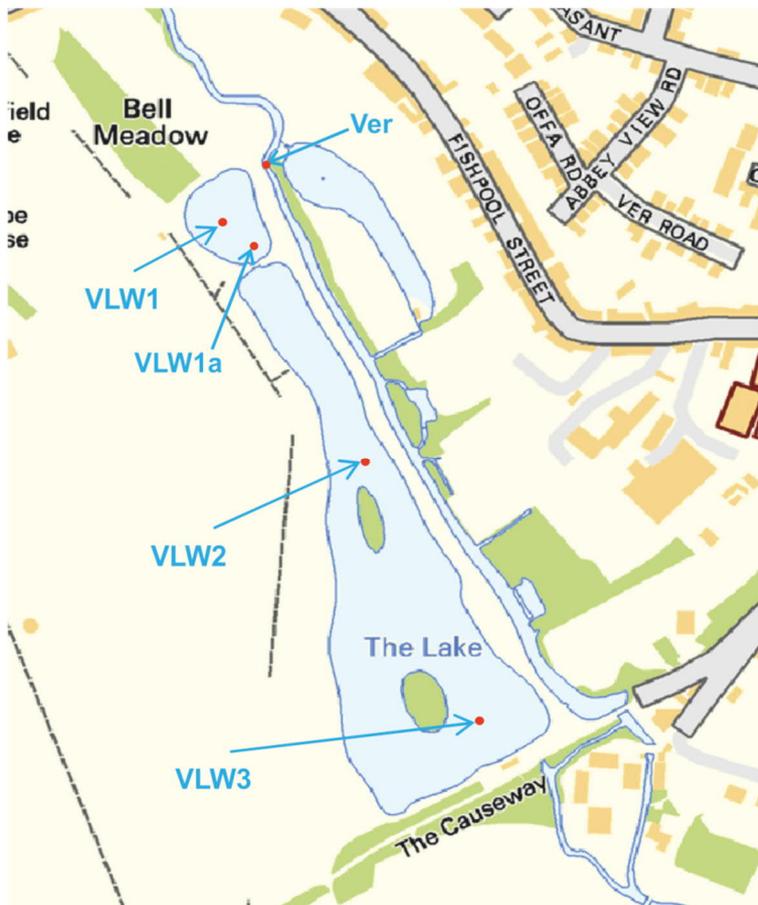
Figure 7 Location of Water Quality Sampling undertaken by AECOM and the Environment Agency in 2016 and 2017

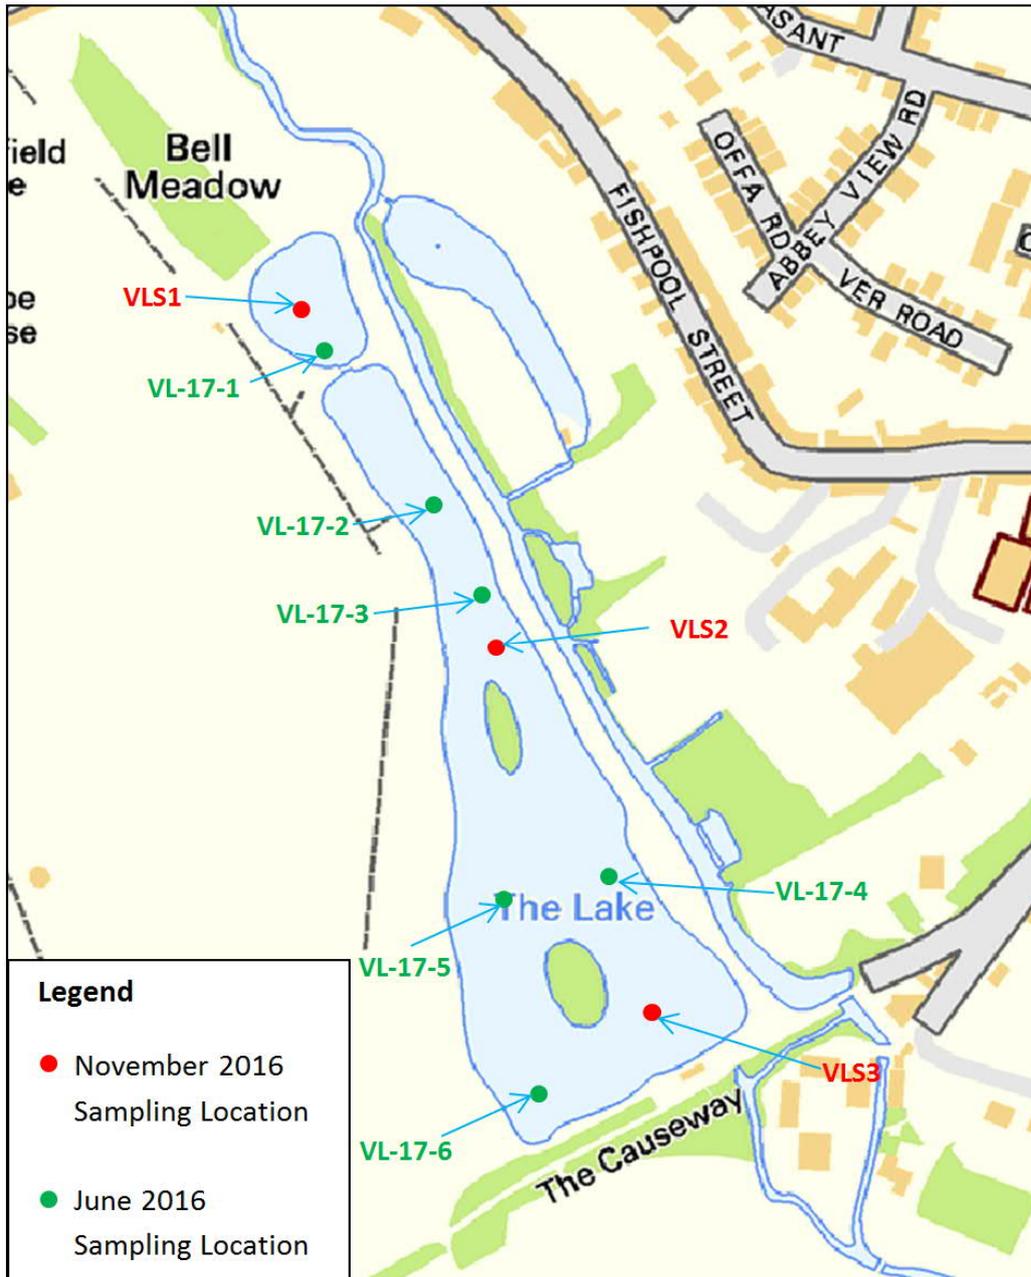
Figure 8 AECOM sediment sampling locations 2016 and 2017

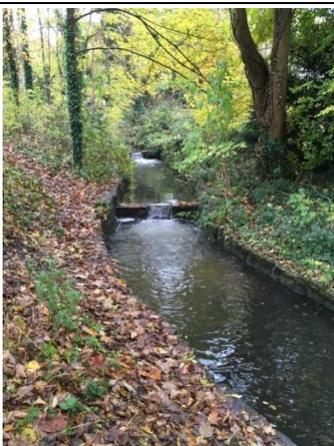
Photo 5: Upstream section of Reach 2.

Reach 2 was separated from Reach 1 by a weir. The section of river immediately following the weir was approximately 1.5m wide, concrete banked and fast flowing with a thin strip of broadleaved trees planted either side of it (Photo 5). This section then joined with another stream flowing from a weir connected directly to the Verulamium Lake. This section of the river was approximately 5m in width, had gently sloping soft earth banks and a pebble/gravel bed (Photo 6). The river flowed through a short section of deciduous woodland before entering an open area covered by species poor semi-improved grassland (Photo 7). The right hand bank of the river was covered by a strip of tall ruderal vegetation dominated by common nettle but also containing hogweed (*Heracleum sphondylium*) and scattered willows (Photo 8). The left hand bank of the river was covered by another strip of broad leaved plantation woodland that appeared very similar to the woodland present along Reach 1, many trees overhung the reach and a few large branches had even fallen in. There were some areas of marginal sedge vegetation present along thinner, meandering sections of the river before the reach ends and the A5138 Bridge (Photo 9 & 10).

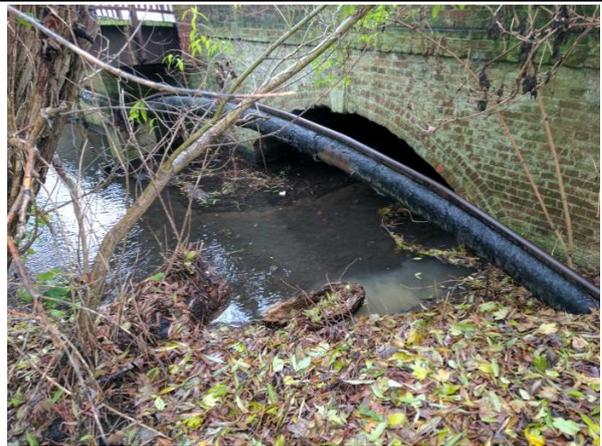
Photo 10: Bridge that separates Reaches 2 & 3.

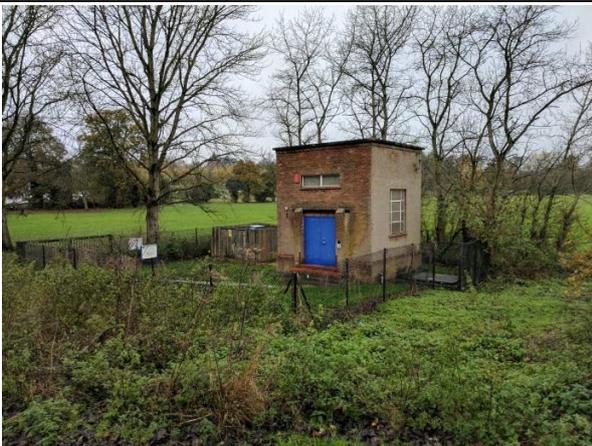
Photo 11: Utility building within area of semi-improved grassland adjacent to Reach 2.

The first of these structures was a small utilities building present in the middle of the area of semi-improved grassland adjacent to Reach 2 at TN9. Depending on the level of re-profiling works that are due to be made to the river, this building may need to be removed. The building was constructed from red brick and had a flat roof, it was located close to suitable foraging habitat (i.e. river and woodland) and did not appear to be in use (its windows were boarded up). The building appeared to be in relatively good condition and no obvious bat entrance/ exit points could be seen (Photo 11). It was therefore considered that this building had 'low' habitat suitability for roosting bats.

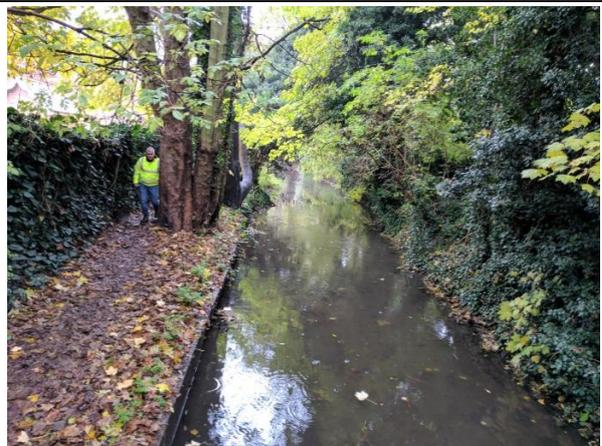
Photo 12: Concrete banked section of Reach 3.

Reach 3 was a mostly straight, concrete banked section of the river Ver that ran through a residential housing area (Photo 12). The river still remained very shallow although siltation levels appeared to be higher than previous reaches. A thin strip of broadleaved woodland with an understorey of common ivy ran along each bank of the river and fences and brick walls separated it from private residential buildings and gardens (Photo 13). There was also a track on the right bank of the river which crossed over to the left bank via a thin footbridge. After the footbridge the space around the river opened up into an area dominated by dense bramble scrub, nettles and a large stand of cherry laurel (*Prunus laurocerasus*) (Photo 14 & 15). Further down the reach the banks once again became dominated by deciduous woodland with an ivy understorey.

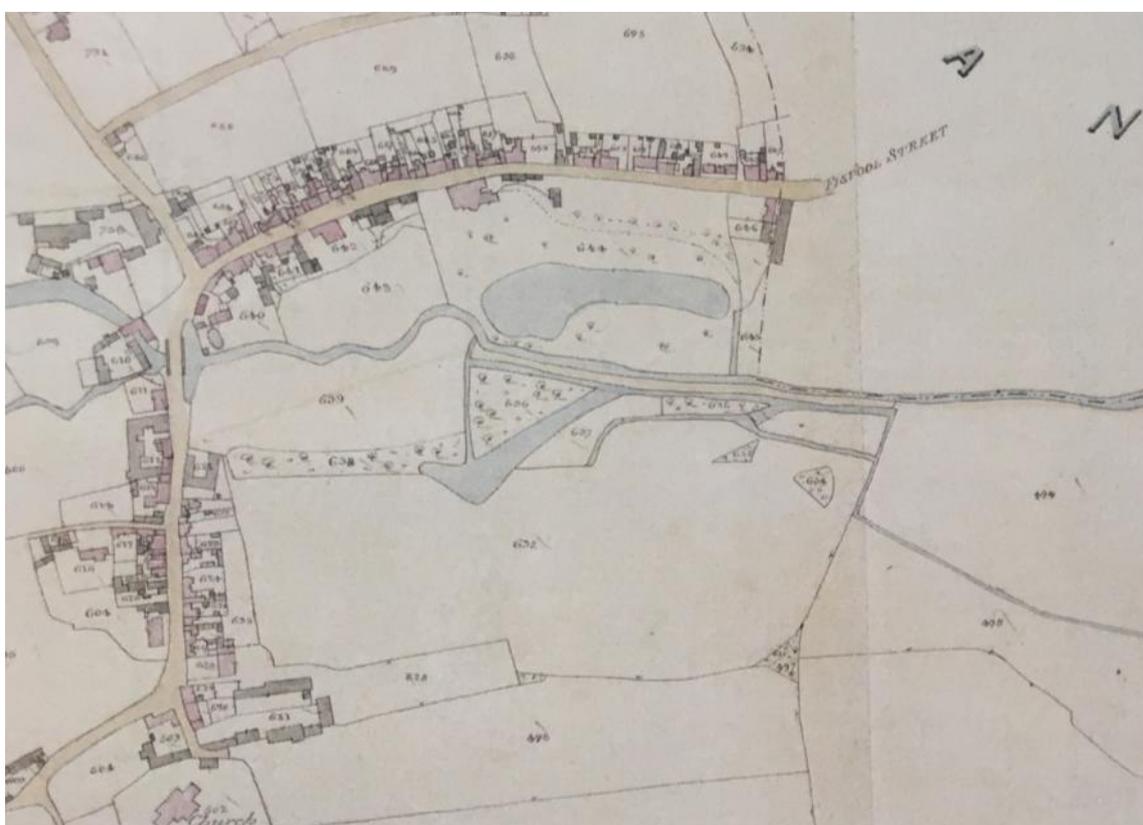
4.4.2 The 1874 Tithe Map of St Michael's Parish depicts Reach One. The plan shows the spread of the town along Fispool (*sic*) Street away from the core of the town. It also records multiple channels and pools crossing the area now under the modern lake (see Plate 1).

Plate 1 Tithe Map of St Michael's Parish (1874) (Reproduced with the permission of HALS)

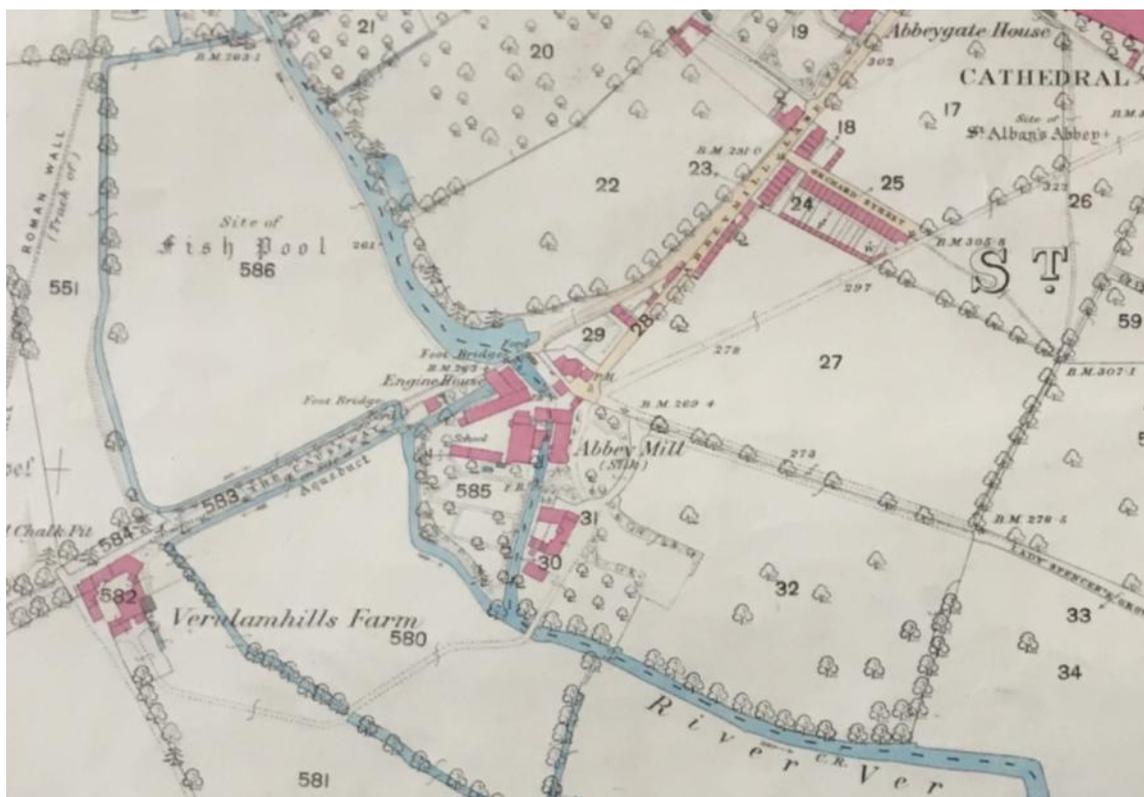
4.4.3 As with the Tithe Map, the first edition Ordnance Survey records the line of the river in the 1870s. The site of a "fish pool" is recorded in Reach One where the lake is currently located. The map also records the line of a second channel running to the western side on the lake, likely at the line of the western side of the lake (see Plate 3)

Plate 3 1879 Ordnance Survey Plan – Reach One and Two

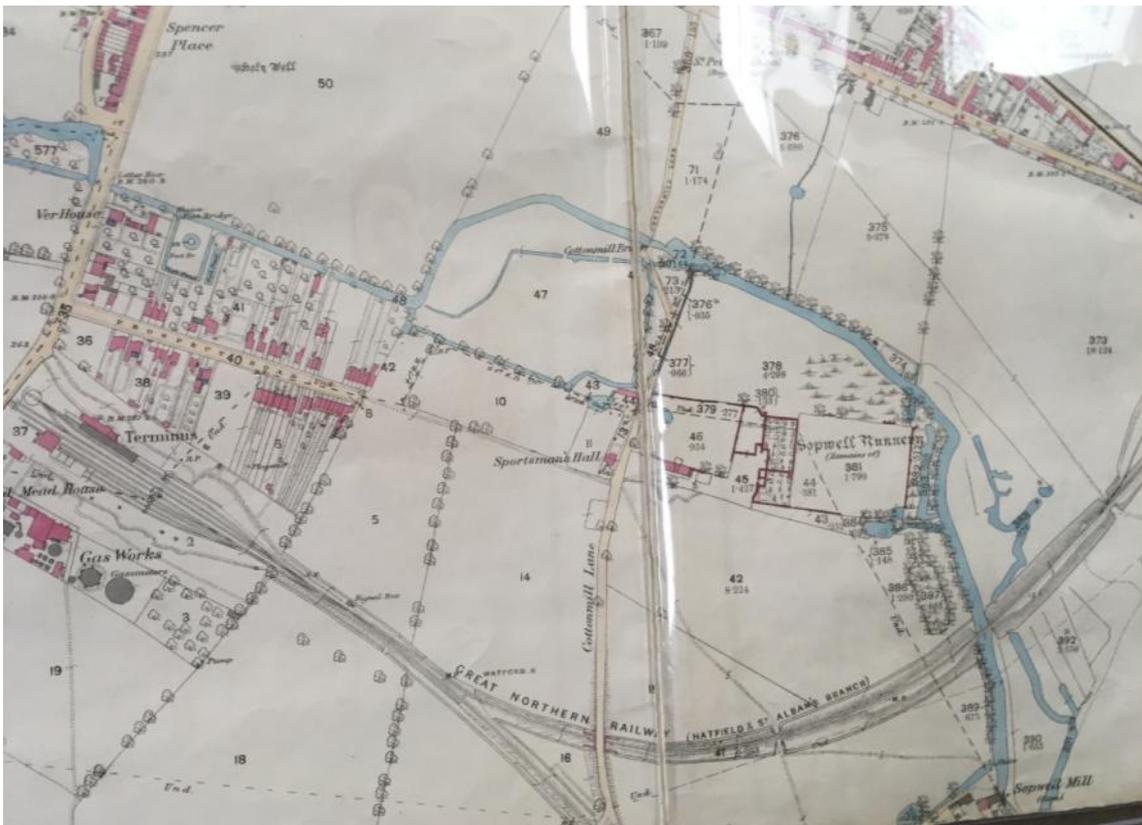
- 4.4.4 Further downstream the first edition plan also records a channel crossing through the area of the modern allotments (see Plate 4). It is likely that this was a mill leat supplying water to the cotton mill (24). Also shown on Plate 4 is the area of Sopwell Nunnery. The map records the remains of the nunnery as occupying the land adjacent to the river.
- 4.4.5 The land adjacent to the river is still recorded as being open fields with some evidence of the spread of the urban extent of St Albans that continued into the late 19th and early 20th century. The land adjacent to the river remains largely unaltered with the open fields maintained throughout the early 20th century. The open landscape was finally overtaken by the expanding town as part of the growth of St Albans following World War II.

Plate 4 1879 Ordnance Survey Plan – Reach Three to Six

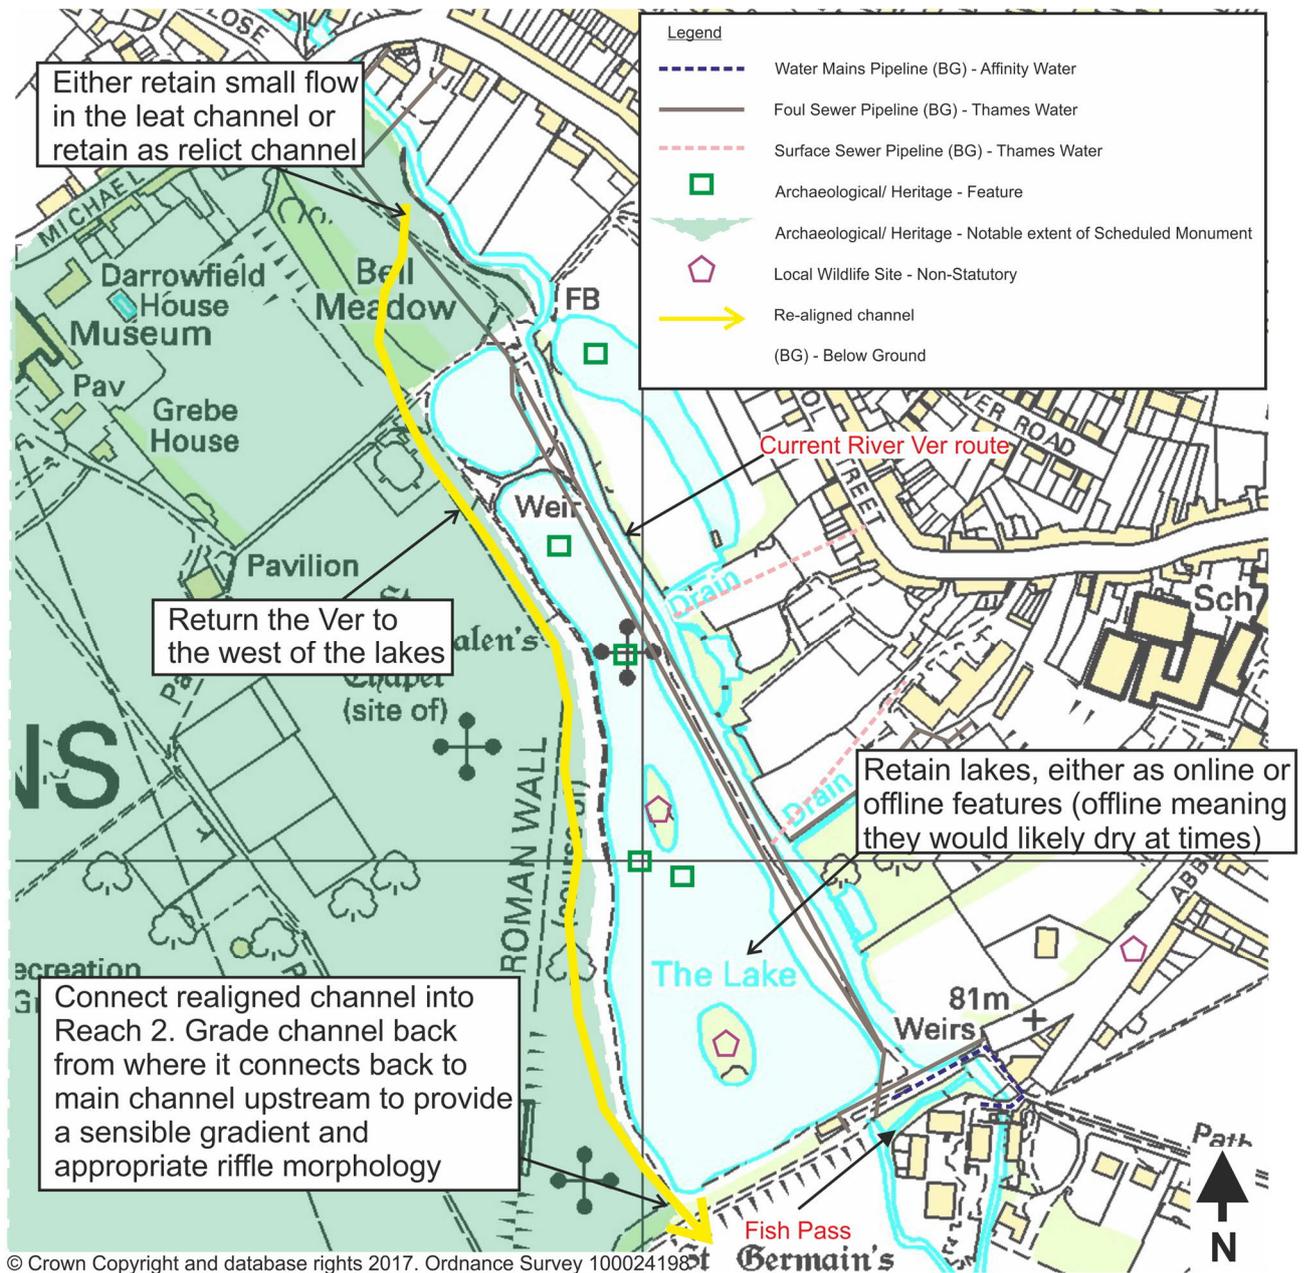
Figure K.8 Option 7 – Re-align channel to west of lakes and connect to Reach 2 to the west of the Causeway

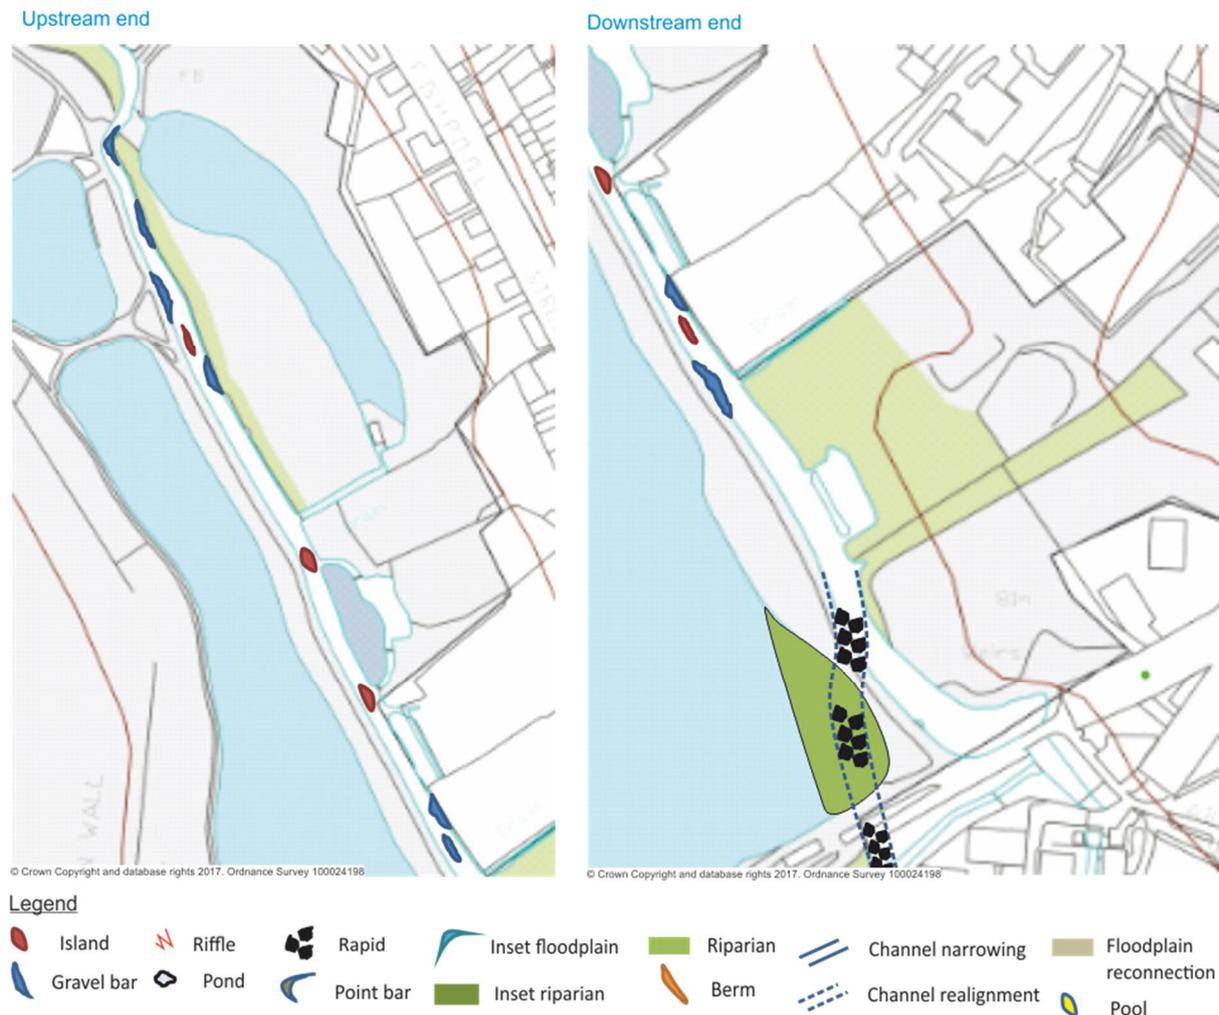
Figure K.17 Restoration Features Plan for Reach 1 Option 5

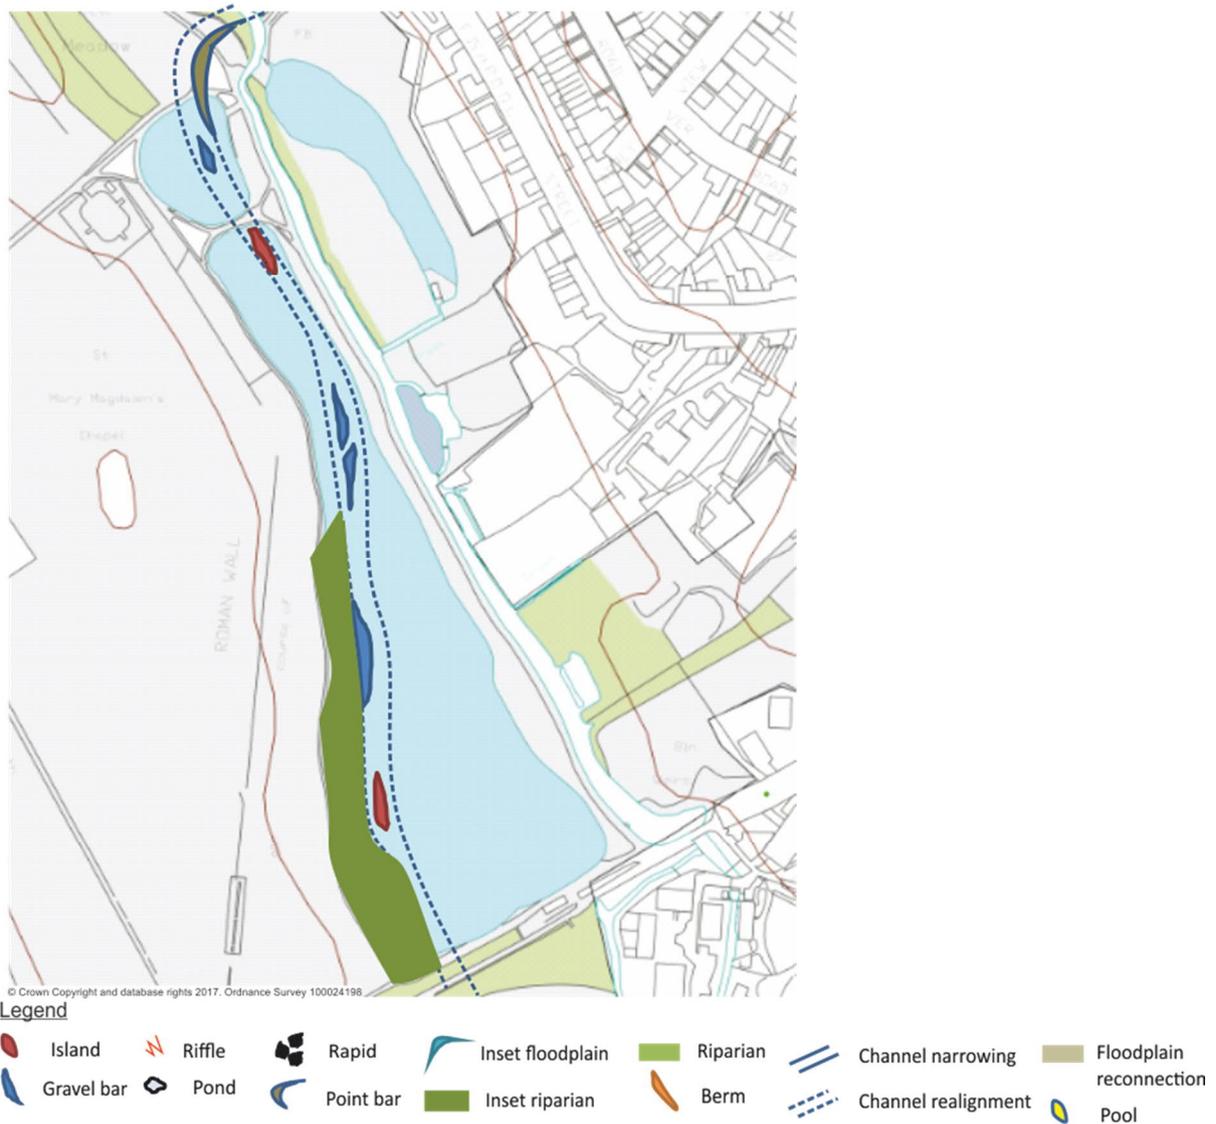
Figure K.18 Feature plans for Reach 1 Option 7

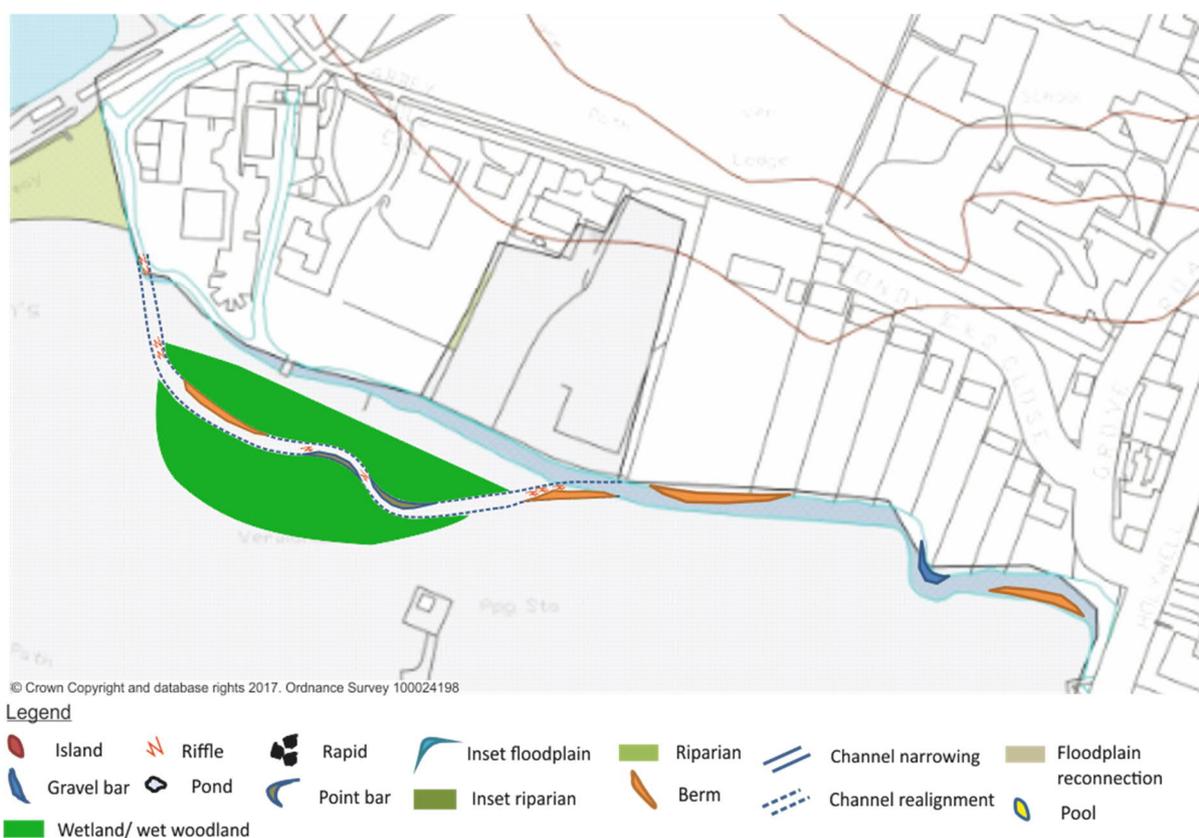
Figure L.7 Feature plans for Reach 2 Option 2

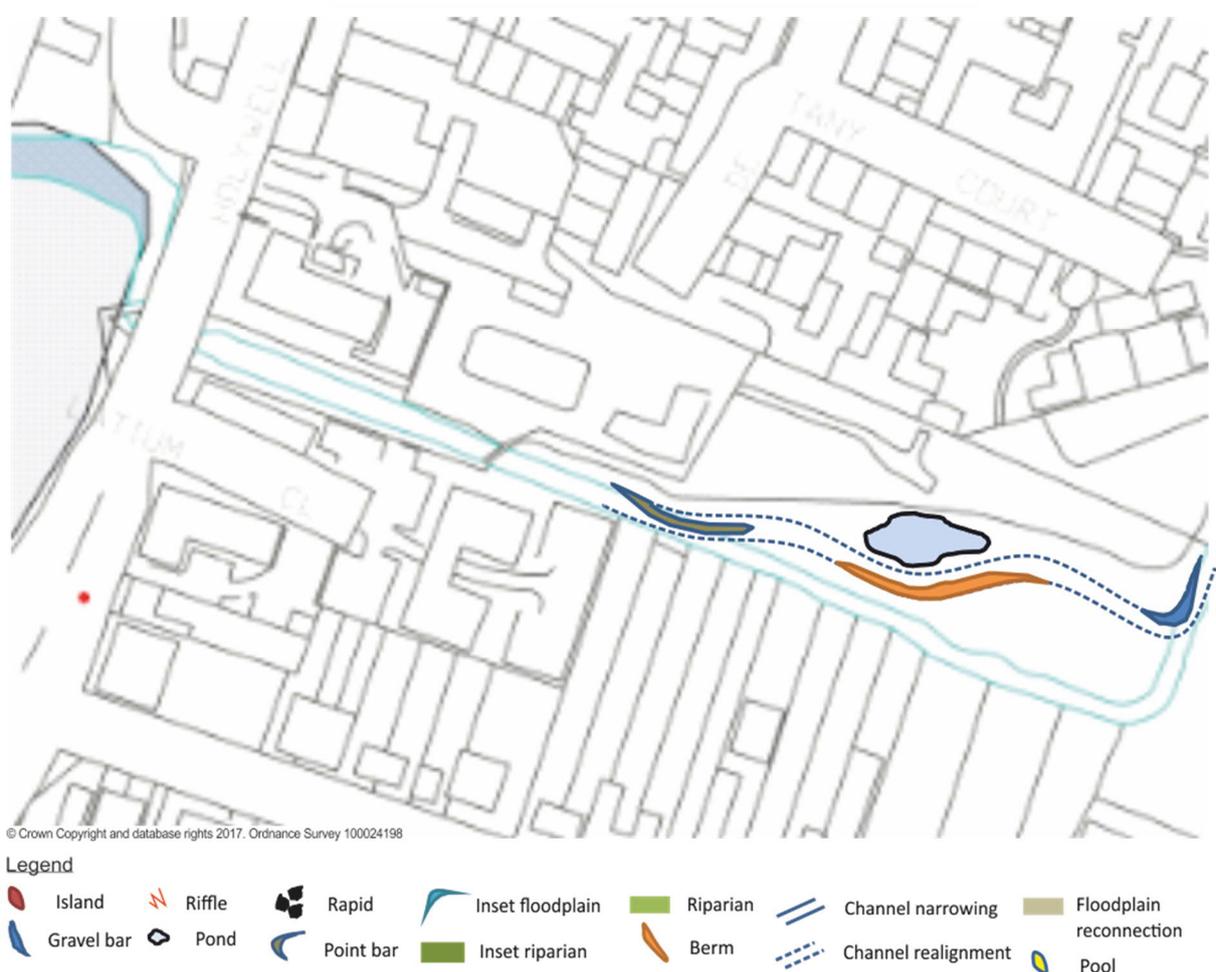
Figure M.7 Feature plans for Reach 3 Option 2

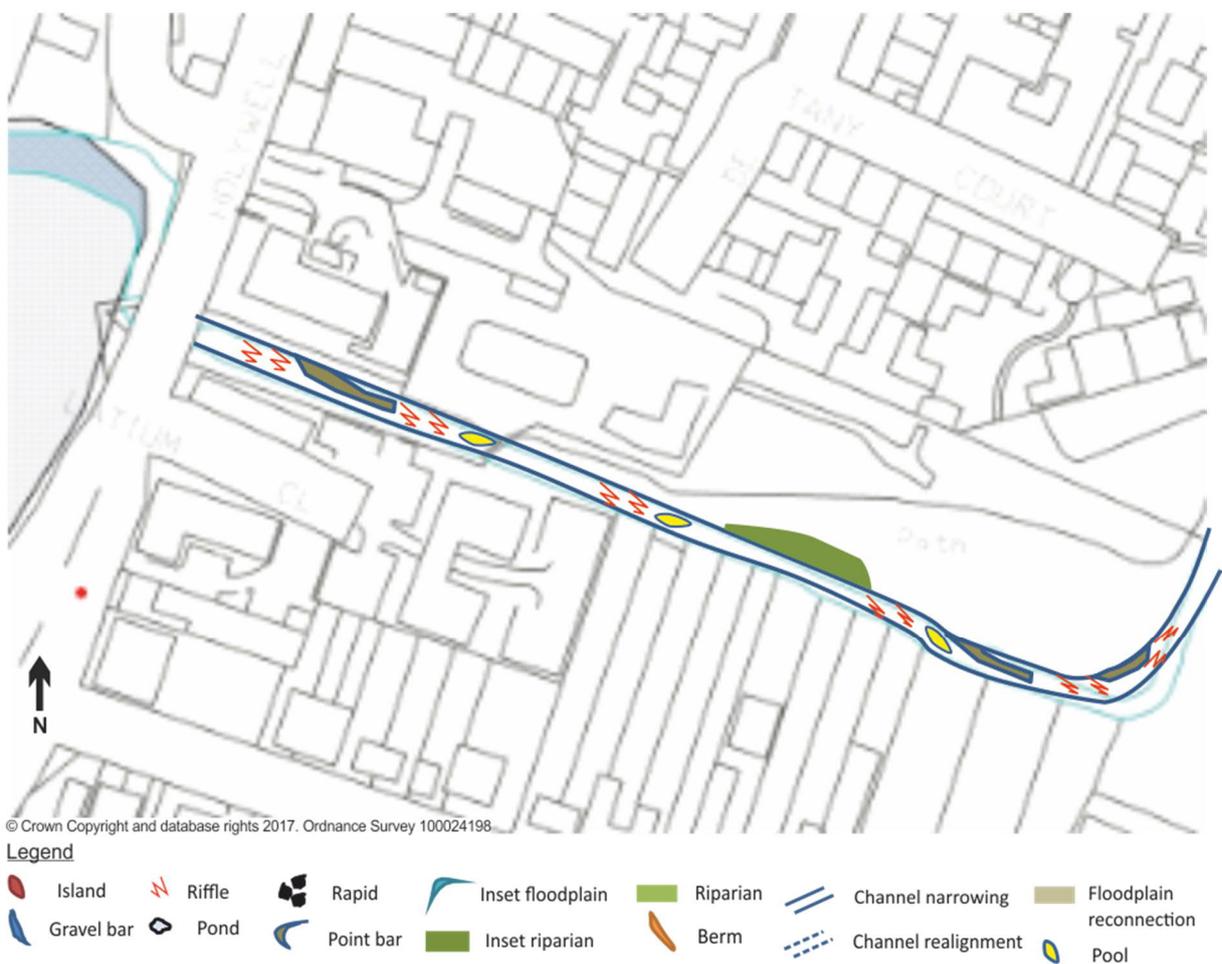
Figure M.8 Feature plans for Reach 3 Option 4
