*River Ver
Restoration St
Albans*

With and on behalf of the Environment Agency

Document name	Ref	Prepared by	Date	Reviewed by	Approved By
River Ver Restoration St Albans	Final	Omar Sholi	25-1-2019	Nigel Pilkington	Omar Sholi
River Ver Restoration St Albans	Draft	Omar Sholi, Alex Deacon, Kate de Smeth, Seb Bentley, George Heritage, Tim Jones, Amy Jones	31-10-18	Nigel Pilkington	Omar Sholi

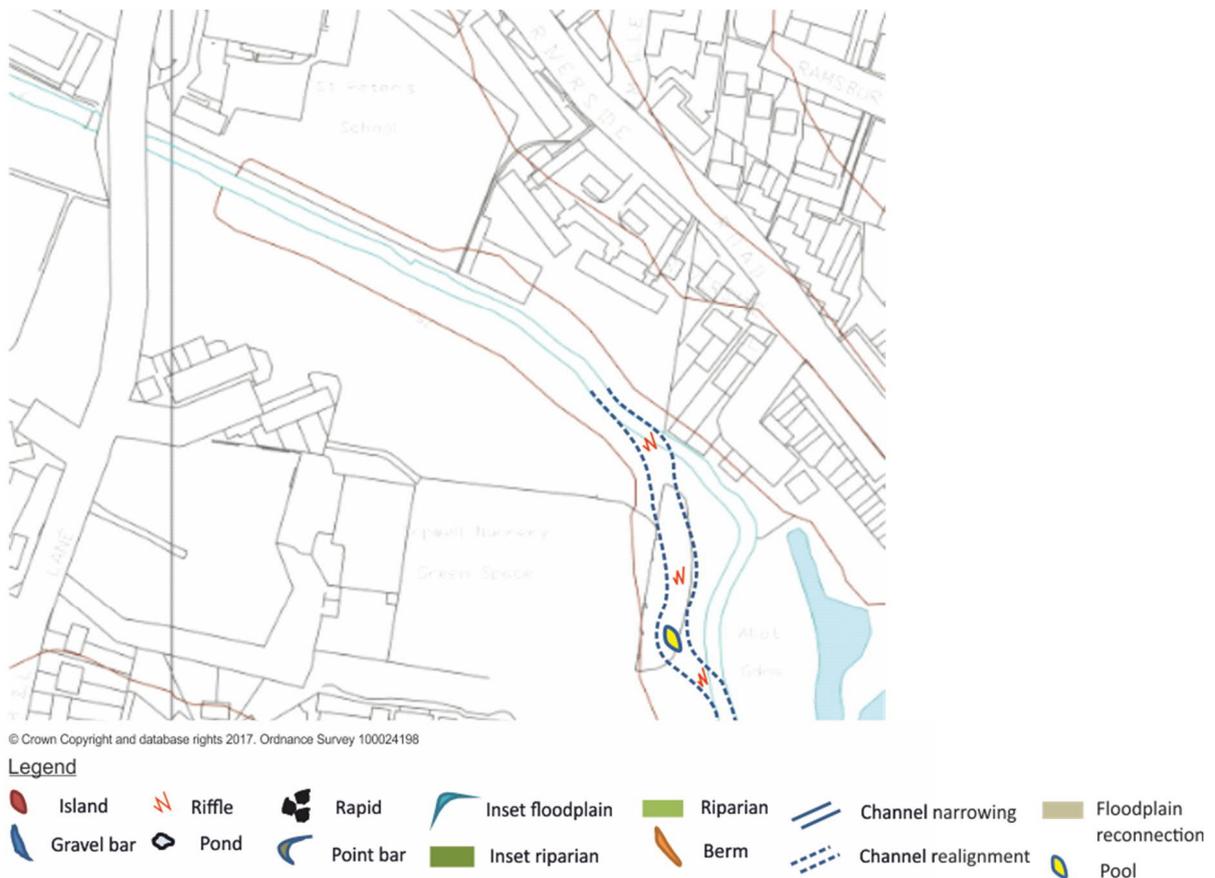
Figure O.9 Feature plans for Reach 5 Option 3

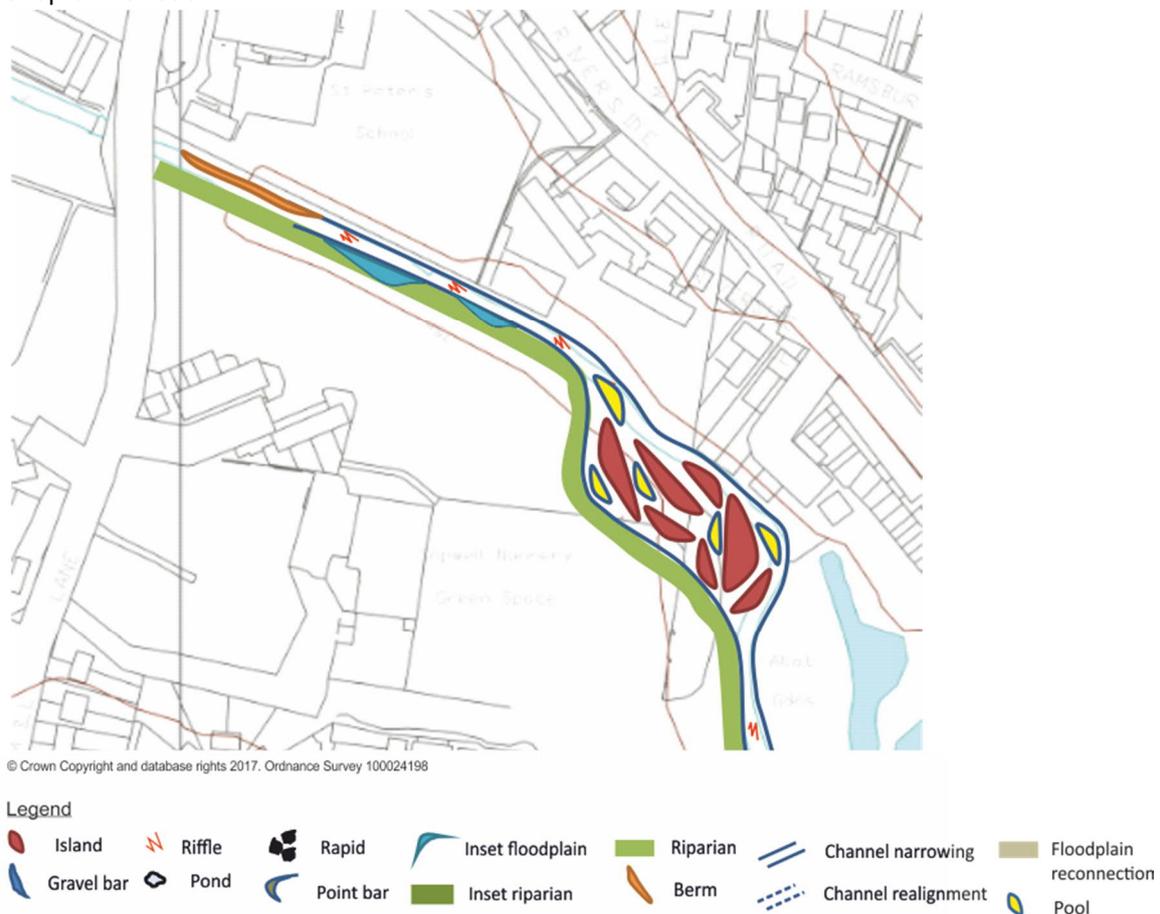
Prior to entering the newly created wet woodland feature, the re-aligned channel would be subject to in-channel re-profiling and incorporation of a suitable morphology including riffle and point bar features, and the creation of inset floodplains (as illustrated in Figure O.10, which also includes the features included within the modelling). The design would complement existing kingfisher habitat at the top of the reach.

Figure O.10 Feature plans for Reach 5 Option 4

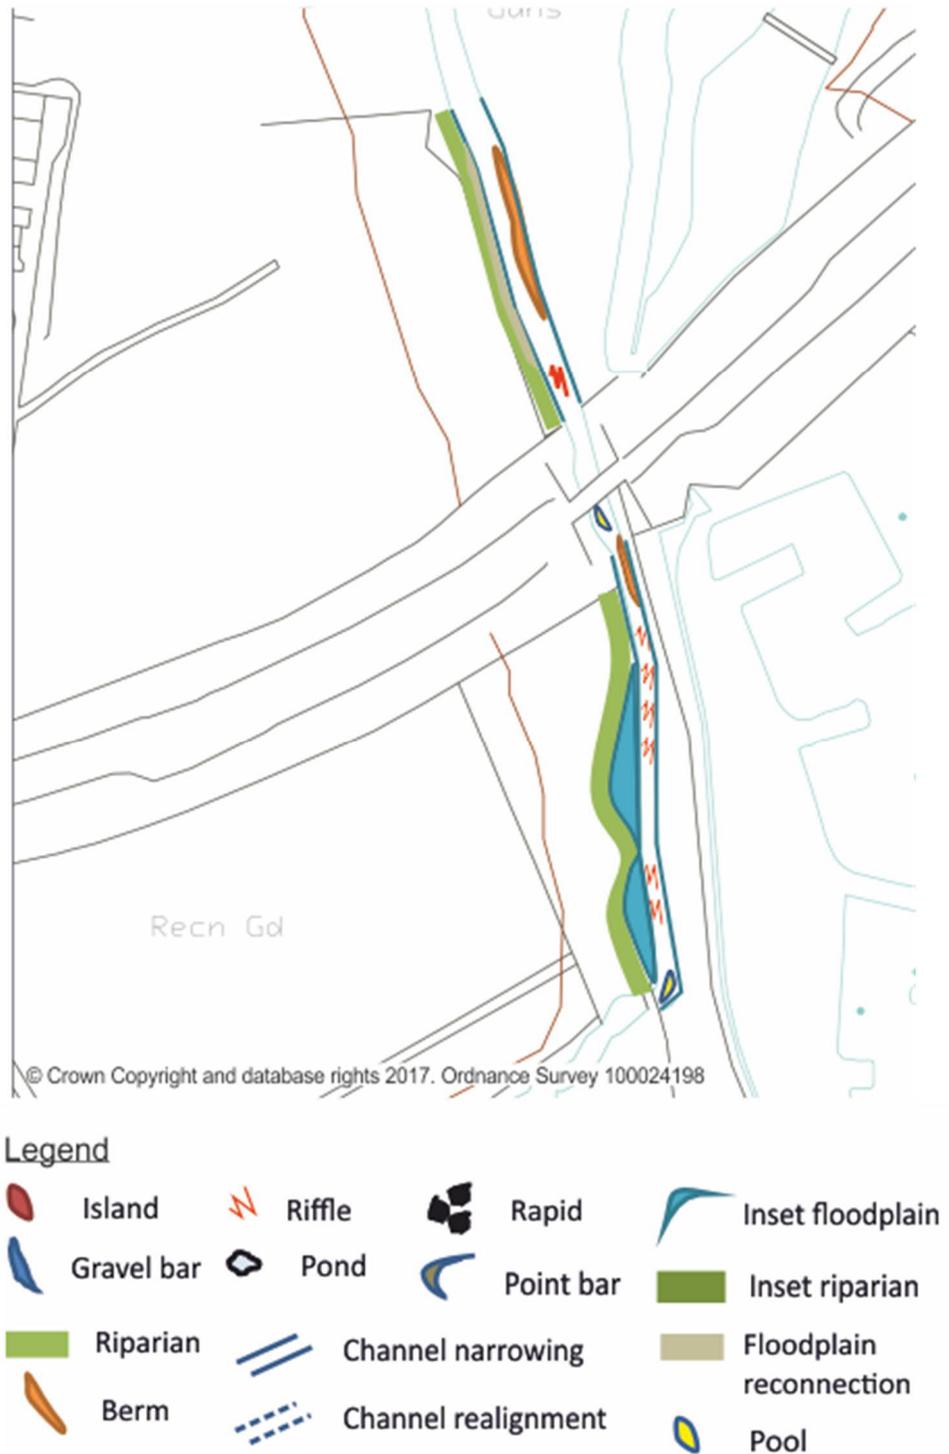
This section of the channel would also be subject to in-channel re-profiling and incorporation of a suitable morphology including a riffle-pool regime and berm features (as illustrated in Figure P.5, which also includes the features included within the modelling).

Figure P.5 Feature plans for Reach 6 Option 2

In this option the existing channel course would be maintained, with right bank lowering upstream of the bridge to encourage floodplain connection, causing one row of the Nunnery allotments to be lost. Right bank lowering also enables the Ver Valley Trail to be set back and stabilised given the current path has many erosion points. Inset floodplain and riparian zones would be created on the right bank immediately downstream of the Alban Way crossing over the river.
