Bat Emergence Surveys - *Interim Report*

**Land south of Chiswell Green Lane, St
Albans, Hertfordshire**

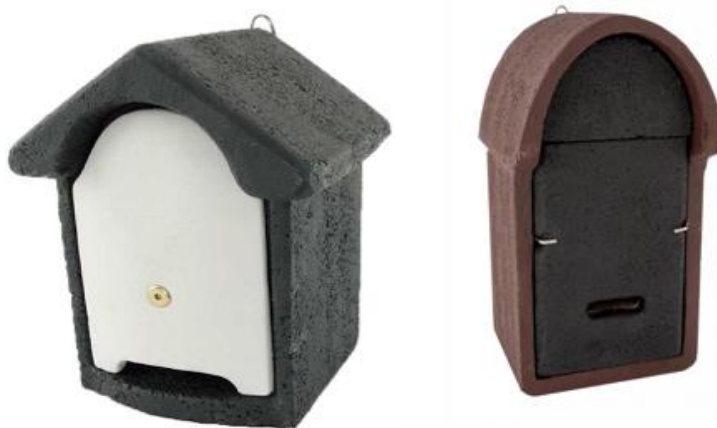
- Vivara Pro WoodStone Bat Box – A general purpose bat box that supports a range of species (Figure 6). These can be hung on trees in a variety of heights and aspects in order to provide a variety of micro-climates.
- Large Multi Chamber WoodStone Bat Box – This is a multipurpose box designed for larger colonies and a range of bat species including pipistrelles, noctules and brown long-eared bats. These should be hung on mature trees around the site (Figure 6).

Figure 6: Vivara Pro WoodStone Bat Box (left) and Large Multi Chamber WoodStone Bat Box (right)
