For the Site of: Chiswell Green Lane and east of The Croft, Chiswell Green, AL2 3AJ

Ecological Appraisal (EA)

The inspection was conducted on the 25/05/2021.

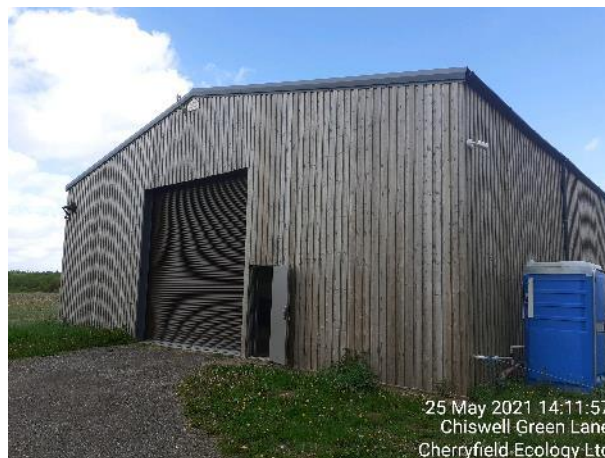
There are four detached agricultural buildings found on site (B1, B2, B3 & B4). B1 is a large, detached barn type building. It has an open gable roof design with metal sheet roofing present. Large metal roller shutter doors are found at the western and eastern

Figure 2: Front and side elevations of B1.

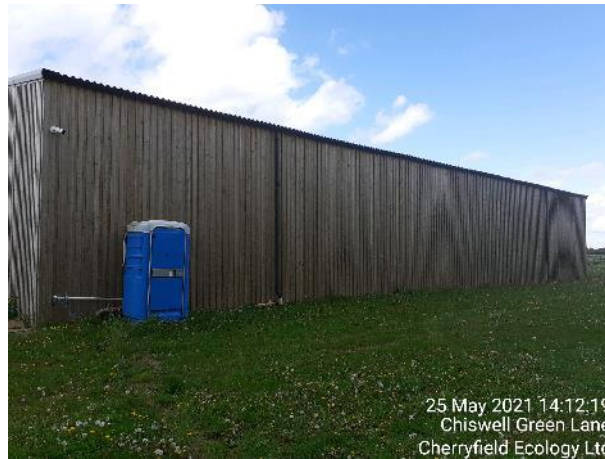
Figure 3: Side elevation of B1.

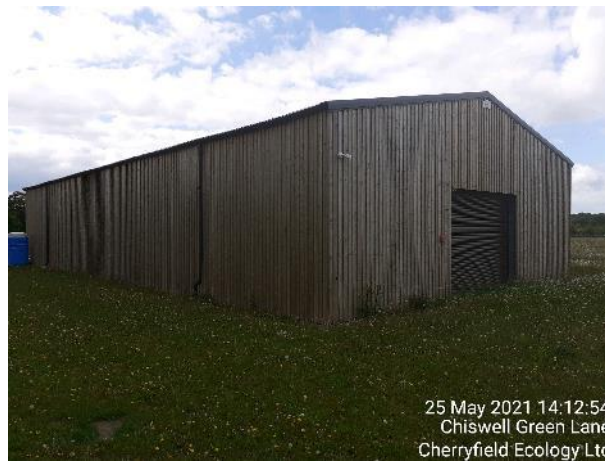
Figure 4: Rear and side elevations of B1.

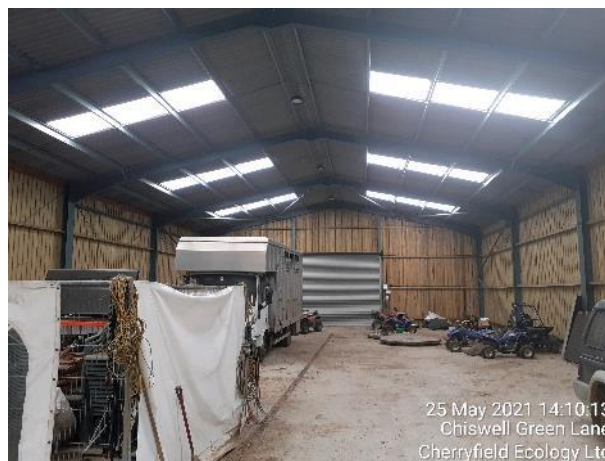
Figure 5: Example of B1's internals.

| Potential for bat use | B1 - Level of likelihood of presence - Negligible. No visible potential entry/exit points were found across the whole of B1. The metal sheet roofing appeared to be tight fitting as were the soffits. Internally there are no loft spaces or roof voids, and the tight-fitting metal |

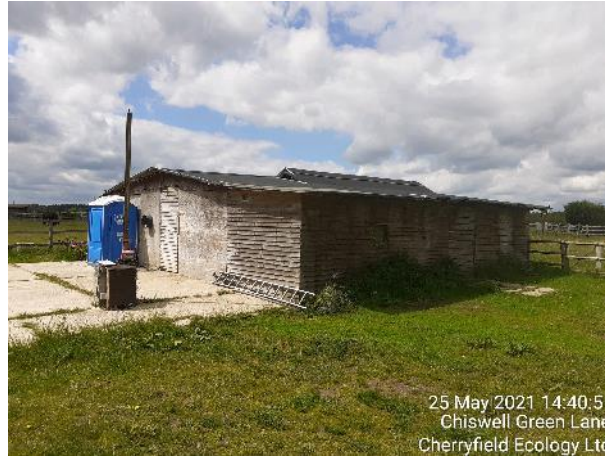
B2 is a detached timber built stable type building. It has a predominantly open gable roof design with a mono pitched section also. The roofing material is made from bitumen felt and the building has plastic rainwater goods. Internally the building has no loft space or roof voids and has a vaulted roof. It should be noted that this building has been sealed internally and is heavily insulated.

Figure 6: Front and side elevations of B2.

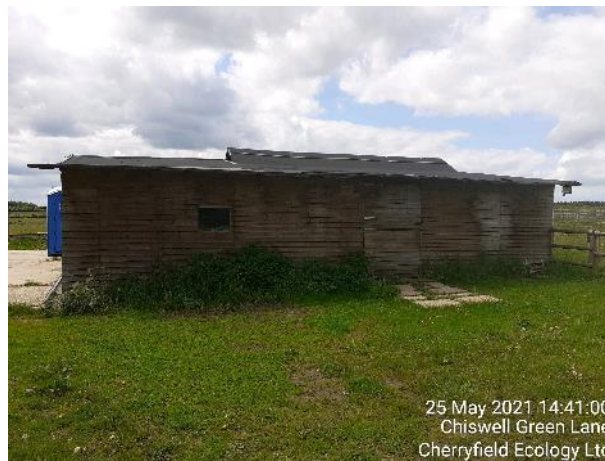
Figure 7: Side elevation of B2.

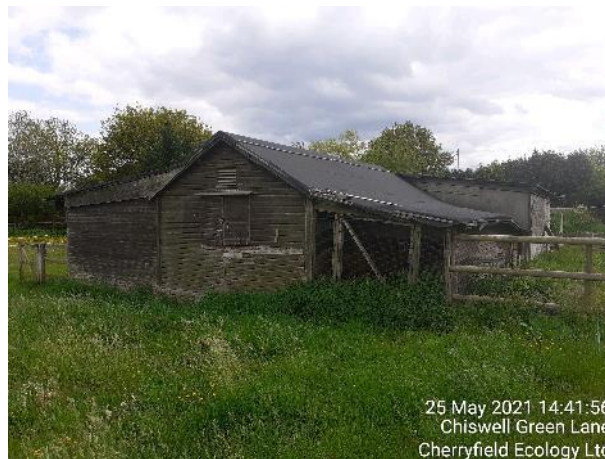
Figure 8: Rear and side elevations of B2.

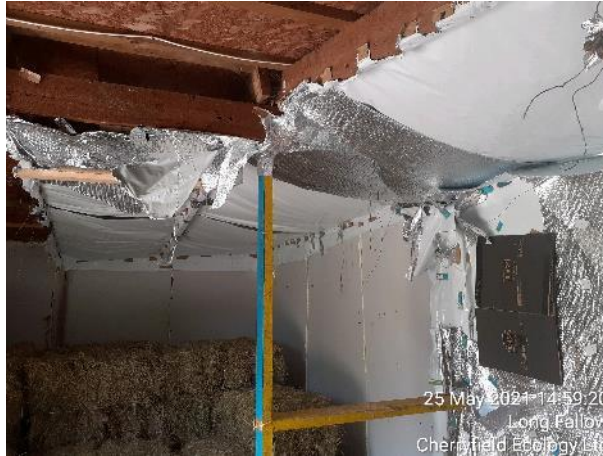
Figure 9: Example of B2's internals.

No visible potential entry/exit points were found across the whole of B2. All the roofing material was tight fitting as were the overhanging eaves on the building. Potential access was found through a louvre window but on closer inspection this had been sealed internally. In addition to the lack of access internally there is no loft space or roof void. The tight-fitting timber framework attached to the roofing material did not provide any suitable gaps and crevices in which roosting bats could utilize. Due to a lack of entry/exit points and suitable potential roosting features building B21 is also considered to be negligible potential.

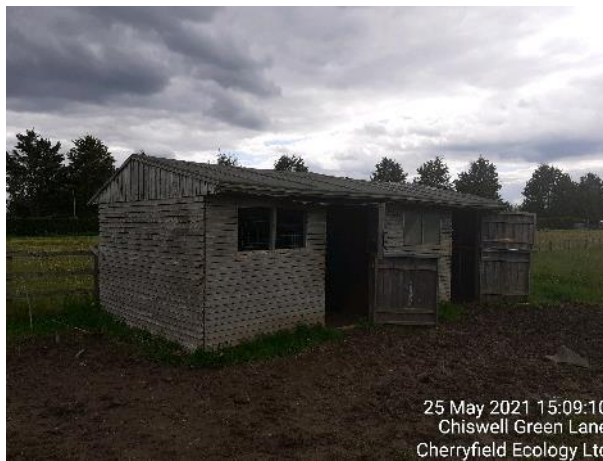
B3 is detached timber built stable type building. It has an open gable roof design with bitumen felt roofing material present and has plastic rainwater goods. Internally the building has no loft space or roof voids and has a vaulted roof. This building is currently 'in-use' as a working horse stable.

Figure 10: Front and side elevations of B3.

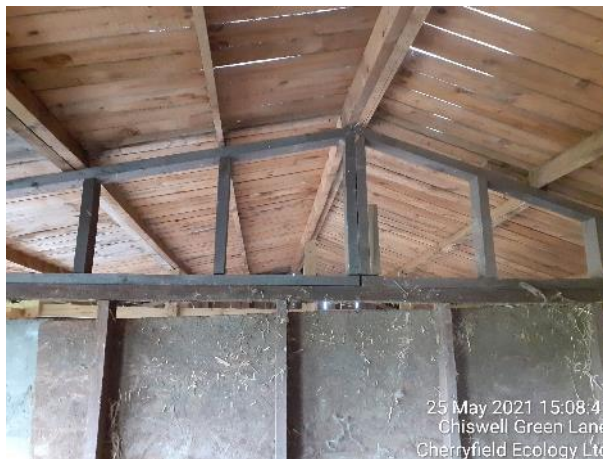
Figure 11: Example of B3's internals.

| | <p>Entry and exit points were found in the form of stable door openings. Internally no suitable gaps and or crevices were found due to the tight-fitting roofing material atop the tight-fitting timber frame. Although entry and exit points can be found through the working stables design no suitable roofing features were found to be present internally therefore building B3 is considered to be of negligible potential for roosting bats.</p> <p>B4 - Level of likelihood of presence - Negligible.</p> <p>Entry and exit points were found in the form stable door openings. Internally no suitable gaps and or crevices were found due to the tight-fitting roofing material atop the tight-fitting timber frame. Although entry and exit points can be found through the working stables design no suitable roofing features were found to be present internally therefore building B4 is considered to be of negligible potential for roosting bats.</p> |

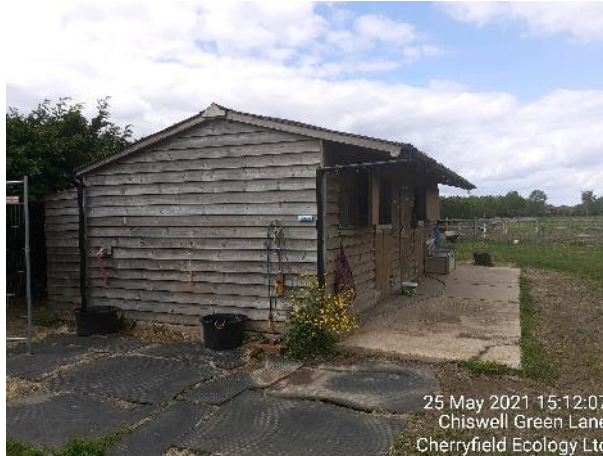
B4 is detached timber built stable type building. It has an open gable roof design with corrugated bitumen sheet roofing material present and has plastic rainwater goods. Internally the building has no loft space or roof voids and has a vaulted roof. This building is currently 'in-use' as a working horse stable.

Figure 12: Side and front elevations of B4.

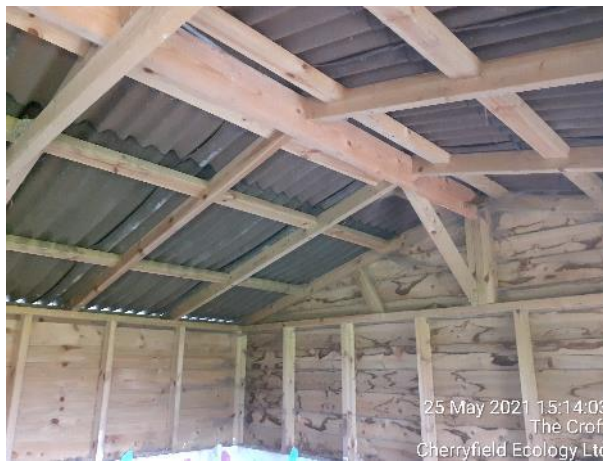
Figure 13: Example of B4's internals.

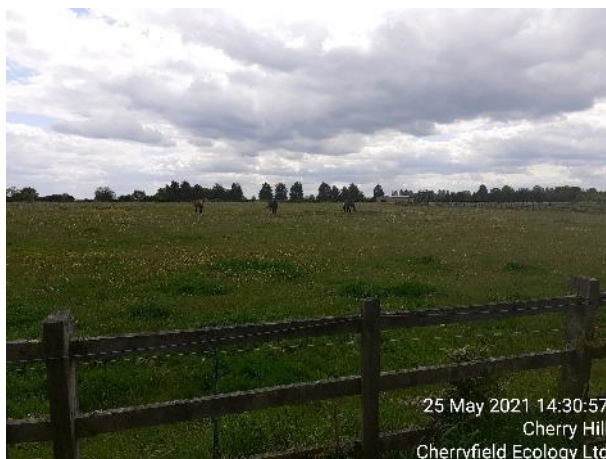
Improved grass is found to cover the majority of the site. This large area is heavily grazed by horses (year-round) and livestock (sporadic) and is also regularly cut, all of which helps to keep the sward height low. Species here include perennial rye-grass *Lolium perenne*, buttercup *Ranunculus repens*, daisy *Bellis perennis*, sheep's sorrel *Rumex acetosella*, white clover *Trifolium repens*, ribwort plantain *Plantago lanceolata* and dandelion *Taraxacum officinale*.

Figure 14: Example of improved grass found onsite.

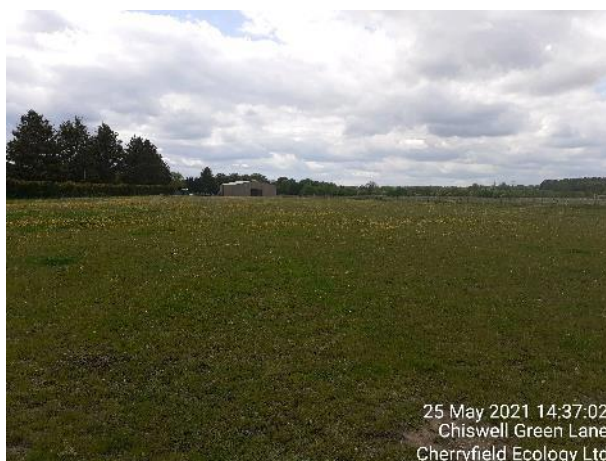
Figure 15: Further example of improved grass found onsite.

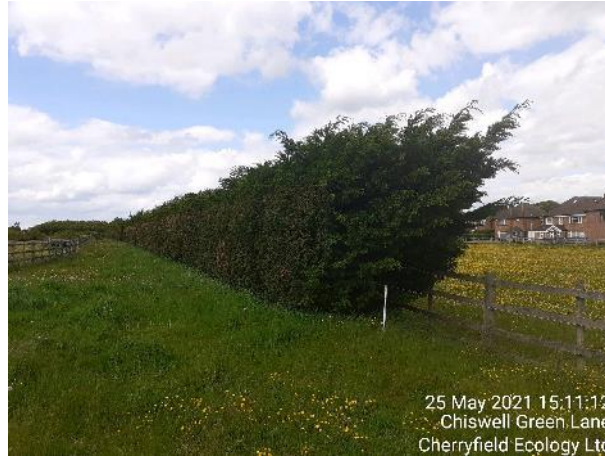
Hedgerow is found predominantly to the boundary of site. Most consists of single species such as pine *Pinus sp.* or beech *Fagus sylvatica*. Some portions to the north and west have a tree standard also, with species including oak *Quercus sp.*, hawthorn *Crataegus monogyna* and blackthorn *Prunus spinosa*.

Figure 16: Example of species poor hedgerow found on site.

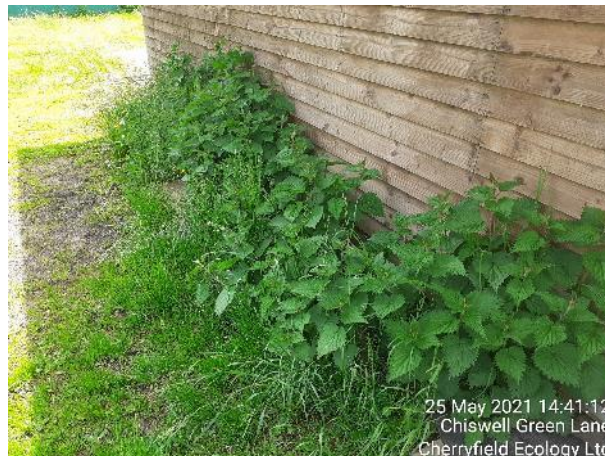
Small amounts of tall ruderal vegetation is found close to boundaries and in the surrounds of building B2. Species here are dominated by nettle *Urtica dioica*.

Figure 17: Example of small amount of tall ruderal vegetation.

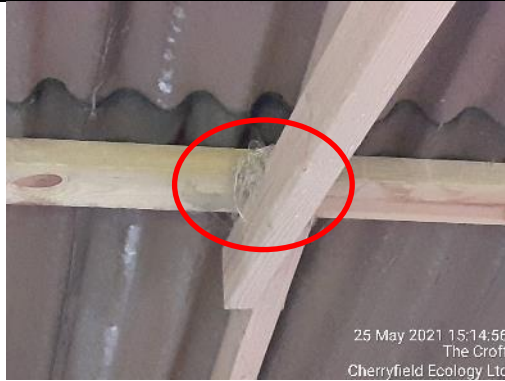
| Target Note | Description |
|---|--|
| T1 | Disused birds nest found in building B4. |

Figure 18: Disused bird's nest.

There is suitable nesting habitat to support breeding birds in the hedgerow found on site. In addition to this buildings B3 and B4 have nesting potential on the internal framework of each building. With access via the stable doors this is easily accessible for breeding birds. This is further evidenced through a disused bird nest found in B4.

Breeding Birds - No further surveys are recommended; however, the development should take place outside the nesting season (March to August). If this is not possible, it is recommended that a qualified ecologist is on site to ensure the buildings and any hedgerow that could be included in plans, is not occupied by breeding birds, prior to demolition or removal. Should an occupied nest be found, a buffer zone would need to be created until the nest is no longer in use.

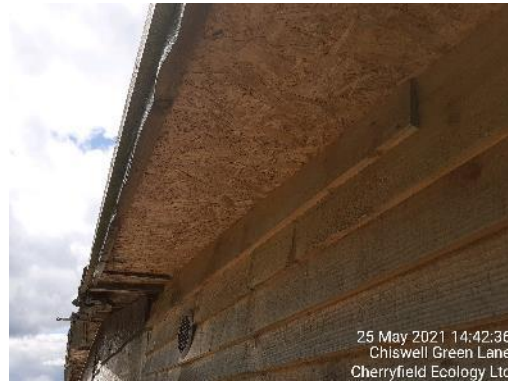
Figure 20: Example of tight-fitting overhanging eaves.

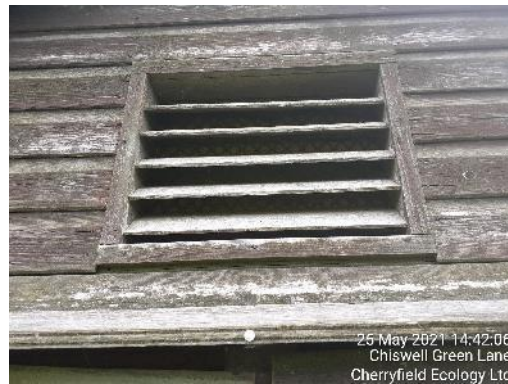
Figure 21: Example of louvre window which has been sealed internally.

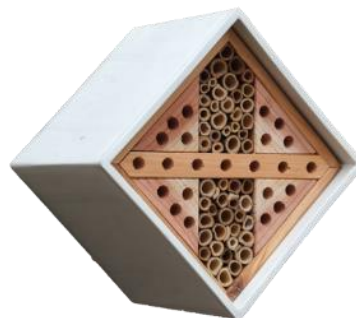
Figure 25: Urban bee nesting box, used for solitary bees and wasps

A variety of insect boxes can be installed in the area; a minimum of two boxes is recommended (Figure 25 and Figure 26).

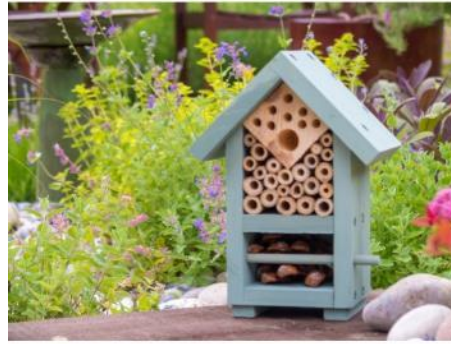
Figure 26: Bug biome, ideal for ladybirds, lacewings and bees

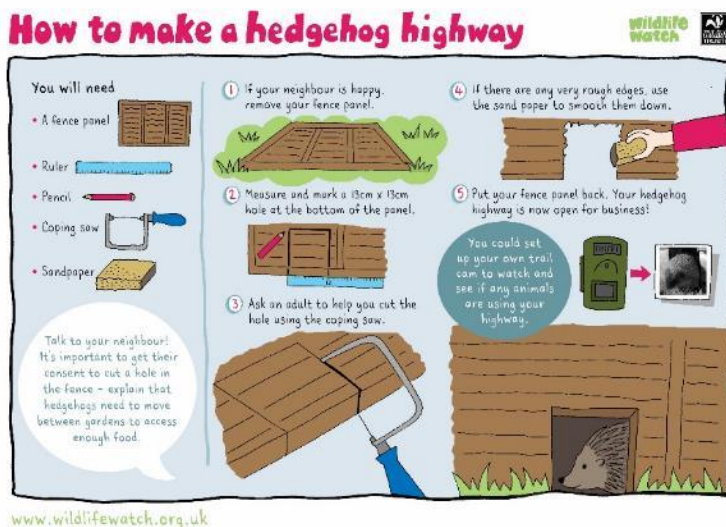
- A 13cm by 13cm is sufficient for any hedgehog to pass through. This will be too small for nearly all pets (Figure 27).
- Remove a brick from the bottom of the wall, creating a 13cm by 13cm hole.
- Cut a small hole in your fence if there are no gaps.
- Dig a channel underneath your wall, fence or gate.
- Ideally, rather than walls or fences, a hedge will provide foraging, shelter and a route along as well as through the site.

Figure 27: Hedgehog Highway, Source - Wildlife Trust - <http://7474fab53f1b6ee92458->

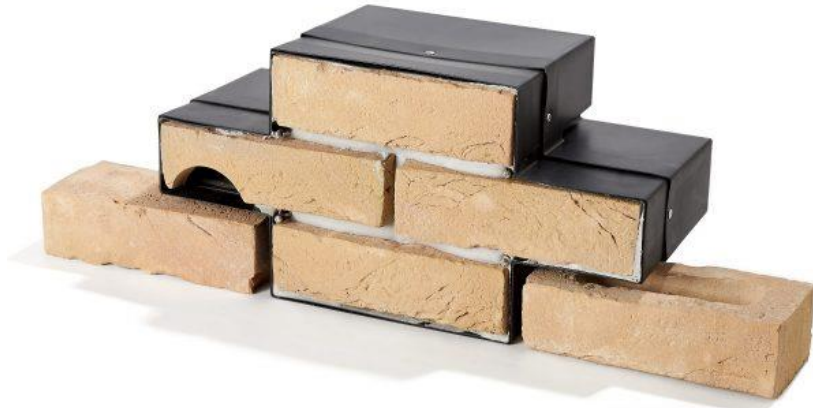
| <p>Swifts <i>Apus apus</i></p> | <p>Swift nest boxes are recommended due to the increased lack of nesting opportunities swifts are finding in modern built dwelling homes.</p> <p>Information is adapted from the RSPB https://www.rspb.org.uk/our-work/rspb-news/news/stories/swift-advice-for-ecologists/ and http://actionforswifts.blogspot.com</p> <p>The following will be undertaken:</p> <ul style="list-style-type: none"> • Wherever possible, swift bricks will be installed into new or restored buildings to increase the overall availability of nest sites for swifts and other species. Birds such as house sparrow can use swift bricks, but swifts cannot use house sparrow nest bricks. • Integral swift bricks are the preferred option on new housing developments. These should be fitted in clusters of 2 to 4 on gable ends and near the roofline where swifts would naturally look for a potential nest site. • Try to ensure swift bricks have a minimum of 5m clearance beneath and in front. Always avoid locating them above doors and windows to help prevent a disturbance issue to both the birds and human owners. • Alternatively, swift boxes can be placed on the external walls of a building when a restoration or opportunities don't exist to build in the boxes. |

Figure 28: Example of swift bricks, that can be built into a dwelling, Source: <https://www.birdbrickhouses.co.uk/brick-nesting-boxes/>

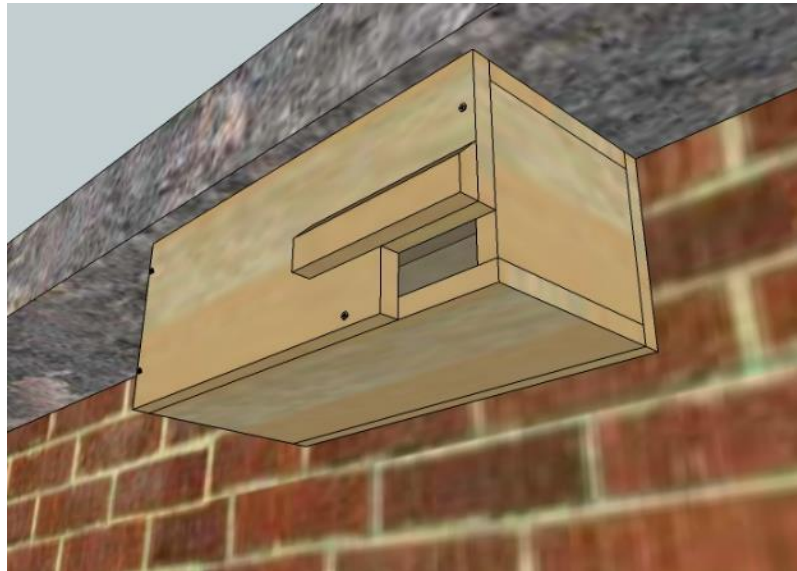
Figure 29: Swift box, source: <http://actionforswifts.blogspot.com/p/diy-swift-box-designs.html>
