LEA VALLEY LINEGREENSPACE ACTION PLAN 2025 – 2030

Site Name: Lea Valley Line

Site Address: Westfield Road, St Albans, AL5 4LT

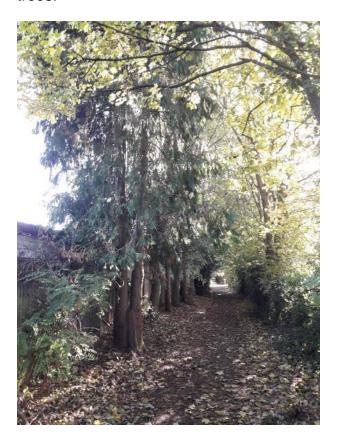
There are a small number of hedgerows delineating the boundary of the site. In particular, heading south from the entrance at Westfield Road the route is very

narrow and is enclosed by a hawthorn hedge with holly stands, and a line of conifer trees.

Line of conifer trees

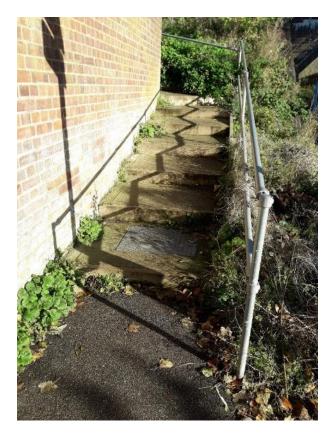
Ox Lane – The route passes over Ox Lane via a bridge, with steps providing access to, and from, the route. The steps were renovated during the last five years, with new timber risers and step surfaces installed. The fencing adjacent to the bridge was also replaced.

Stepped access from Ox Lane

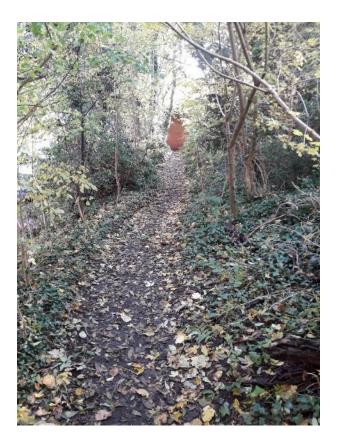
Informal access from Coldharbour Lane – Leads on to the route through the developing secondary woodland.

Informal access from Coldharbour Lane

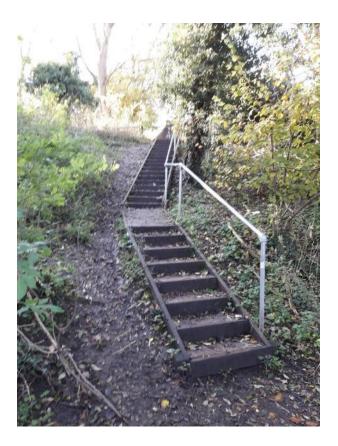
Crabtree Fields – There are steps which lead down from the area of waste ground and woodland adjacent to Harpenden Sewage Works. There are a number of informal paths through the woodland leading to Crabtree Fields, a local greenspace, and surrounding residential streets.

Stepped access towards Crabtree Fields

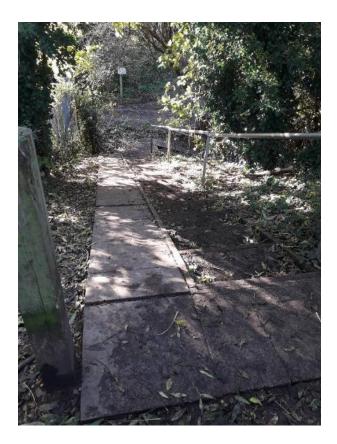
Marquis Lane – The route passes over Marquis Lane via a bridge, with steps and adjacent cycle ramp providing access to and from the route. These steps were renovated during the last five years with new timber risers and stepped surface, however erosion at the bottom of the steps has created an uneven final step.

Stepped access from Marquis Lane with adjacent ramp

Marquis Lane Bridge – Existing fencing adjacent to the top of the bridge should be replaced to match the post and rail fencing recently installed at the Ox Lane bridge. The ground at the bottom of the steps should be reprofiled to fix the uneven final step.

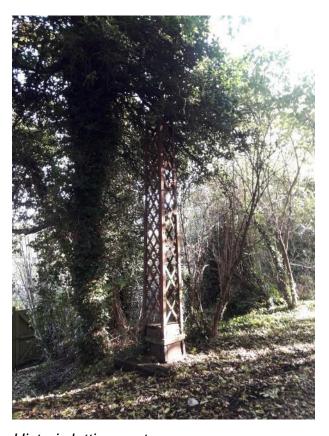
Few features relating to the railway heritage of the route survive, with the main remaining feature a lattice post found along the section between Westfield Road and Ox Lane.

Historic lattice post
