The Wick

Greenspace Action Plan

2017 - 2022

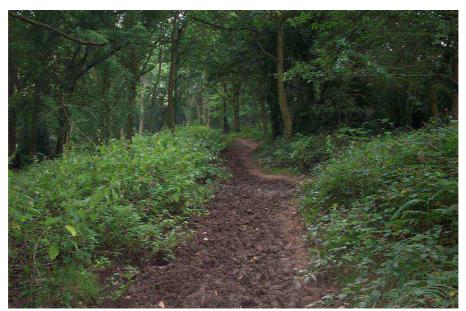
Woodland before path surfacing

To try and reduce the damage to the woodland and encourage people to stay on the path, the surfaced paths will be reinstated around the woodland to make a suitable walking surface all year long. Paths will be surfaced using clean recycled concrete aggregate or virgin aggregate, which are permeable materials so that water can drain away. Disruption will be kept to a minimum when carrying out the works. Using woodchip is unsuitable as it soaks up the water and creates boggy patches, which makes it difficult for people with buggies, wheelchairs or mobility scooters to cross. It can also pose a biosecurity risk. The main path from Marshal's Drive to Sandpit Lane and into the grassland (at the northern and southern ends) will be wide enough and of a suitable specification for use by maintenance, utility and emergency service vehicles. The footpath around the west of the site will be only suitable for pedestrians. By the play area a vehicle crossing point will be installed over the western footpath to allow access into the south west corner of the woodland. This will be in the form of a sleeper installed either side of the path, so when vehicles cross no weight is put onto the path surface. No vehicle access is intended from Sandpit Lane.

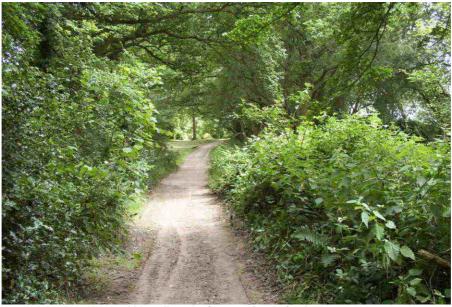
Woodland after path surfacing
