Outbuilding Immediately To East Of Burston Manor House

Location: Outbuilding Immediately To East Of Burston Manor House, North Orbital Road, St Stephen, St Albans, Hertfordshire

Reference: IOE01/04887/35

Type: Photograph (Digital)

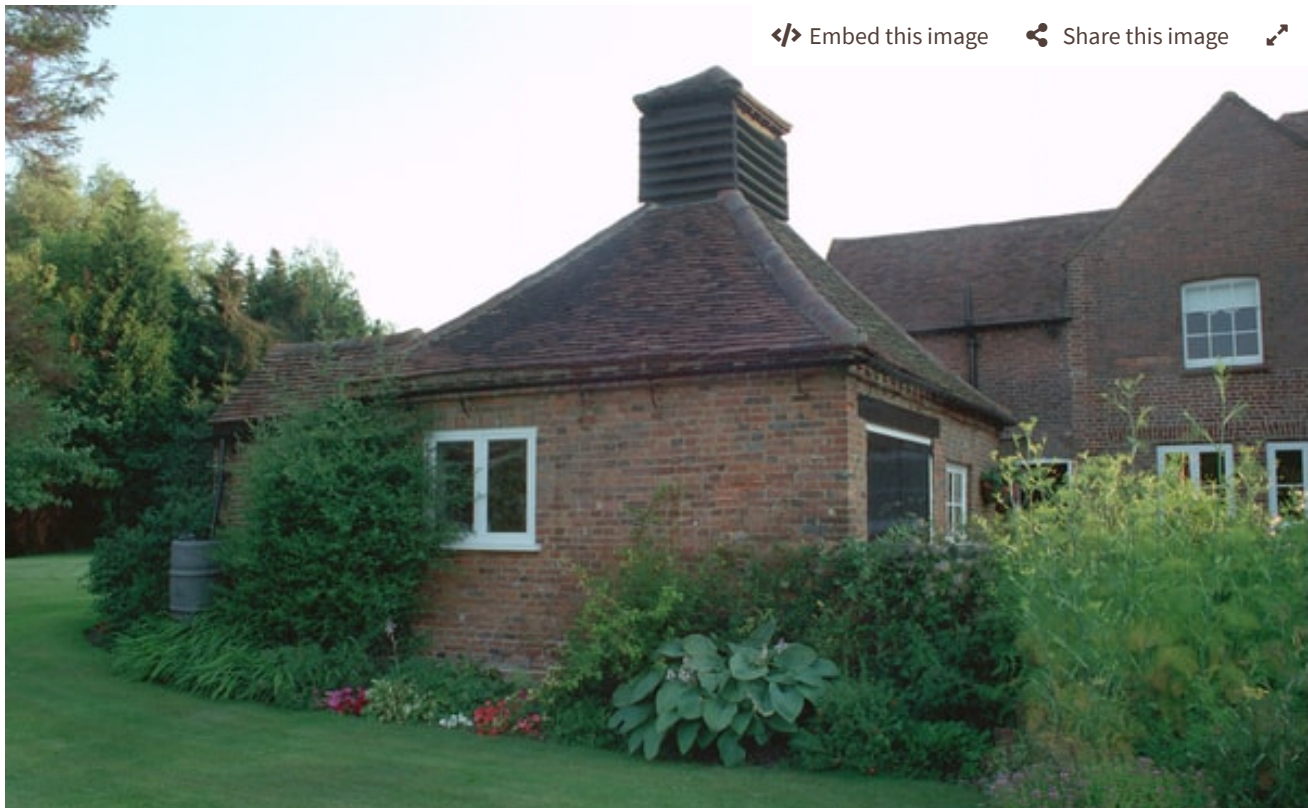
12/330 Outbuilding immediately to E of Burston Manor House

Small outbuilding, built as granary and dovecote. Late C17, altered early C19. Red brick. Plain tile pyramid roof surmounted by a slatted wood square ventilator, itself with pyramid roof. Dentilled brick eaves. W side has a broad plank door in a heavy oak frame. Adjoining at right end on this side is a short stretch of mid-C17 garden wall with saw-tooth corbels and saddleback coping. C20 garage door on S side.
